# SAFETY RECALL BULLETIN

SUBJECT: <b>ENDEAVOR SHIFT INTERLOCK SAFETY RECALL CAMPAIGN</b>			No: <b>SR-08-003</b>
			DATE: <b>June, 2008</b>
			MODEL: <b>2004-08 Endeavor</b>
<b>CIRCULATE TO:</b>	<input type="checkbox"/> GENERAL MANAGER	<input checked="" type="checkbox"/> PARTS MANAGER	<input checked="" type="checkbox"/> TECHNICIAN
<input checked="" type="checkbox"/> SERVICE ADVISOR	<input checked="" type="checkbox"/> SERVICE MANAGER	<input checked="" type="checkbox"/> WARRANTY PROCESSOR	<input checked="" type="checkbox"/> SALES MANAGER

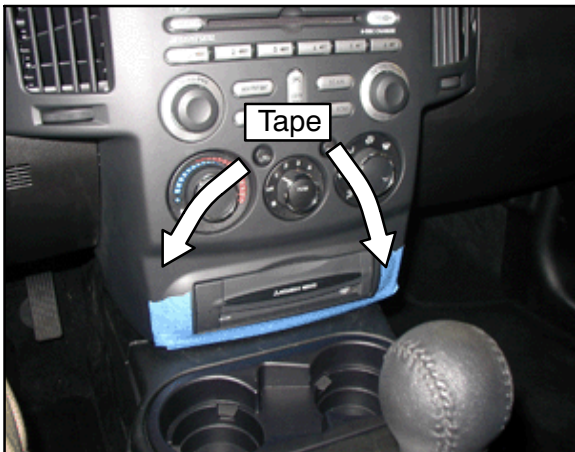
1. Place the shift selector lever in the "P" position.
2. Turn the ignition key to the "Lock" (off) position.
3. Apply the parking brake.
4. Apply masking tape to the corners of the center console to prevent scratching during floor console disassembly.

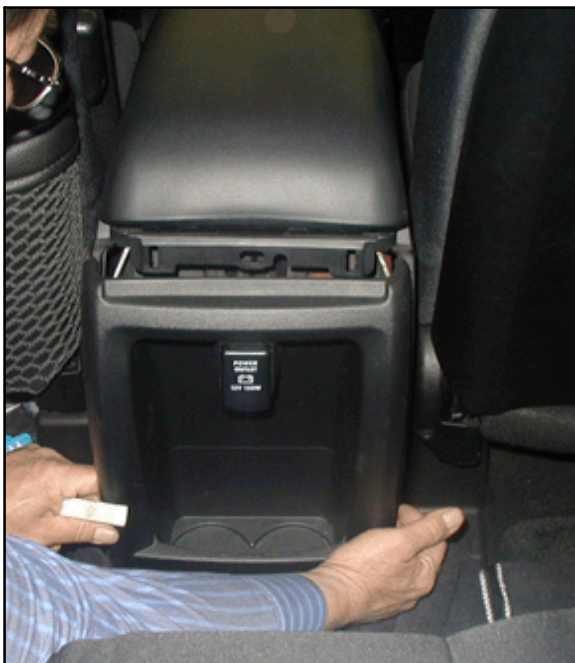
5. Remove the rear floor mat (if equipped).
6. Remove the floor console rear panel using a trim removal tool.

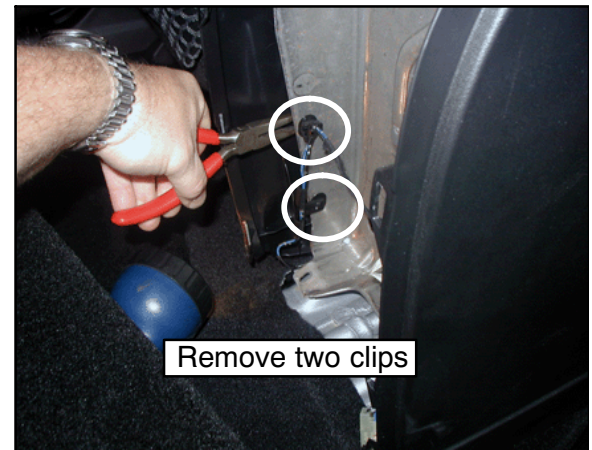
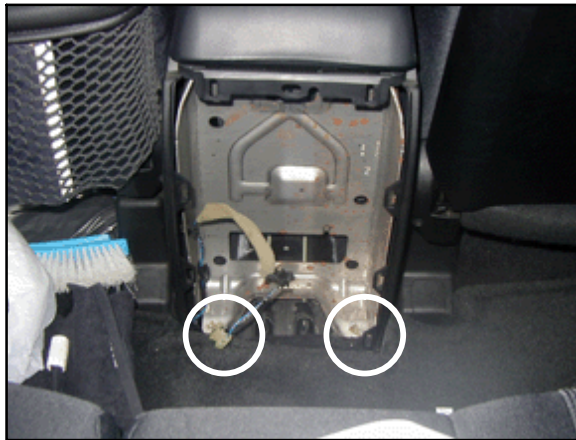
7. Disconnect the harness from the ACC (accessory) socket and rear fan (if equipped). Remove the clip securing the harness to the rear console panel and set the panel aside. Use needle-nose pliers to remove the harness from the console structure as shown.

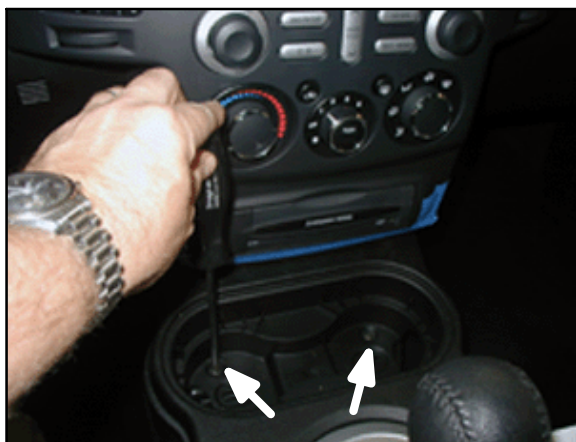
8. After removing the rear panel and the harness, use a 10mm socket to remove the two 10mm bolts from the bottom of the floor console as shown.

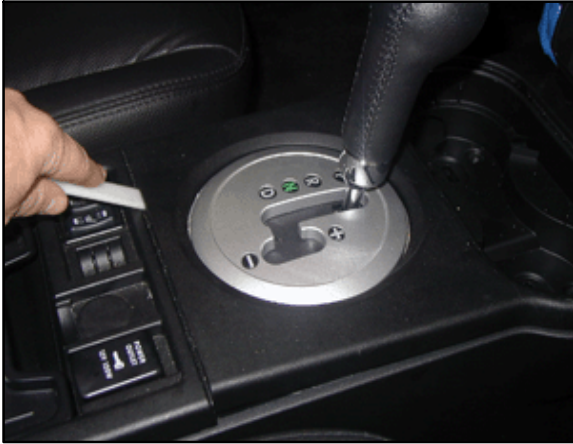
10. After removing the cup holder, remove the two front floor console retaining screws as shown.

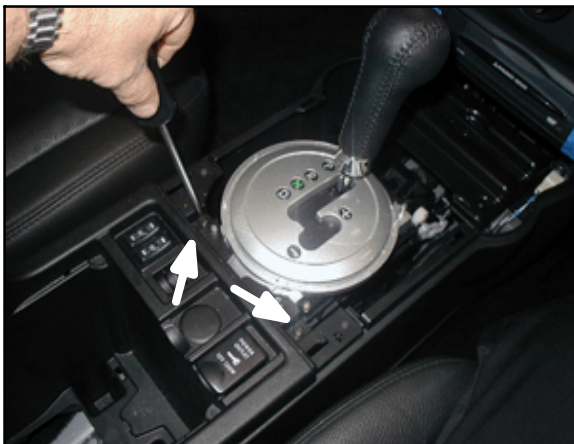
16. Disconnect the floor console harness connector at the right front area of the floor console.

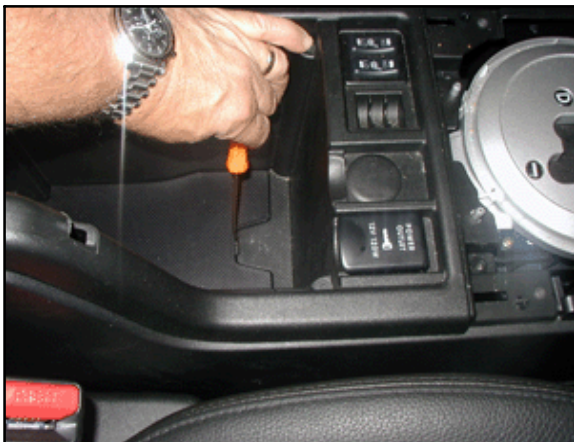
17. Remove 2 screws from the floor console at the rear of the shifter.

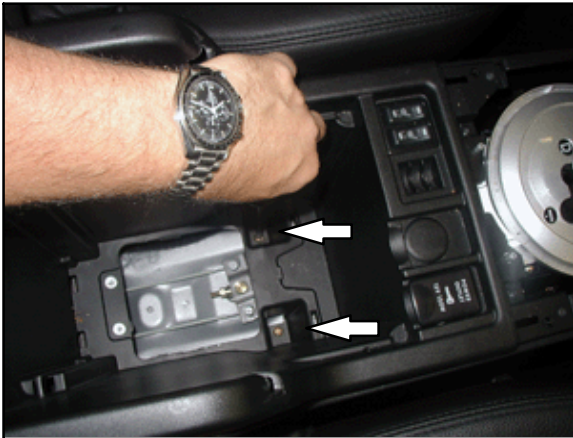
18. Using a small screwdriver or 90° pick, lift the floor plate from the bottom of the floor console storage box.

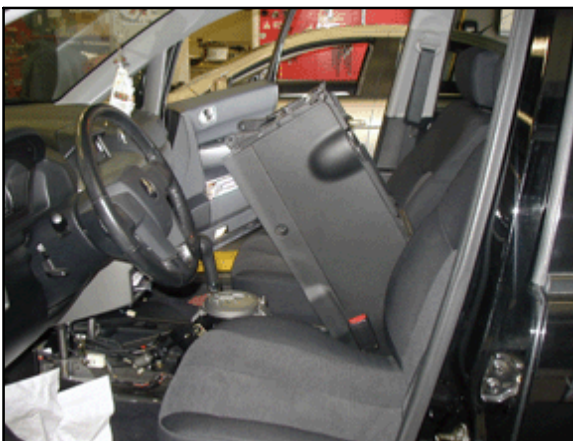
20. Turn the ignition key to the "ACC" position and place the shift lever in "D".
21. Grasp the the floor console at the rear and near the shift plate. Lift the floor console straight up until it clears the pins indicated in the photo, then slide the console toward the rear of the vehicle.
22. If the vehicle is equipped with heated seats, reach under the switch assembly and push it out of the floor console cover. Disconnect the electrical connector from the switch assembly and set the switch assembly aside.
