**Subject: Revised Documents for Recall Campaigns 08V-157 (20L8/JY),
08V-064 (70D1/JX) and 07V-375 (JL00/JL)**

**Subject: 2001-2004 MY Audi A6 quattro® equipped with 2.7L, 2.8L, or 3.0L
and 2001-2005 MY Audi allroad quattro® equipped with 2.7L or 4.2L
Reinforce Fuel Tank Rollover Valve Nipple**

20L8/JY Safety Recall

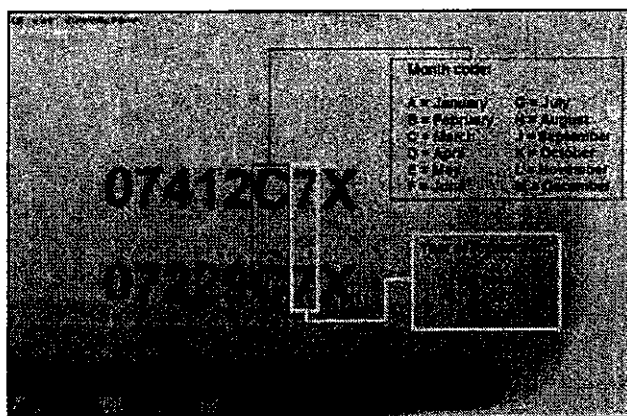
- Check 3M™ adhesive production date by referencing 3M™ Adhesive Storage / Expiration chart above

⇐ Production date located on 3M™ adhesive tube label

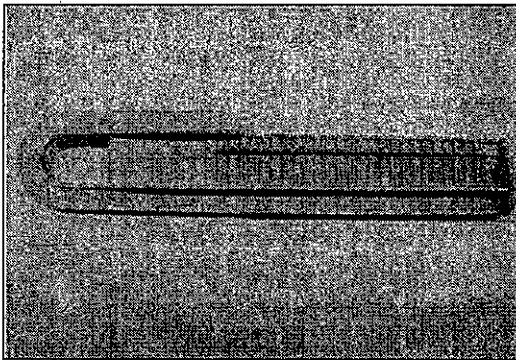
⇐ Feed plunger VAS 5155/3

(for glue cartridge with mixing ratio 1:10)

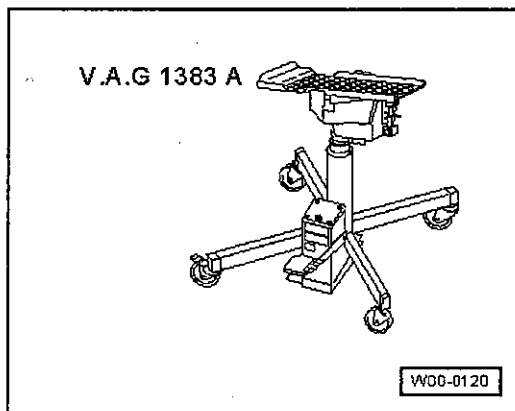
⇐ V.A.G. 1383 A with universal support V.A.G. 1359/2 or equivalent

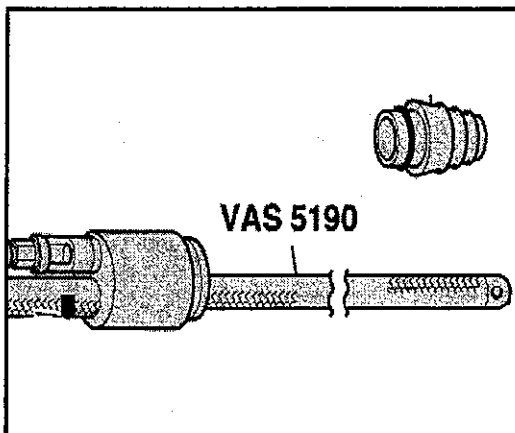
⇐ Fuel siphoning device VAS 5190 or equivalent

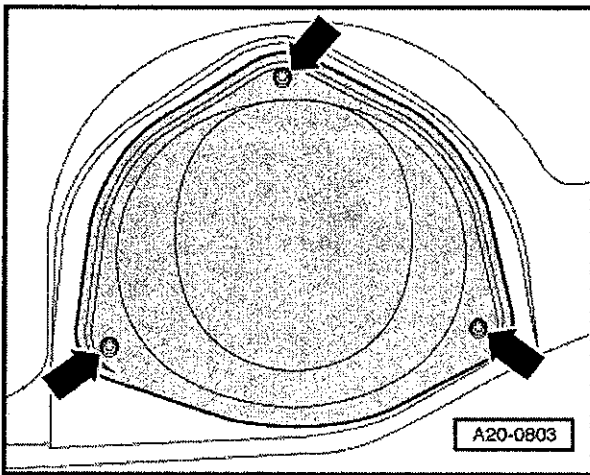
- Remove rear seat bench
- ⇐ Remove cover for flange on fuel tank under rear seat bench (driver side)

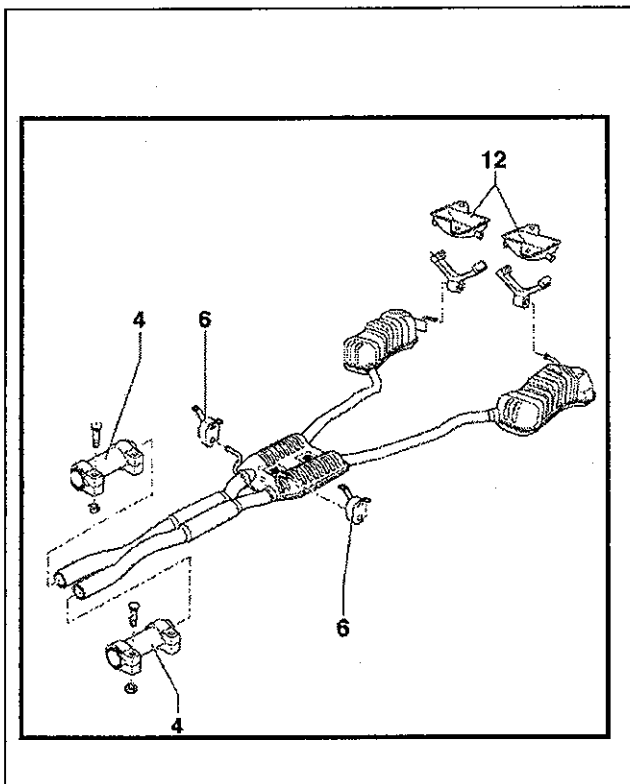
- Lift vehicle
- ⇐ Disconnect rear exhaust at clamps -4-
- ⇐ With assistance of another person, disconnect rear support brackets -12- and -6- and lower exhaust onto floor
- Move exhaust from underneath vehicle and place aside

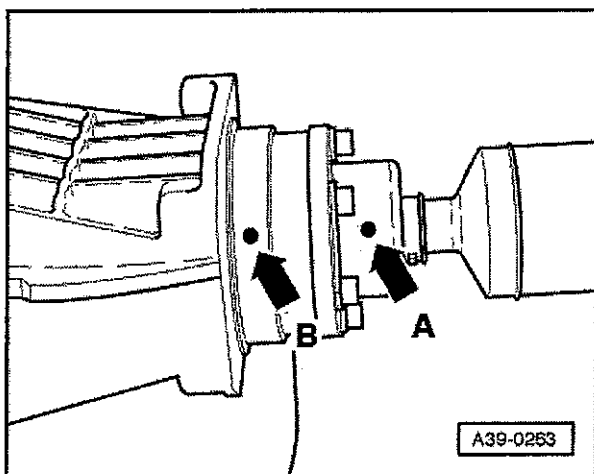
- ⇐ Check whether there is a factory marking (paint) on driveshaft. If not, mark location of driveshaft flange -arrow A- to rear final drive -arrow B-

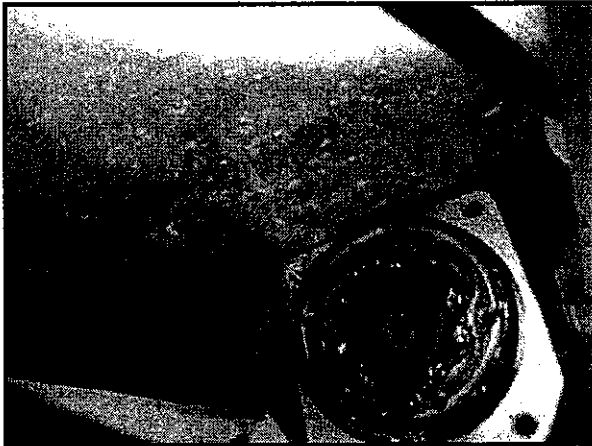
- ⇐ Lower fuel tank as far as rear final drive
(Tank can rest on rear final drive as shown)

Note: Fuel tank is not removed completely from vehicle

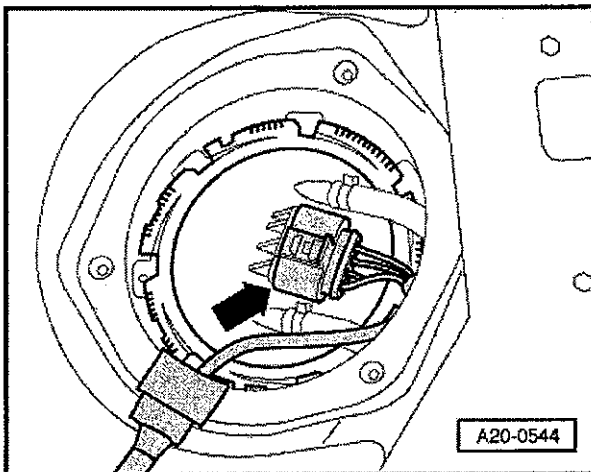
- Lower vehicle
- ⇐ Carefully release 4-pin connector -arrow- and disconnect harness for fuel sending unit

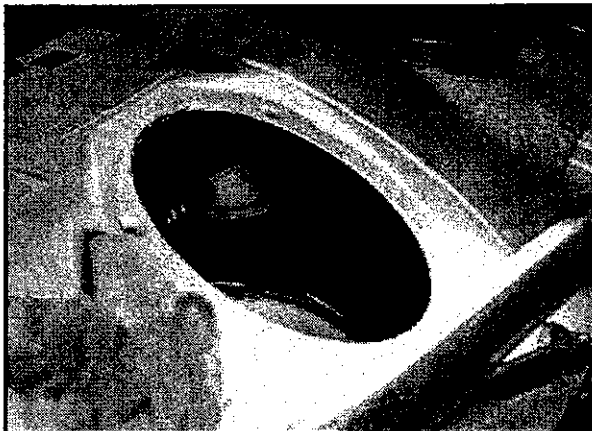
- ⇐ Clean rollover valve carefully with cleaning fluid (D 009 401 04) to ensure valve is free of dust and grease

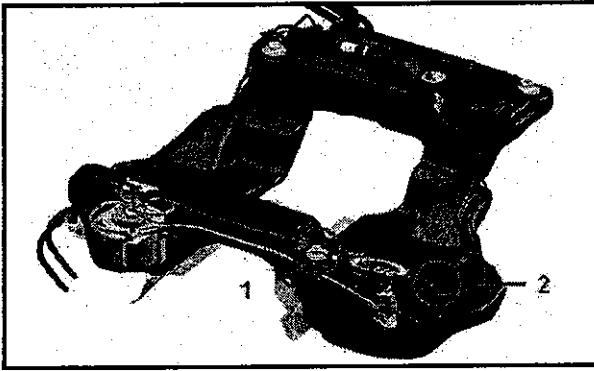
- ⇐ Install serrated rubber clip -2- from kit (4B0 298 403) onto ventilation line leading to rollover valve connection and release clip from mounting on fuel tank

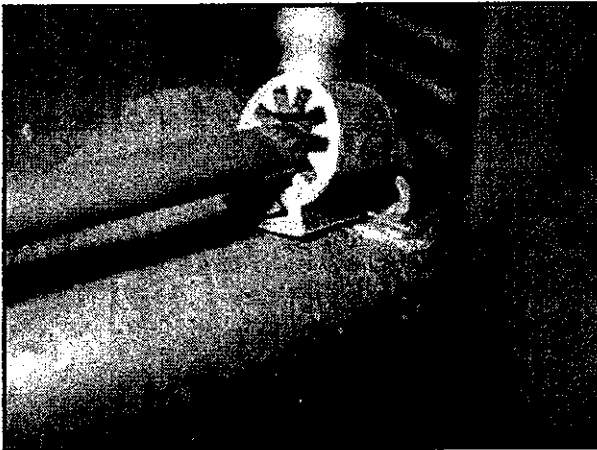
- ⇐ Close rubber clip and allow ventilation line to rest on fuel tank (as shown); **proceed to Section C**

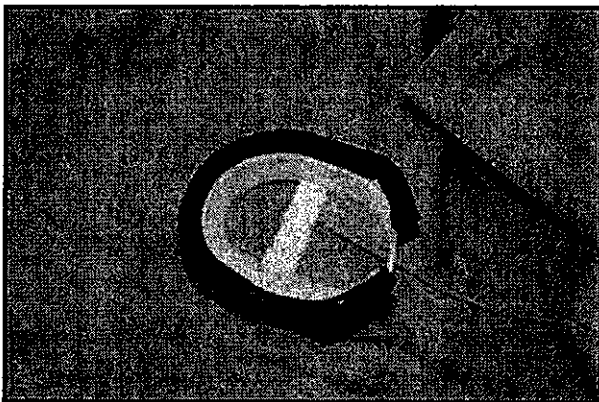
⇐ Remove mold from rollover valve, then place butyl cord around mold

Note: Leave an opening for the ventilation line connection

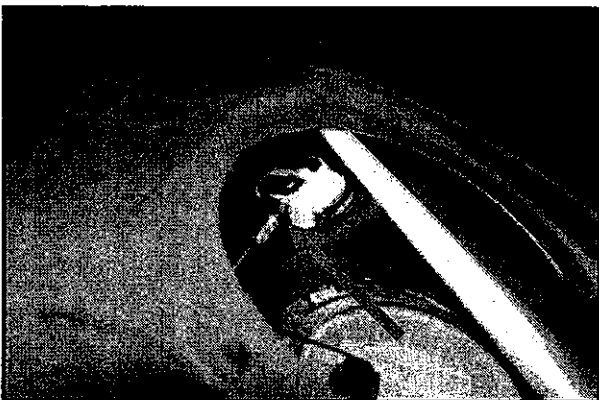
- Install mold with butyl sealant cord (AKL 450 005 05) into position over rollover valve

⇐ Seal off remaining openings at the connection with the butyl sealant cord (AKL 450 005 05)
-arrow-

Note: Ensure all openings are closed completely to prevent leaking from mold

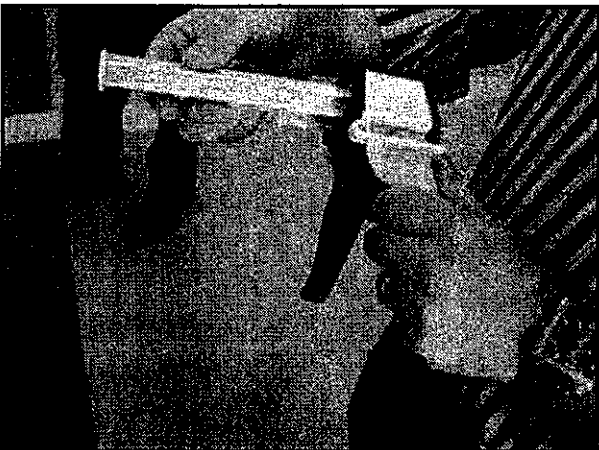
⇐ Assemble VAS 5155 applicator gun by sliding the VAS 5155/3 (10:1) plunger into applicator gun

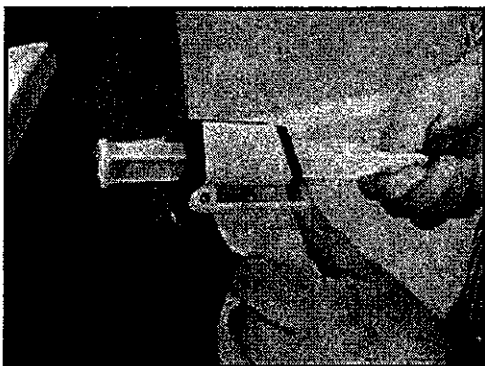
⇐ Pull plunger VAS 5155/3 to rear

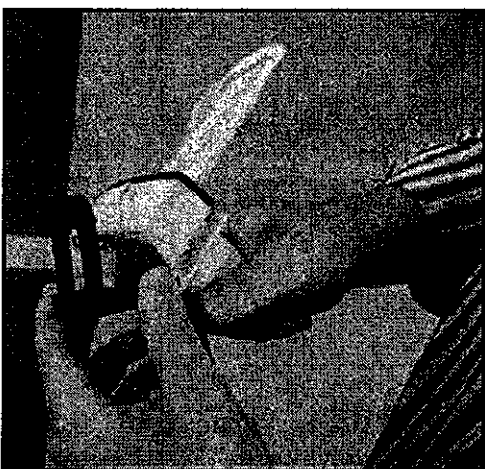
⇐ Lift black tab and fold to front of applicator gun

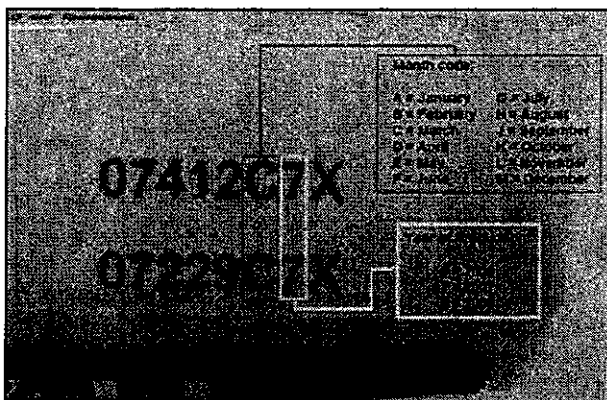
- Check 3M™ adhesive production date by referencing 3M™ Adhesive Storage/Expiration chart on p. 5

⇐ Production date located on 3M™ adhesive tube label

Note: DO NOT use expired adhesive

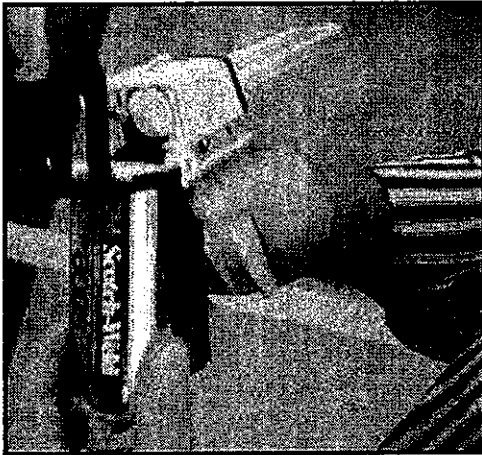
- ⇐ Insert adhesive cartridge (Z3MDP8005) in the VAS 5155 applicator gun and remove cap

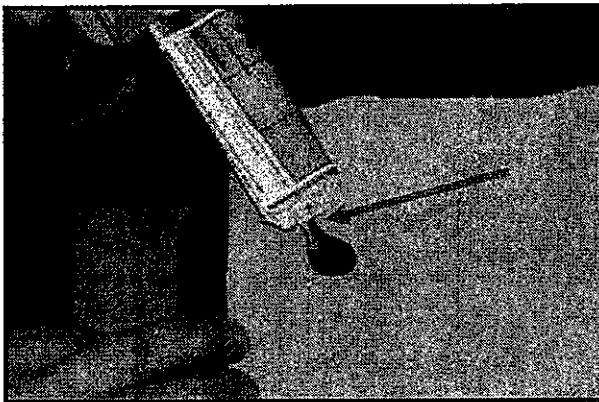
- ⇐ Operate adhesive gun **without** the mixing nozzle (D 001 001) until visible amount of adhesive comes out of both chambers of the cartridge -arrow-
- Clean tip of cartridge and fit the mixing nozzle (D 001 001)
- With nozzle installed, check 3M™ adhesive flow to ensure compounds are blended

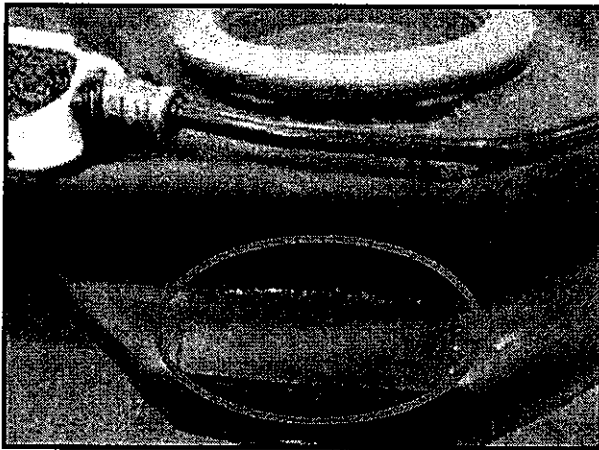
- Lift vehicle
- Apply small amount of adhesive to spacer plate
- ⇐ Attach spacer plate to contact surface of fuel tank -circle-

Note: Ensure that the spacer plate fits flat onto the surface of the fuel tank and not over the upward curve of the fuel tank wall

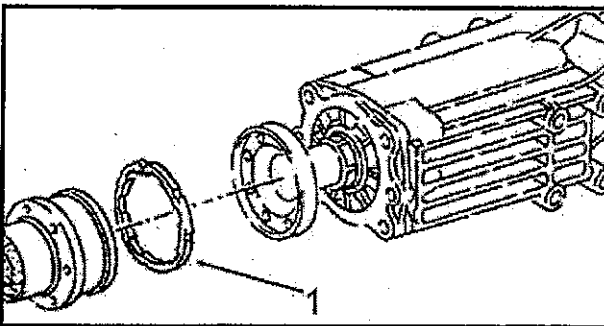
- To replace rear final drive gasket (183 521 141A), peel off backing foil, then affix self-adhesive side of gasket to flange shaft

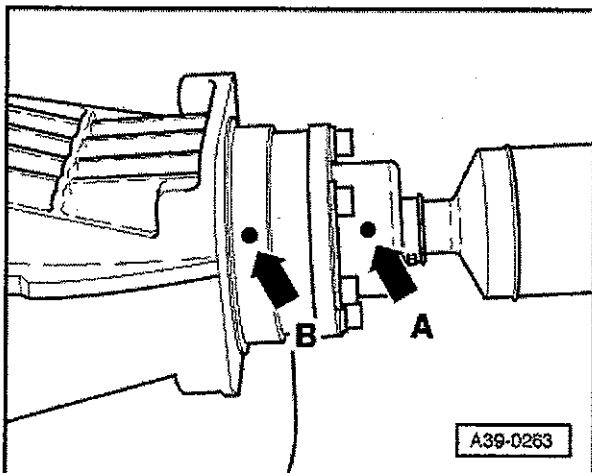
⇐ Using new bolts (N 019 926 1), install driveshaft by lining up marks -A- and -B-, torque to 55 Nm

Note: For proper balance, the driveshaft flanges -arrow A- and the rear final drive -arrow B- must be installed so that the factory color markings or markings which were made afterward are aligned

The threads in the drive flanges of the rear final drive must absolutely be cleaned of locking compound residue; otherwise, there is a possibility that the new bolts may get jammed when installed and shear when removed

Cleaning can be performed with a thread tap

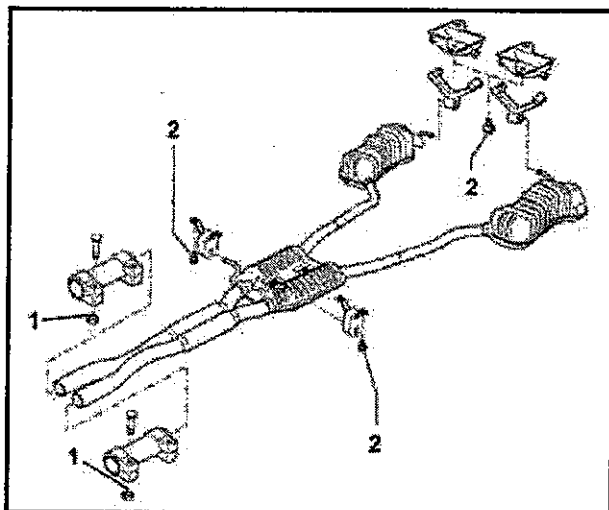
- Install rear exhaust
- Position exhaust system free of tension
- ⇐ Tighten clamp bolts -1- to 40 Nm
- ⇐ Tighten mounting bracket bolts -2- to 25 Nm
- Reconnect 4-pin connector for fuel sending unit
- Reinstall cover for flange on fuel tank under rear seat bench (driver side) and reinstall rear seat bench
- Replace any fuel removed from vehicle

Note: Let vehicle sit for approximately six (6) hours for adhesive to cure to prevent damage due to vibrations or movement of ventilation line
