RECALL CAMPAIGN BULLETIN

NTB08-048

VOLUNTARY RECALL CAMPAIGN 2008 ARMADA, TITAN, QUEST MANUAL FRONT SEAT TRACK

CAMPAIGN ID # PB068
NHTSA # 08V-187
APPLIED VEHICLES: 2008 Titan (A60) with manually adjusted front seats
2008 Armada (TA60) with manually adjusted front seat
2008 Quest (V42) with manually adjusted front seats

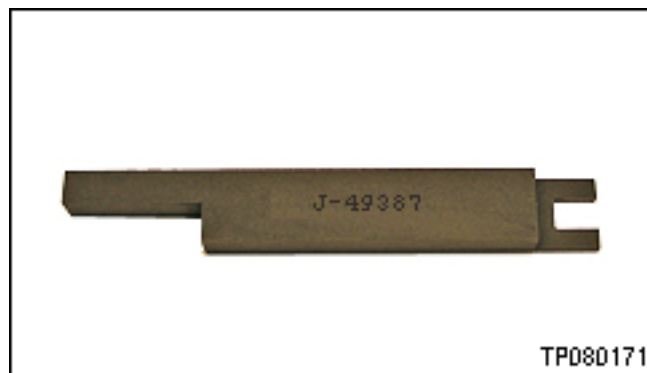
Figure A

Required Special Tool (J-49387)

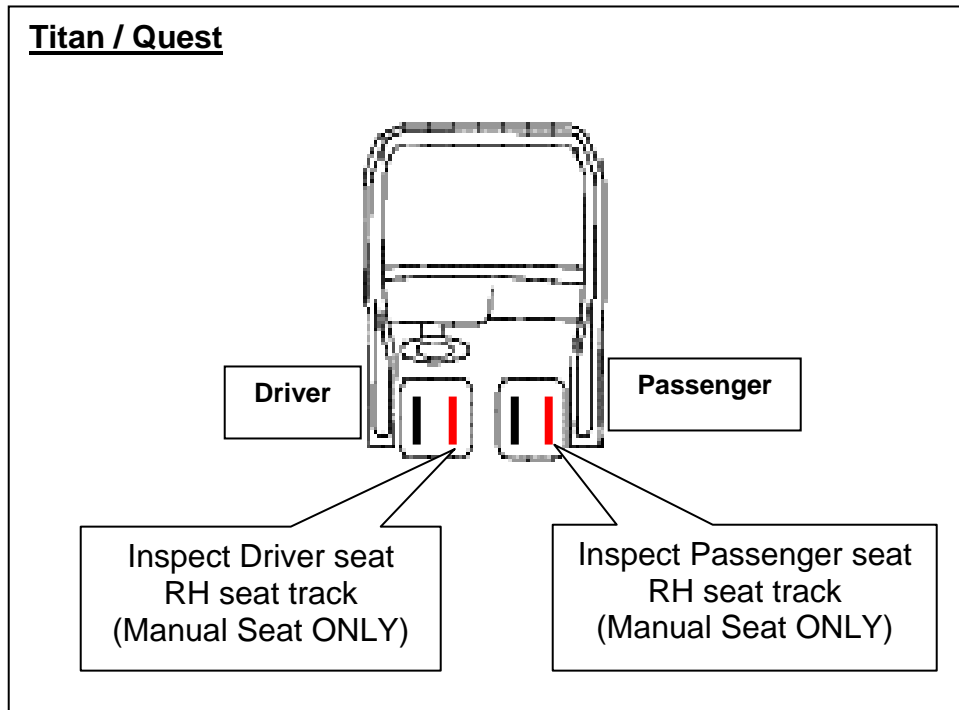
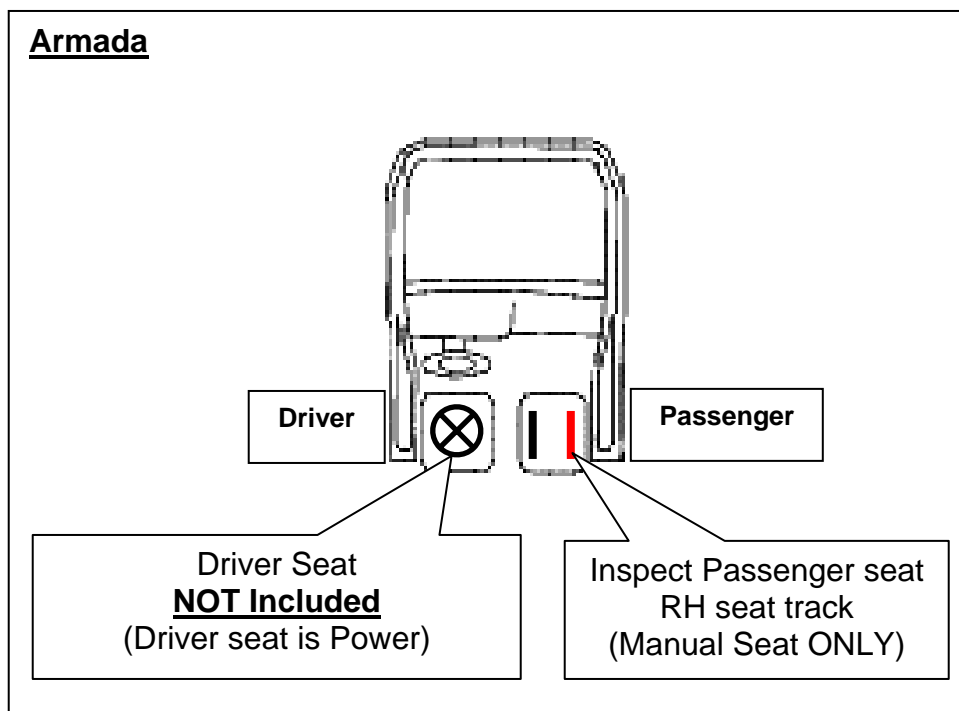
Affected seat tracks are located on the Right Hand side on BOTH the Driver and Passenger front Manually Adjusted seats ONLY (see Figure B & C).

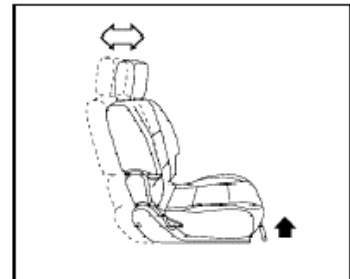
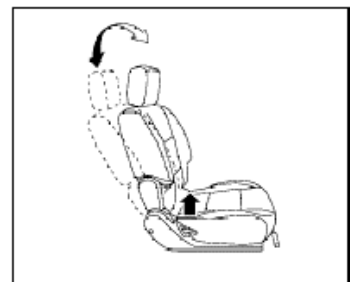
Figure 1

- Manually adjusted seats are identified by the manual levers used to adjust the seat forward, backward, and recline (see Figures 1 and 2).
- If it is not a manually adjusted seat, this procedure does not apply.

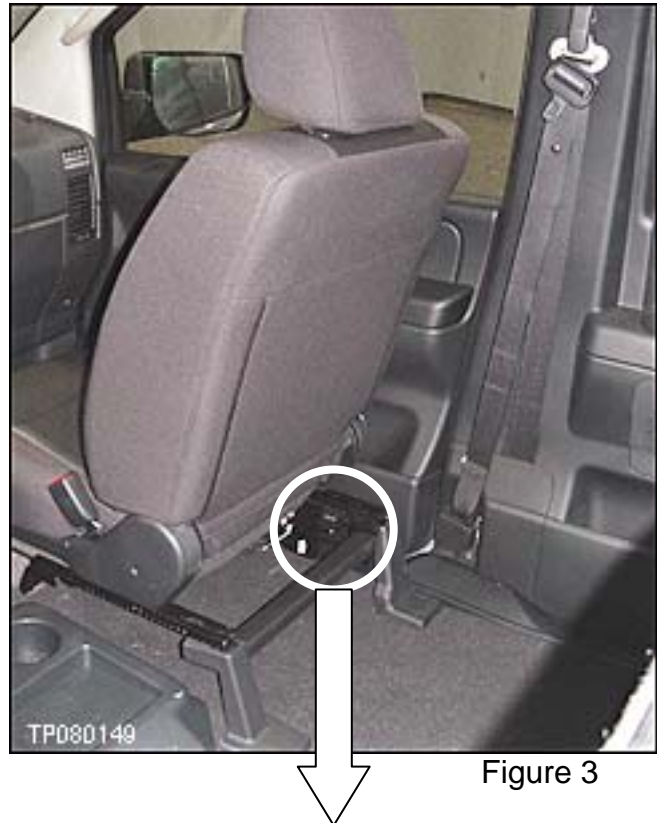
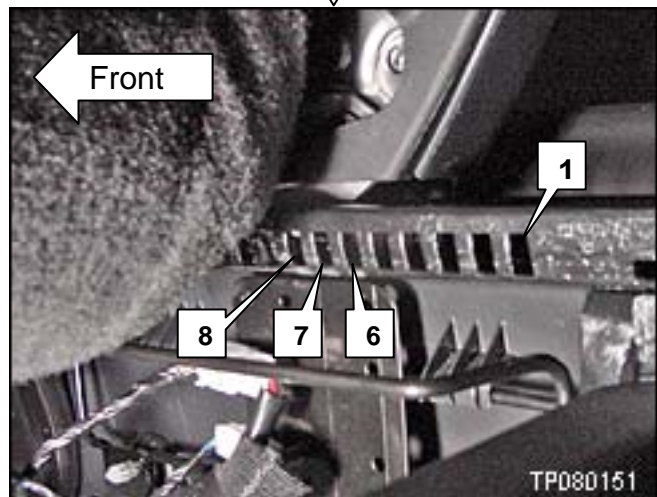
3. At the back of the right side seat track (see Figure 3 and 4);

Count the slots (back to front). Identify and mark slots 6, 7, and 8.

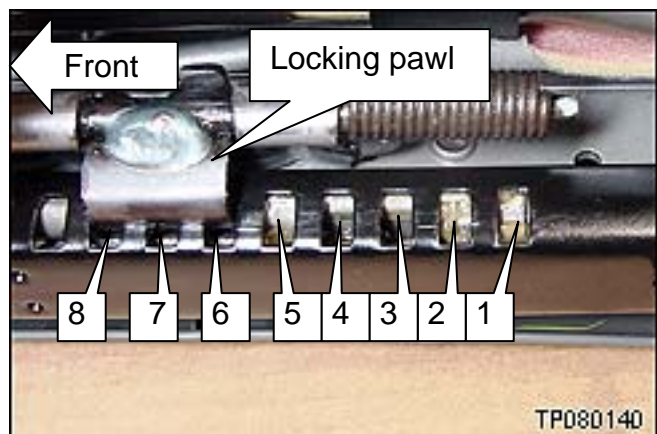
Figure 5

4. Move the seat backwards and position it so the 3 teeth on the locking pawl are engaged in slots 6, 7, and 8 of the seat track.

5. Sit in the seat and shift your body weight forward and rearward to confirm the seat locking pawls are securely in position.

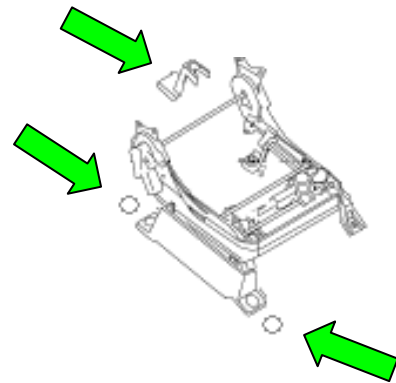
Figure 6

9. Remove seat trim pieces to access seat mounting bolts.

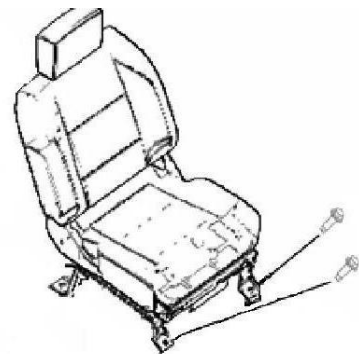
Figure 7

10. Remove the two front mounting bolts.

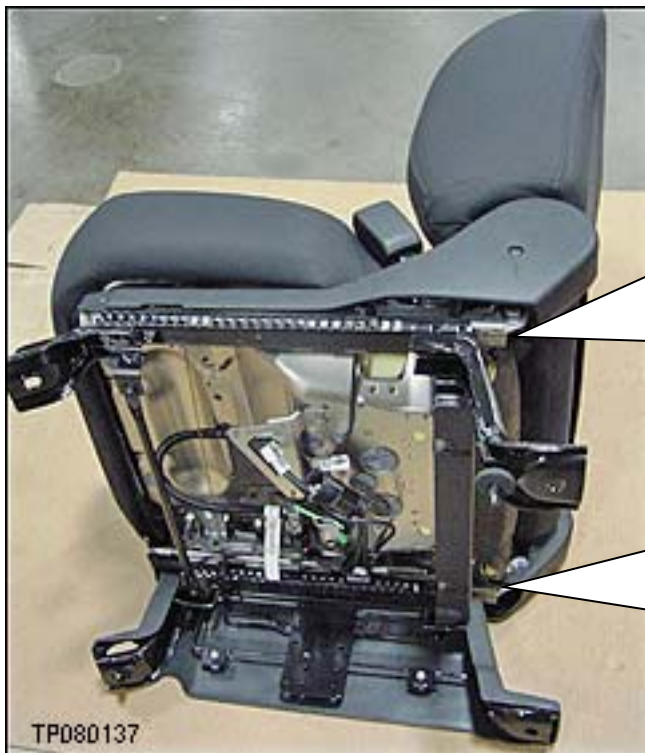
Figure 9

15. Make sure the seat tracks are adjusted / set to the correct position using the special tool (J-49387) as shown in Figure 9.

- Both tracks must be in the same position.
- Make sure the locking pawls are fully engaged.

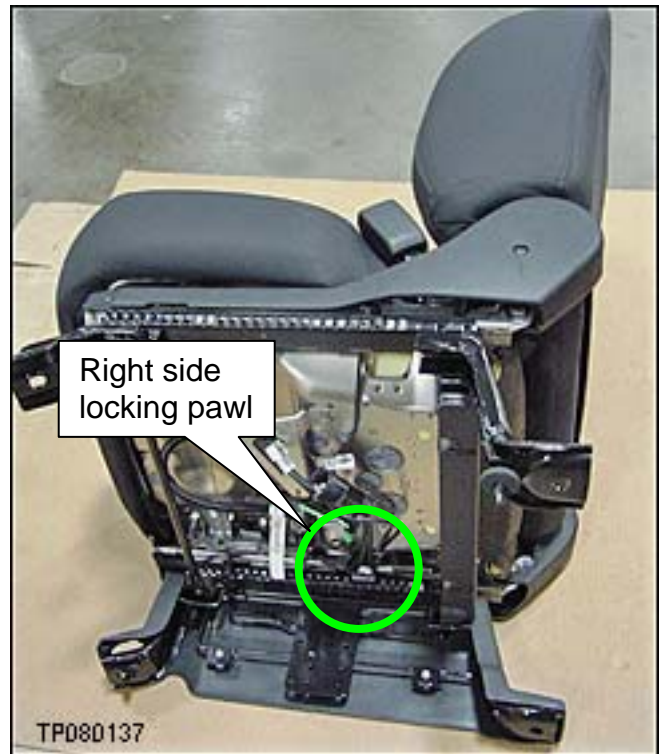
Figure 10

NOTE: All inspection steps will be done at the location shown in Figure 10.

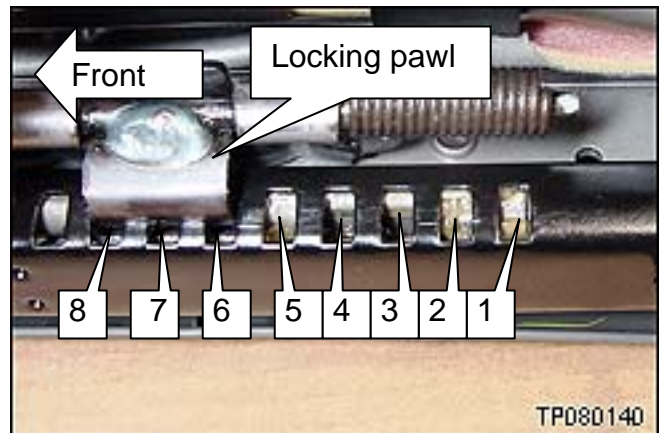
Figure 11

- The three teeth on the pawl should be in slots 6, 7, and 8; counting from the rear.

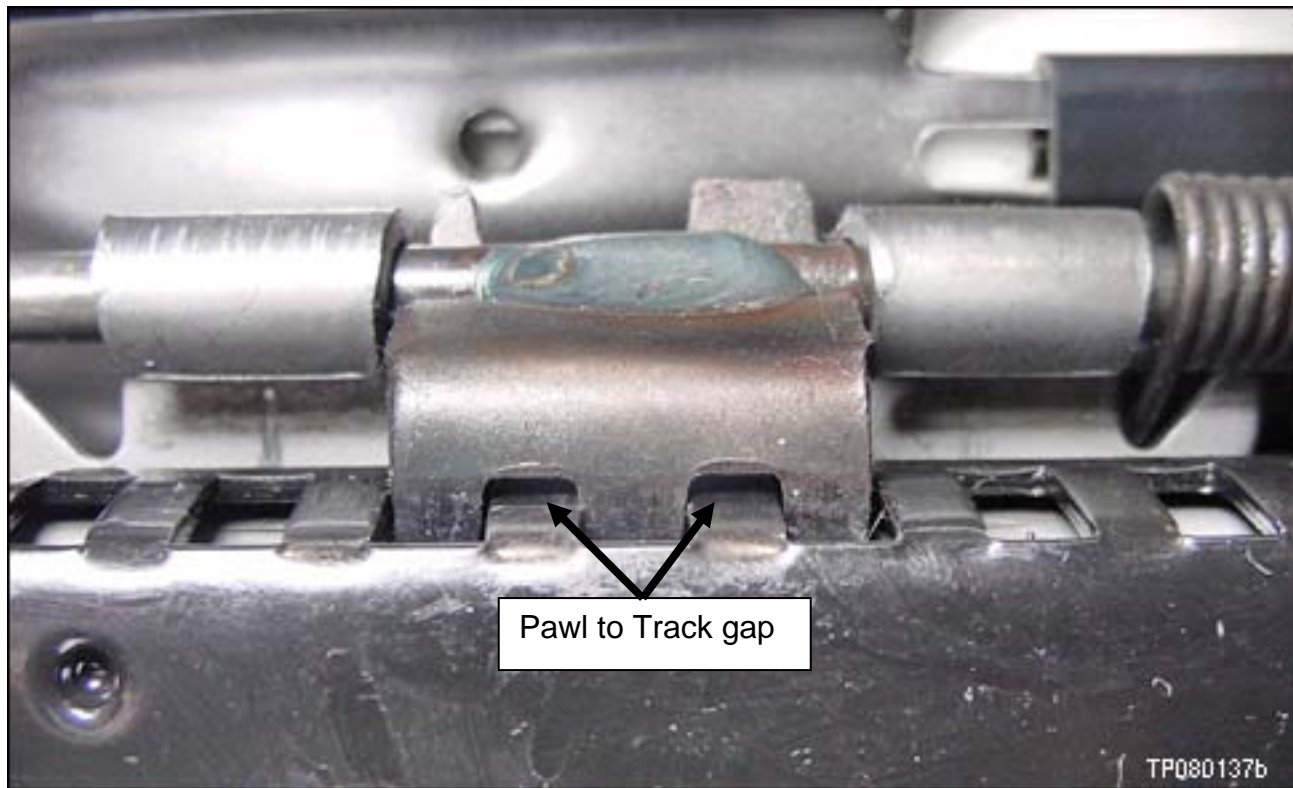
Figure 12

NOTE: In step c (on the next page) you will be checking the “Pawl to Track gap”.

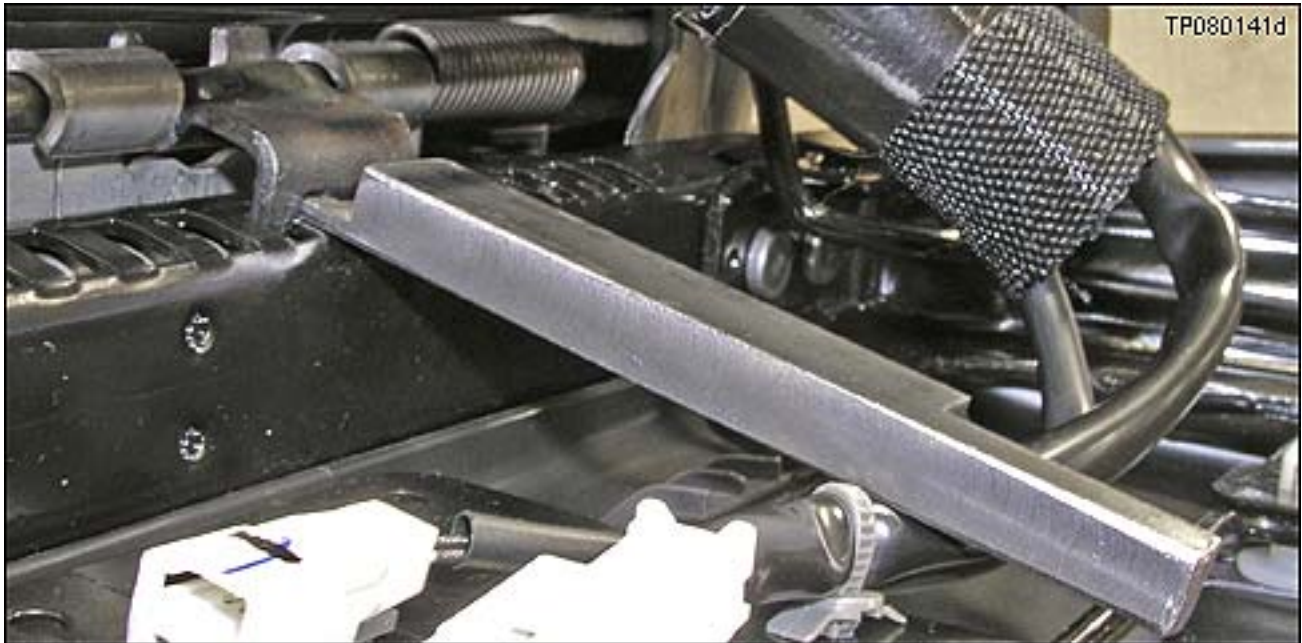
Figure 13

VERY IMPORTANT: When making the check in step c below, be sure to hold special tool J-49387 at the angle shown in Figure 13.

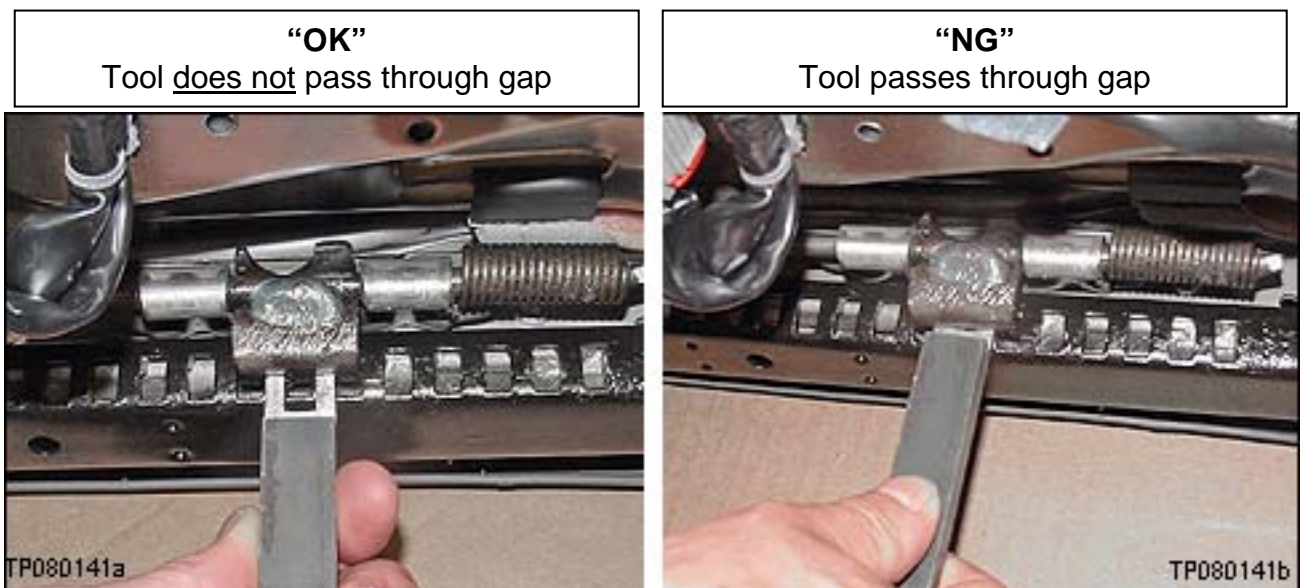
Figure 14

- c. Use the special tool (J-49387) to check the “Pawl to Track gap” as shown in Figure 14.

- If **“OK”**, continue to step 17 and re-install the seat.
- If **“NG”**, order a NEW seat (refer to the Parts Information on page 29); then proceed to step 17 and install the new seat.

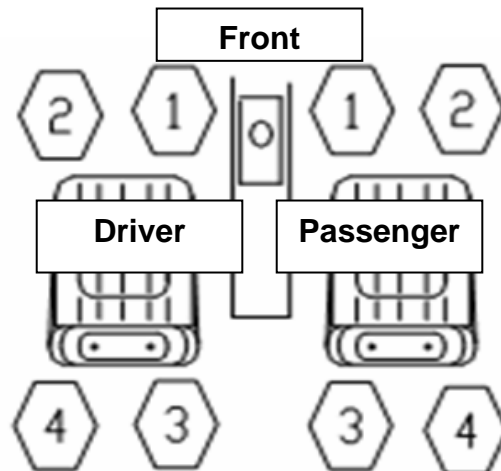
Figure 15

19. Install the seat mounting bolts by hand, then tighten and torque the bolts in the order shown in Figure 15.

- Torque: 49 N-m (5.0 kg-m, **36 ft-lb**)

NOTE: After setting the bolt torque, mark bolt 2 with type correction fluid (white-out).

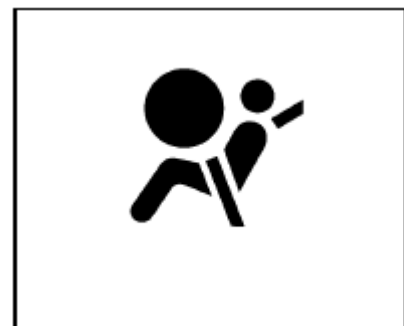
Figure 16

22. Sit in the driver's seat; watch the air bag warning light as you turn the ignition ON.

- The air bag warning light should turn ON for 5 – 7 seconds and then go OFF.
- If the air bag warning light does not turn ON at all, does not turn OFF, or blinks; refer to the Service Manual for diagnosis and repair.

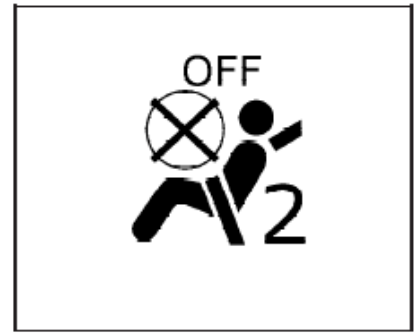
Figure 17

- a. Turn the ignition OFF.
- b. Make sure no one is sitting in the passenger front seat.
- c. Sit in the driver seat, watch the occupant detection system warning light as you turn the ignition ON.

- The occupant detection system warning light should turn ON for 5 – 7 seconds and then go OFF.
- d. Have someone who weighs approximately 150 lbs or greater sit in the passenger front seat in accordance with the recommended seating position in the Owners Manual.
 - The occupant detection system warning light should remain OFF (warning light may turn ON >OFF>ON>OFF for only a few seconds).
 - e. If the occupant detection system warning light correctly operates as described in c and d above, proceed with the next step.
 - If the occupant detection system warning light does NOT operate correctly as described in c and d above, refer to the Service Manual for diagnosis and repair. Then proceed with the next step.

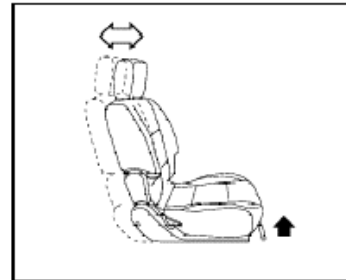
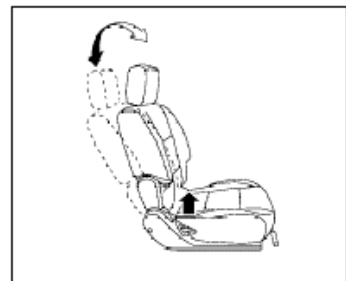
Figure 1-1

- Manually adjusted seats are identified by the manual levers used to adjust the seat forward, backward, and recline (see Figures 1-1 and 1-2).
- If it is not a manually adjusted seat, this procedure does not apply.

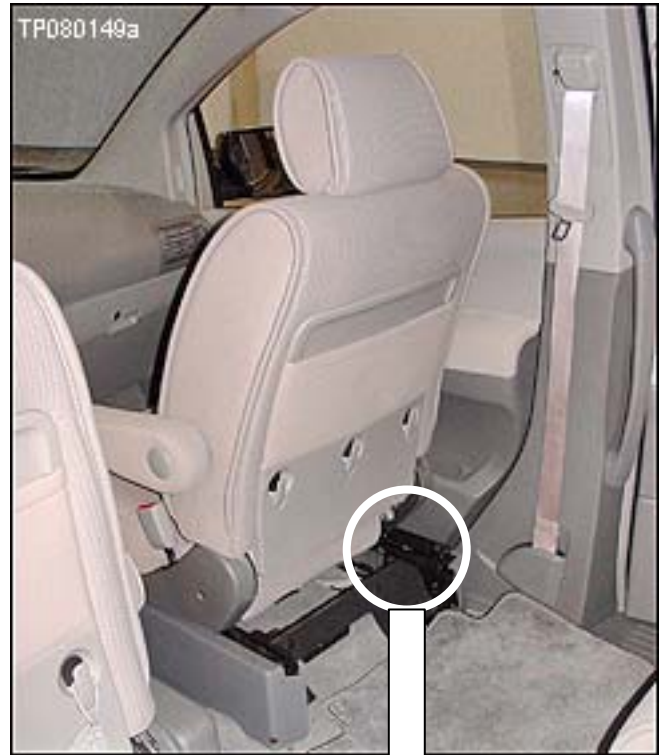
Figure 1-3

5. Move the seat to full forward position (toward the front of the vehicle).

NOTE: This photo shows the passenger seat. If you are working on a driver seat, perform this same operation on the right seat track of the driver seat.

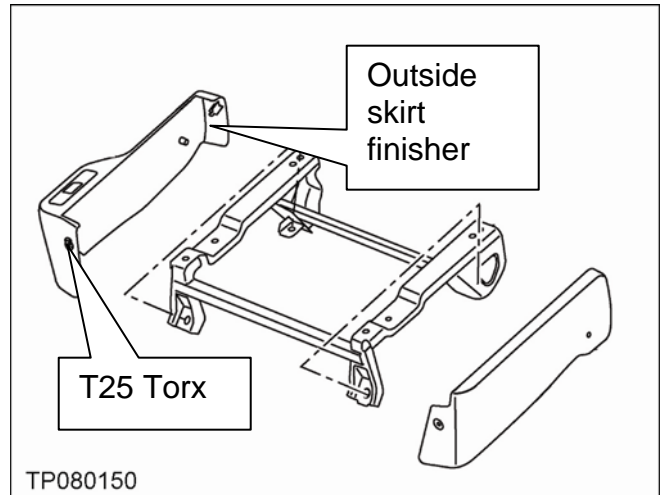
9. Remove the outside seat skirt finisher.

- Use a T25 Torx® to remove the screw at the front end of the finisher.
- Carefully pull on the finisher to release (snap loose) any securing clips.

NOTE: Figure 1-6 depicts the passenger seat. The driver seat is a mirror image.

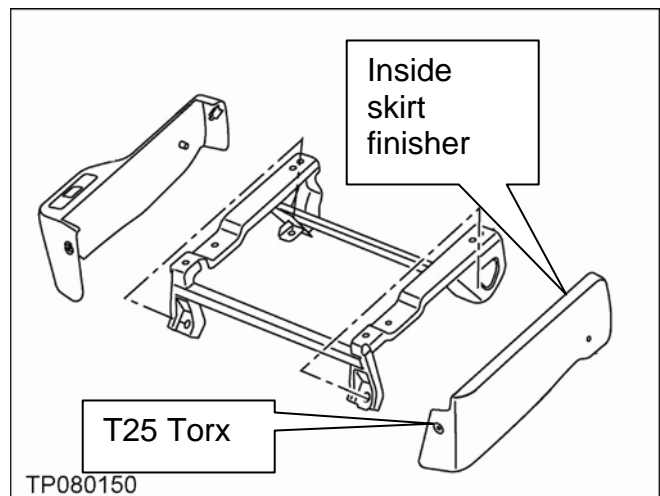
10. Remove the inside seat skirt finisher.

- Use a T25 Torx® to remove the screw at the front of the finisher.
- Carefully pull on the finisher to release (snap loose) any securing clips.

NOTE: Figure 1-7 depicts the passenger seat. The driver seat is a mirror image.

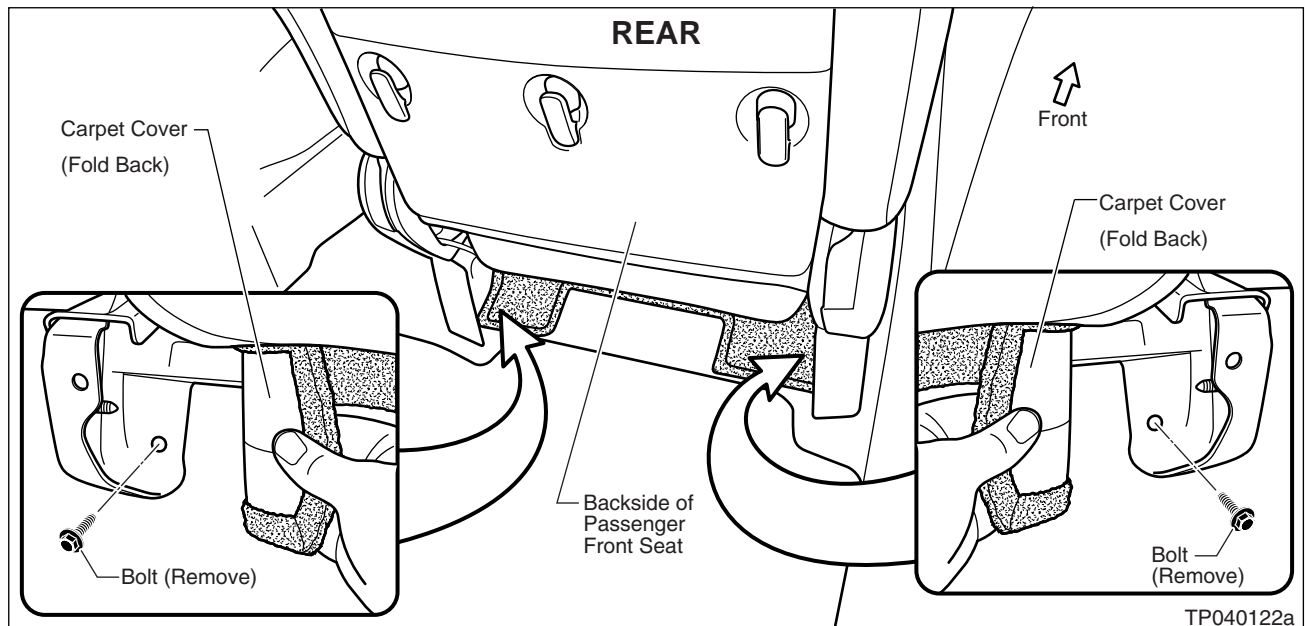
Figure 1-9

12. Remove the 2 rear mounting bolts (see Figure 1-9).

- To reach the rear mounting bolts, carefully fold the carpet cover back towards the rear of the vehicle.

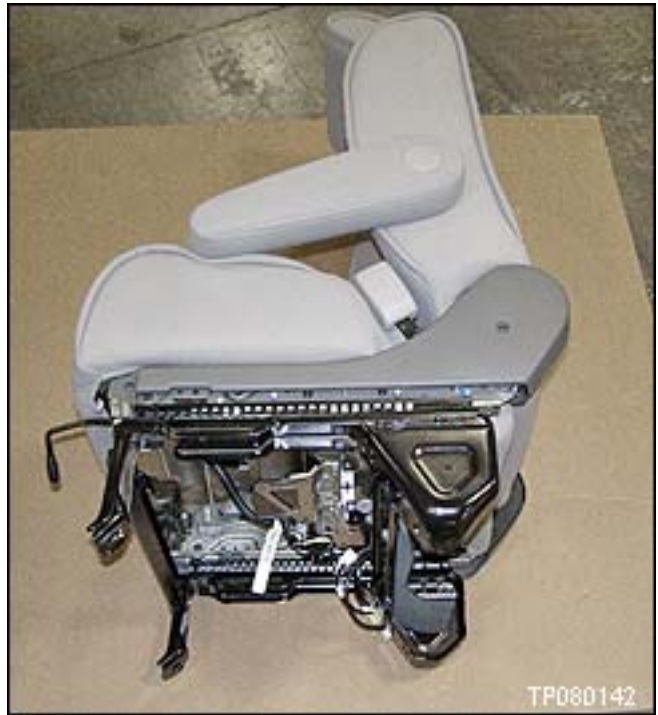
Figure 1-10

15. Place the seat in a CLEAN working area with the Right Side Down as shown in Figure 1-10.

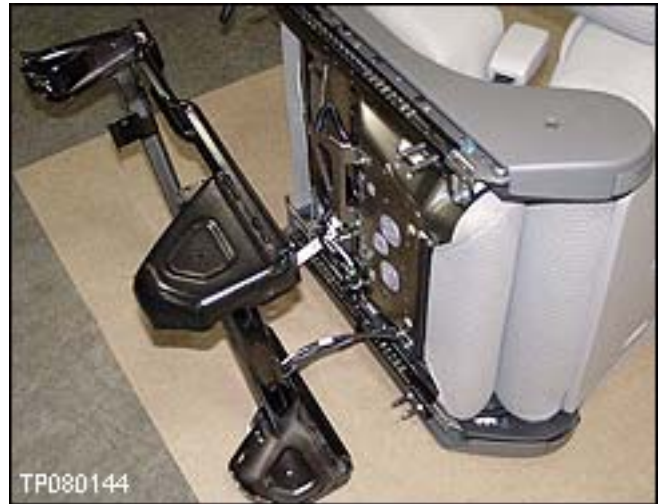
Figure 1-12

17. Carefully pull the pedestal a few inches away from the seat as shown in Figure 1-12.

- Do not disconnect electrical connectors or harness mounting clips.
- The pedestal needs to be moved just far enough to allow inspection of the seat track.
- This inspection can be done with electrical connectors and harness clips in place.

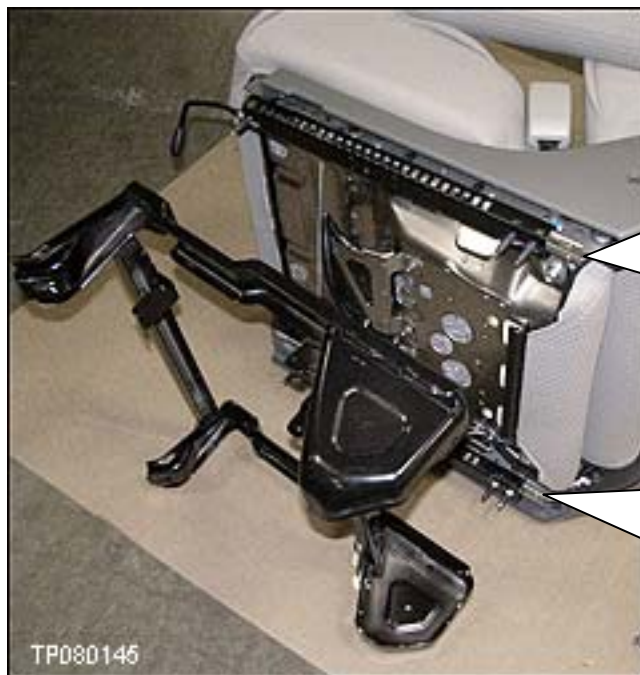
Figure 1-13

18. Make sure the seat tracks are adjusted / set to the correct position using the special tool (J-49387) as shown in Figure 1-13.

- Both tracks must be in the same position.
- Make sure the locking pawls are fully engaged.

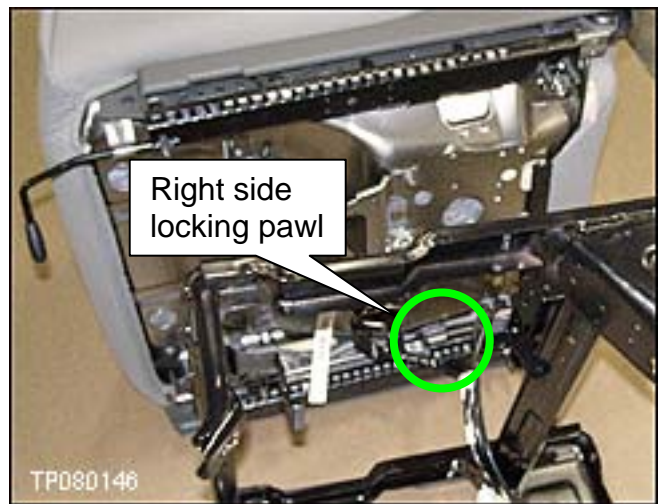
Figure 1-14

NOTE: All inspection steps will be done at the location shown in Figure 1-14.

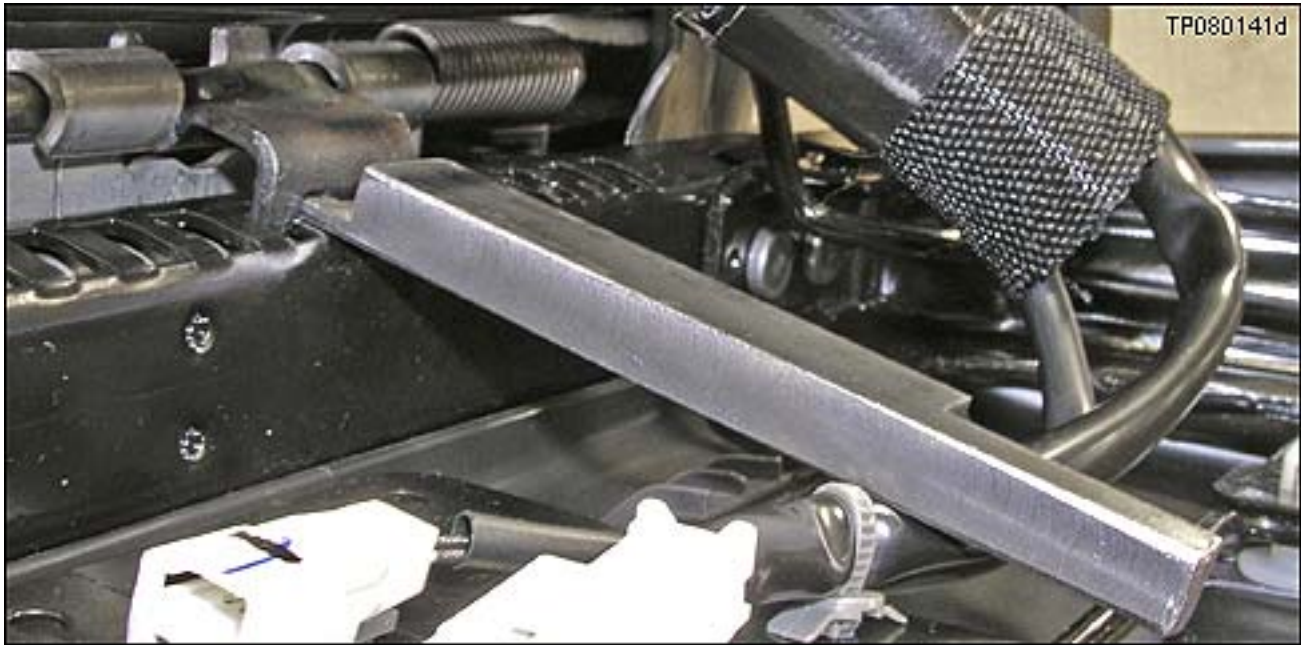
Figure 1-17

VERY IMPORTANT: When making the check in step c below, be sure to hold special tool J-49387 at the angle shown in Figure 1-17.

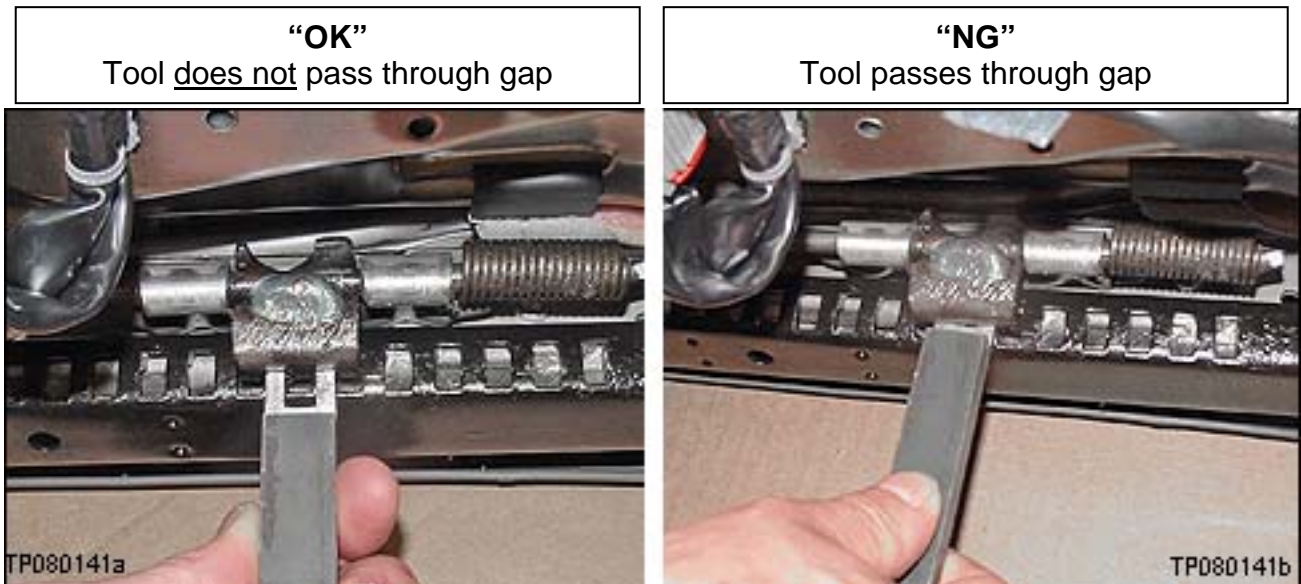
Figure 1-18

- c. Use the special tool (J-49387) to check the “Pawl to Track gap” as shown in Figure 9.

- If **“OK”**, continue to step 20 and re-install the seat.
- If **“NG”**, order a **NEW** seat (refer to the Parts Information on page 29); then proceed to step 20 and install the new seat.

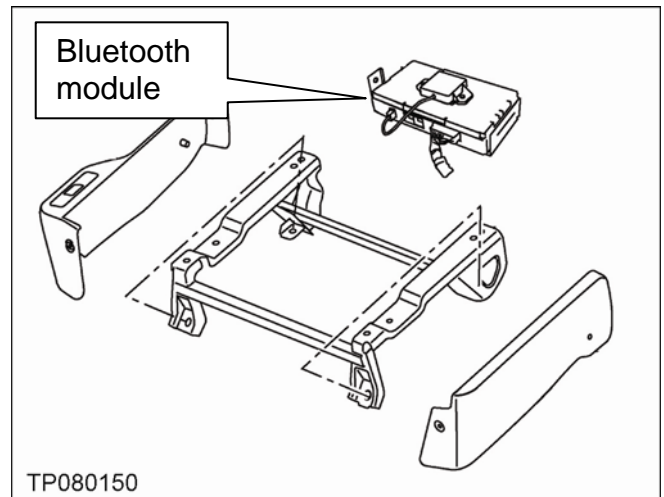
Figure 1-19

- If equipped, make sure to transfer the Bluetooth® module from the old seat to the new seat.

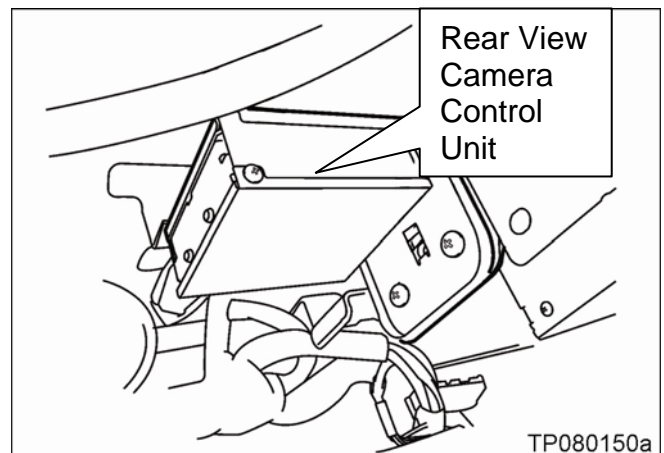
Figure 1-19a

- If equipped, make sure to transfer the Rear View Camera Control Unit from the old seat to the new seat.

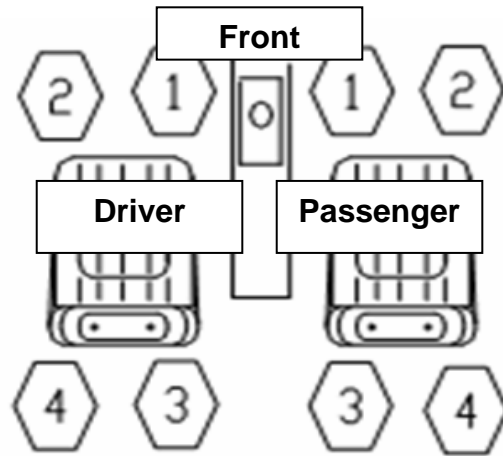
Figure 1-20

23. Install the seat mounting bolts by hand, then torque the bolts in the order shown in Figure 1-20.

- Torque: 49 N-m (5.0 kg-m, **36 ft-lb**)

NOTE: After setting the bolt torque, mark bolt 2 with type correction fluid (white-out).

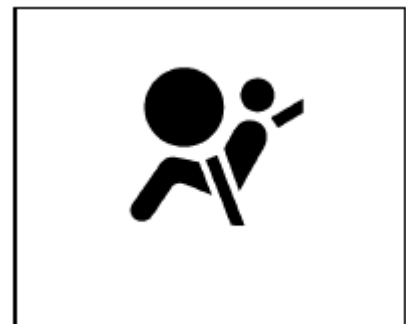
Figure 1-21

26. Sit in the driver seat and watch the air bag warning light as you turn the ignition ON.

- The air bag warning light should turn ON for 5 – 7 seconds, then go OFF.
- If the air bag warning light does not turn ON at all, does not turn OFF, or blinks, refer to the Service Manual for diagnosis and repair.

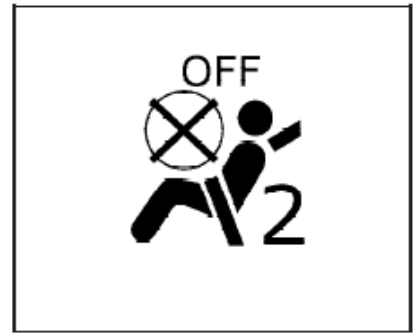
Figure 1-22

- a. Turn the ignition OFF.
- b. Make sure no one is sitting in the passenger front seat.
- c. Sit in the driver seat and watch the occupant detection system warning light as you turn the ignition ON.

- The occupant detection system warning light should turn ON for 5 – 7 seconds, then go OFF.
- d. Have someone who weighs approximately 150 lbs or greater sit in the passenger front seat in accordance with the recommended seating position in the Owners Manual.
 - The Occupant Detection System Warning Light should remain OFF (warning light may turn ON >OFF>ON>OFF for only a few seconds).
 - e. If the Occupant Detection System Warning Light correctly operates as described in c and d above, proceed with the next step.
 - If the Occupant Detection System Warning Light does NOT operate correctly as described in c and d above, refer to the Service Manual for diagnosis and repair. Then proceed with the next step”.

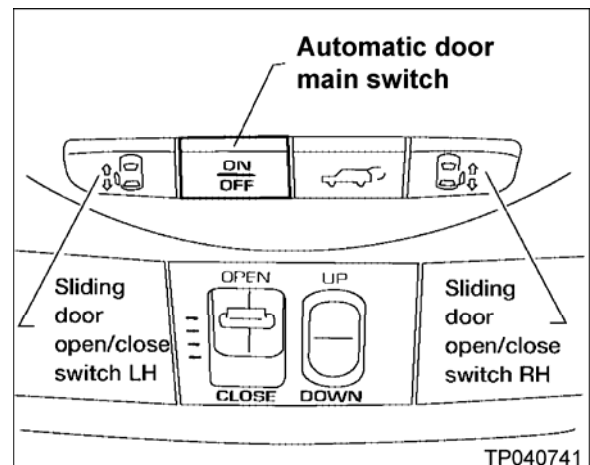
Figure 1-23

c. Turn the Automatic Door Main Switch OFF.

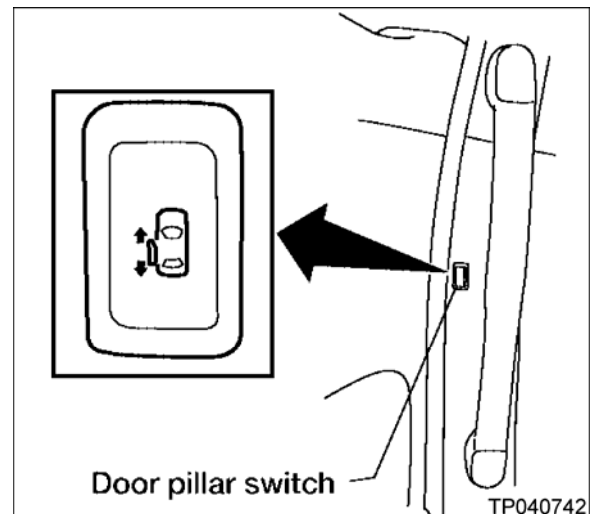
Figure 1-24

d. Within 3 seconds after doing step c, press the sliding door B-pillar switch 10 times within 10 seconds.

NOTE: LH or RH, depending on which door you are initializing.
