Safety Recall

Subject: Front Leaf Spring Hanger Bracket Nut & Bolt Replacement

Bulletin: R0023A

Affected Models: Select 2005-2008 145 (NA6J), 165 (NB6J), 185 (NC6J), 238 (ND8J), 258 (ND8J), 268 (NE8J), 268A (NJ8J), 338 (NV8J)

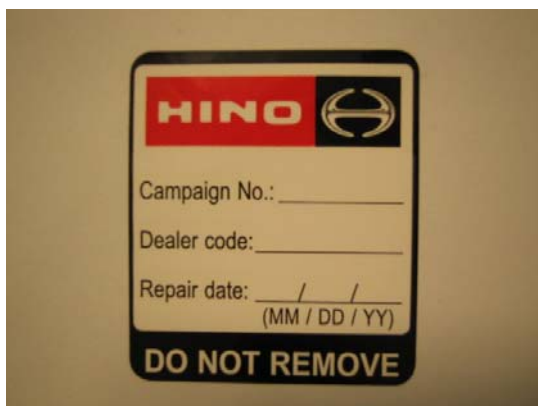
Fill out the Recall Completion sticker as shown in the picture to the left. This sticker should be attached to the door jam above the V.I.N. Plate.

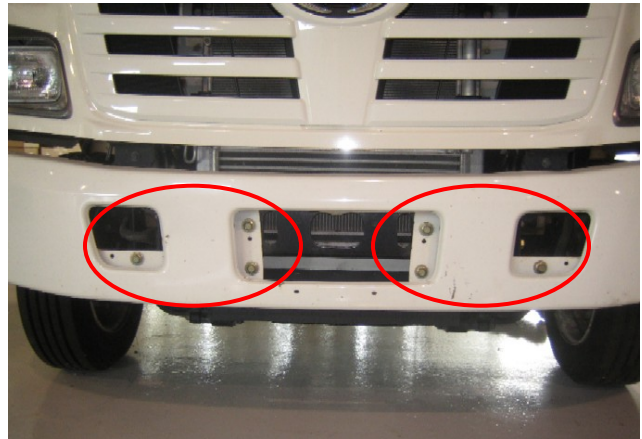
1. Remove front bumper (six bolts).

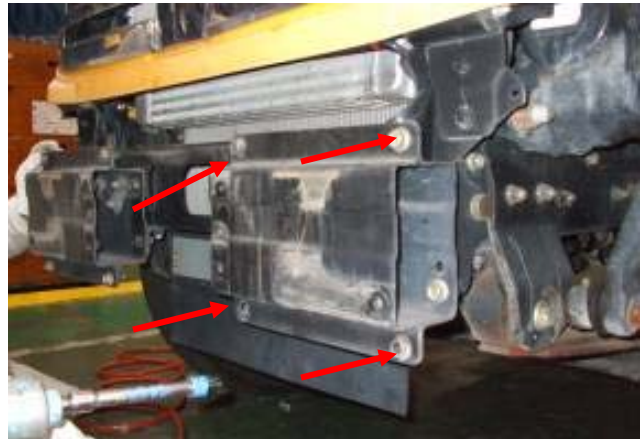
2. If the vehicle is equipped with the extended bumper option, remove right and left bumper extension brackets. Four bolts per bracket.

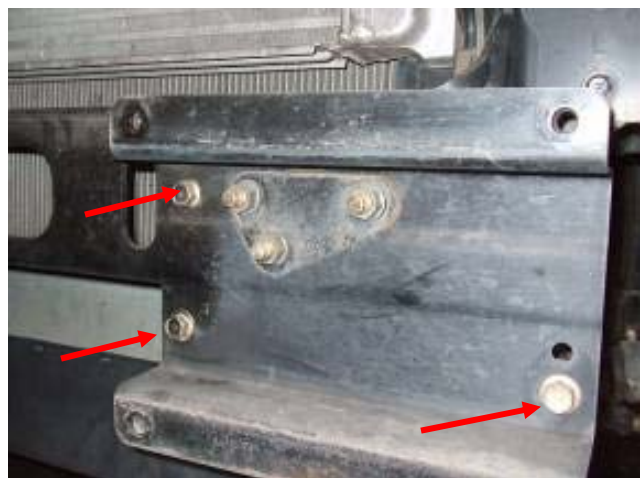
3. Remove right and left bumper stay. Three bolts per stay.

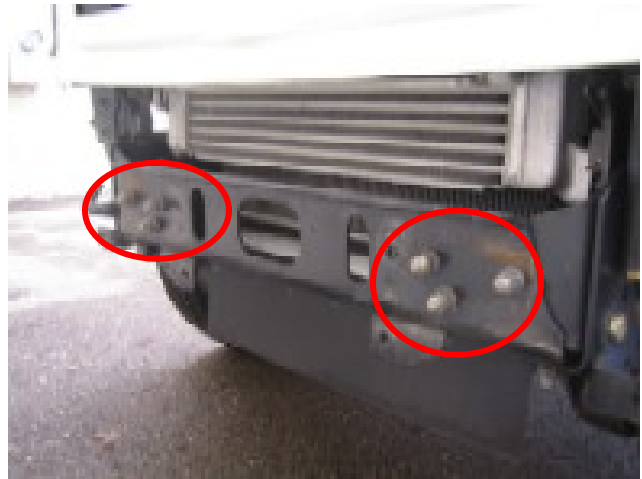
4. Remove the six nuts and bolts from the front side of the #1 crossmember.

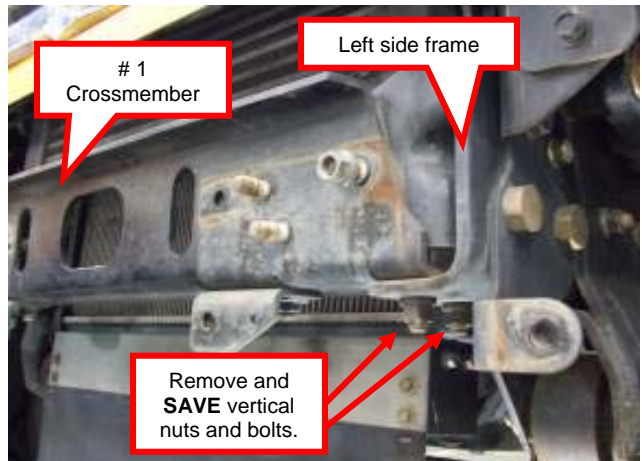
5. Remove and save the four vertical nuts and bolts (2 each / side) on the underside of the #1 crossmember.

Remove the #1 crossmember from the vehicle.

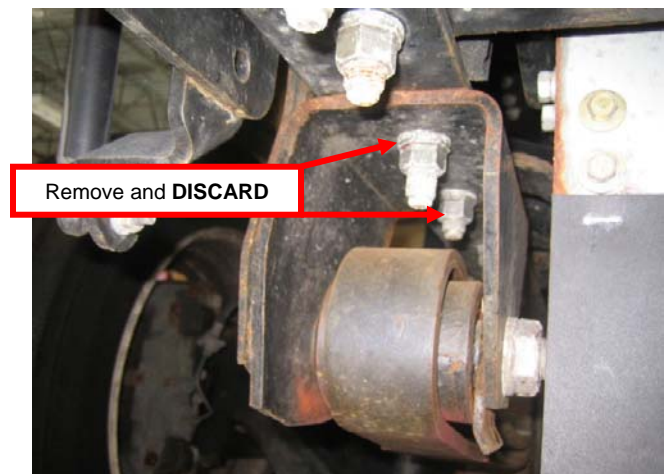
6. On the right side of the vehicle, remove and discard both lower bolts and nuts for spring hanger bracket.

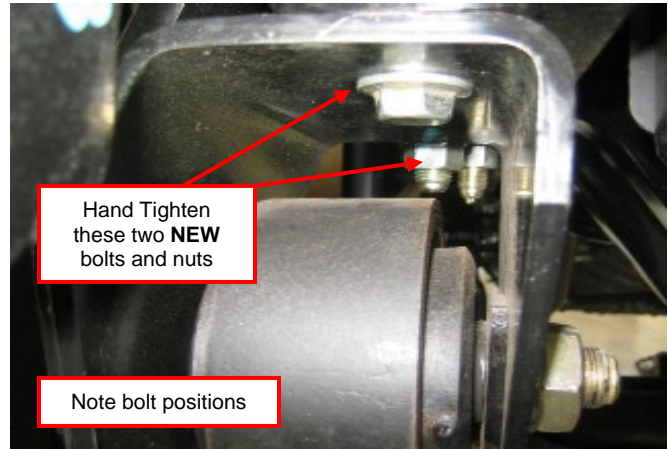
7. Install two **NEW** bolts and nuts, **HAND TIGHTEN ONLY.**

NOTE: The front bolt must be installed with the bolt head contacting the spring hanger bracket. The rear bolt must be installed with the nut contacting the spring hanger bracket.

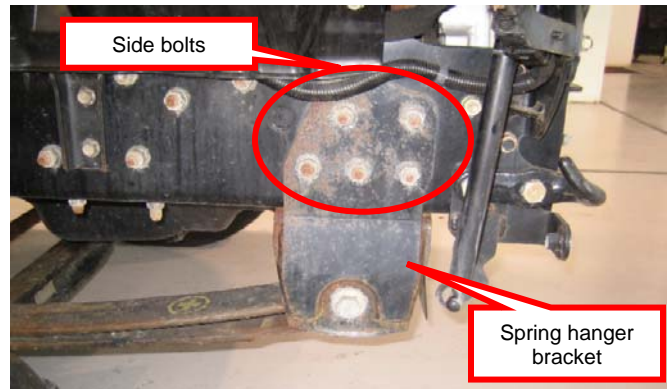
8. Still working on the right side of the vehicle, loosen the side bolts that secure the spring hanger bracket to the frame rail.
(number of bolts varies by model)

NOTE: Loosen the nuts until the bolts are free to move in all directions. This will ensure the bracket is loose and free to move.

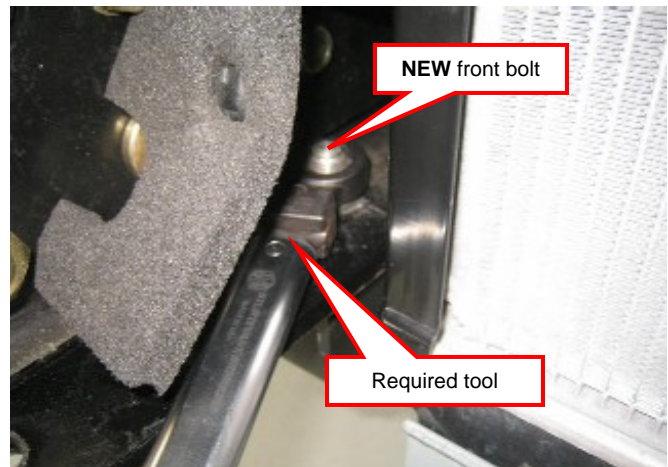
9. Torque the **NEW FRONT** bolt and nut right side lower spring hanger.

NOTE: Torque the front bolt from the top.

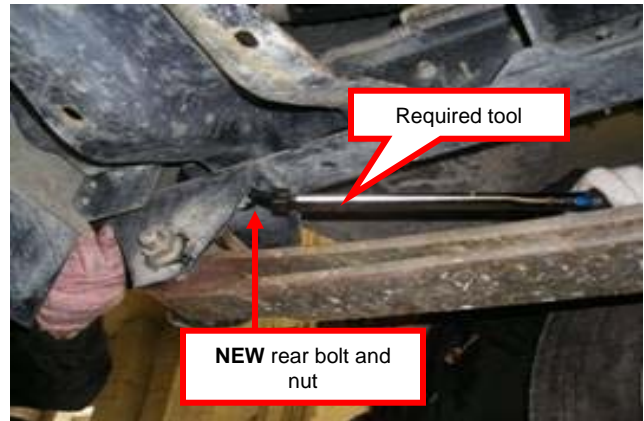
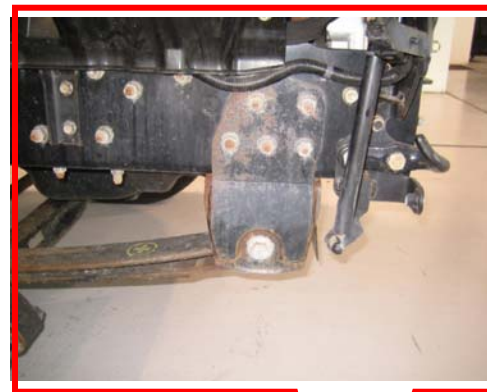
10. Torque the **NEW REAR** bolt and nut right side lower spring hanger.

NOTE: Torque the rear bolt from the bottom
As seen in the picture at the right.

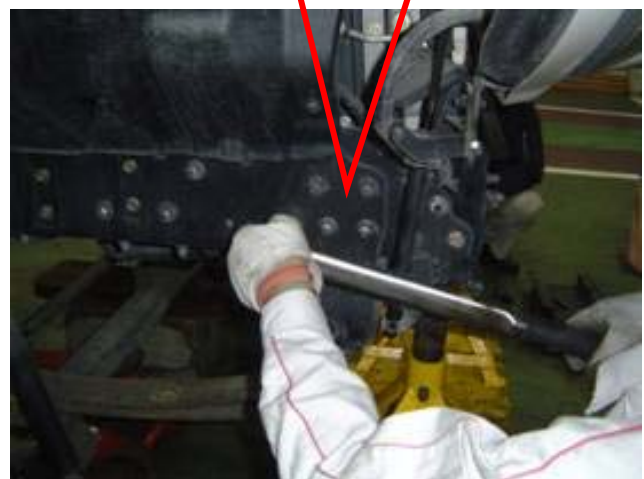
11. Tighten the side bolts to the specified torque.
(number of bolts varies by model)

81 +/- 8 ft. lbs. (110 +/- 10.8 Nm)

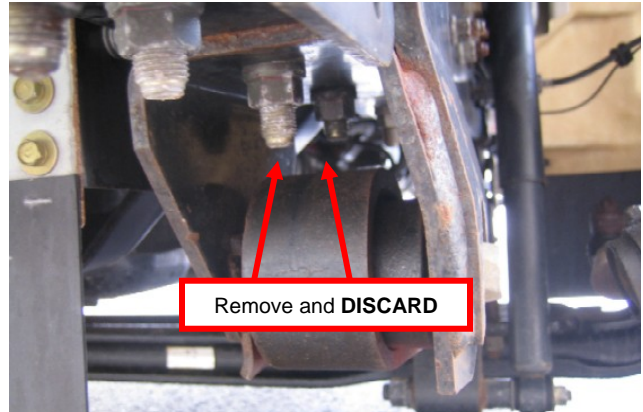
13. On the left side of the vehicle, remove and discard both lower bolts and nuts for spring hanger bracket.

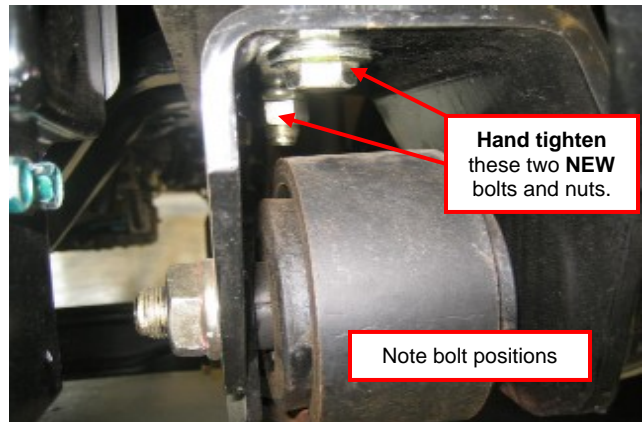
14. Install two **NEW** bolts and nuts, **HAND TIGHTEN ONLY.**

NOTE: The front bolt must be installed with the bolt head contacting the spring hanger bracket. The rear bolt must be installed with the nut contacting the spring hanger bracket.

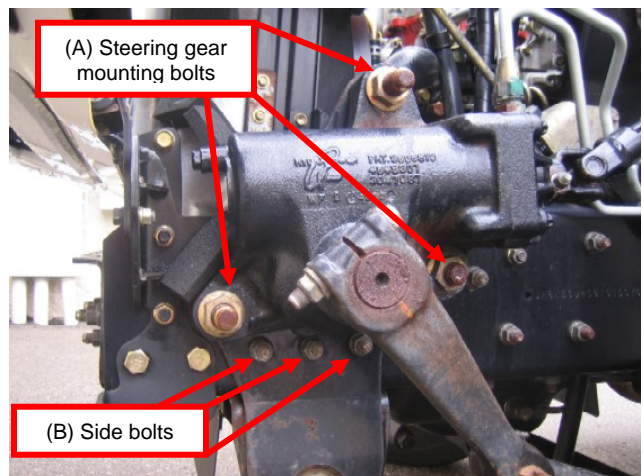
CAUTION: DO NOT loosen the steering gear mounting bolts (A) prior to the side bolts (B). This will cause the side bolts to bend.

15. On the left side of the vehicle, loosen the side bolts (B) that secure the spring hanger bracket to the frame side rail. **(number of bolts varies by model)**

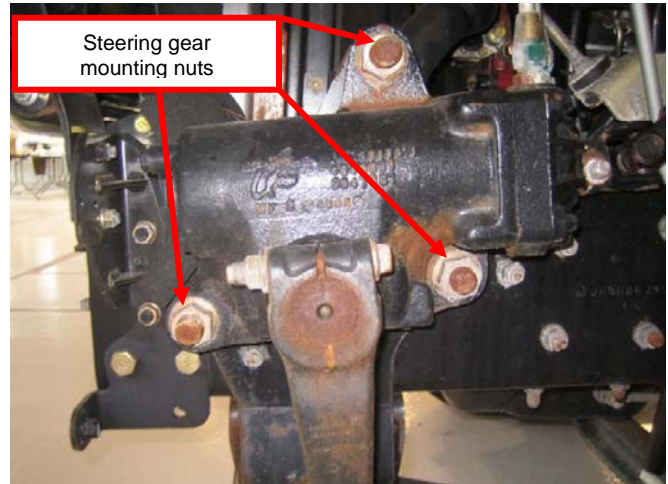
16. Loosen the three steering gear mounting nuts.

Make sure the steering gear and spring hanger bracket are loose and free to move.

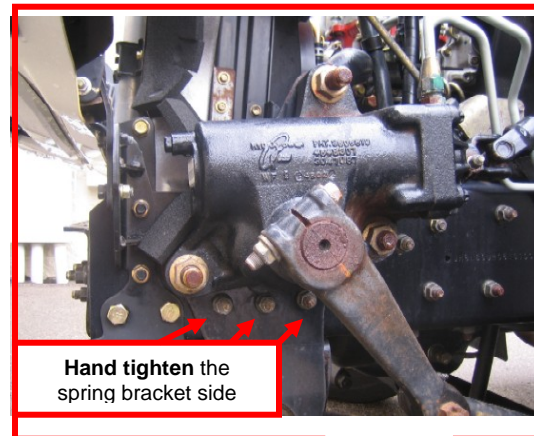
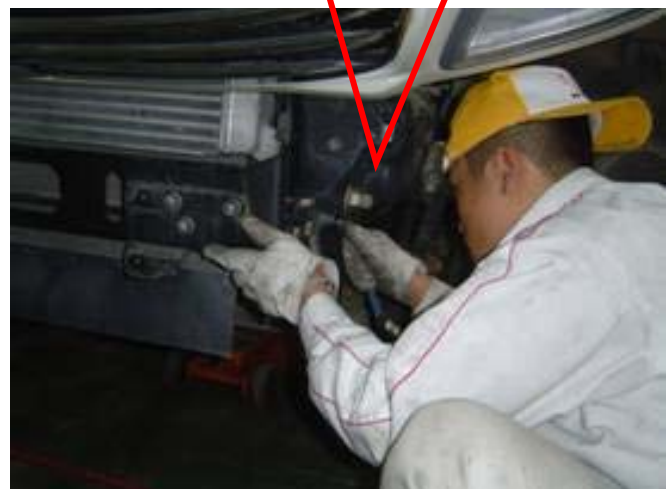
17. **HAND TIGHTEN** the side bolts until the spring bracket contacts the frame rail.

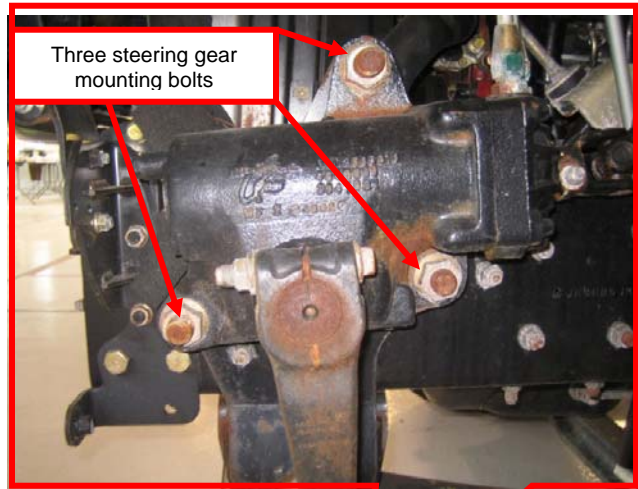
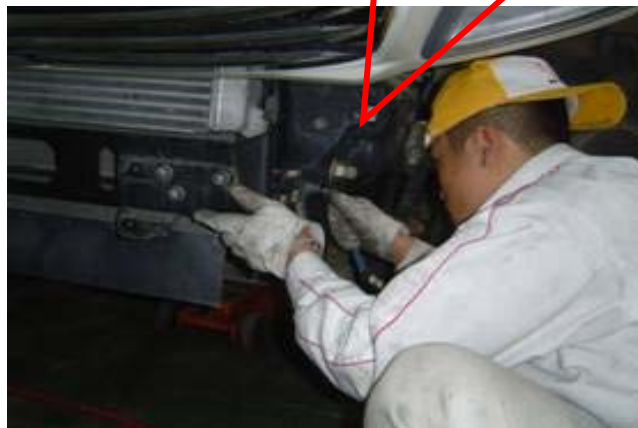
18. **HAND TIGHTEN** the three steering gear mounting nuts until the steering gear touches the spring hanger bracket.

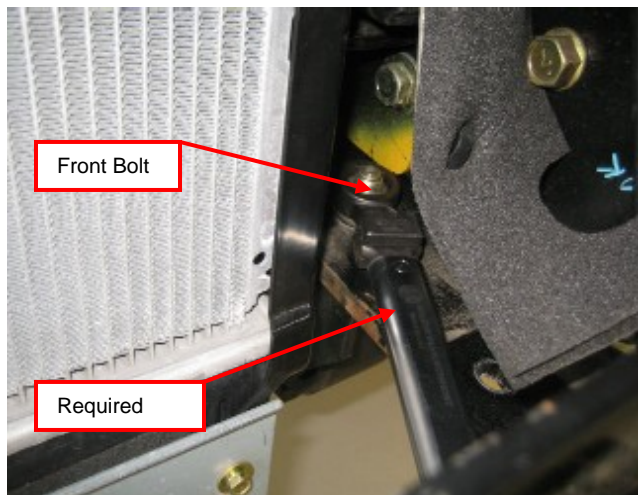
19. Torque the **NEW FRONT** and **REAR** left side lower spring hanger bracket bolts and nuts.

NOTE: Torque the front bolt from the top. Torque the rear bolt from the bottom.

The picture at right shows the front bolt being torqued from the top.

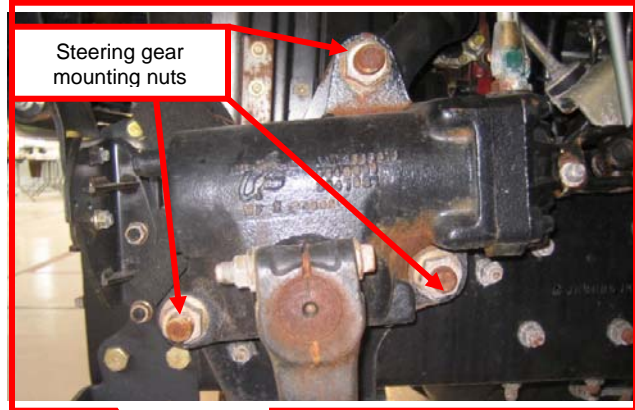
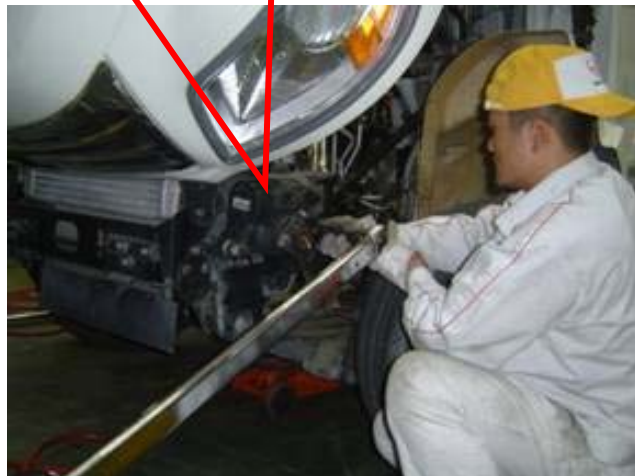
- 20. Torque the three steering gear mounting nuts to the specified torque.

385 +/- 20 ft. lbs (522 +/- 27.1 Nm)

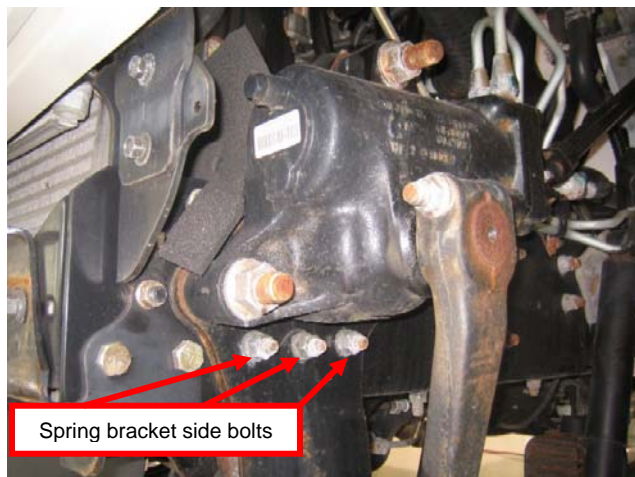
- 21. Torque the left spring hanger bracket side bolts to the specified torque.
(number of bolts varies by model)

81 +/- 8 ft. lbs. (110 +/- 10.8 Nm)

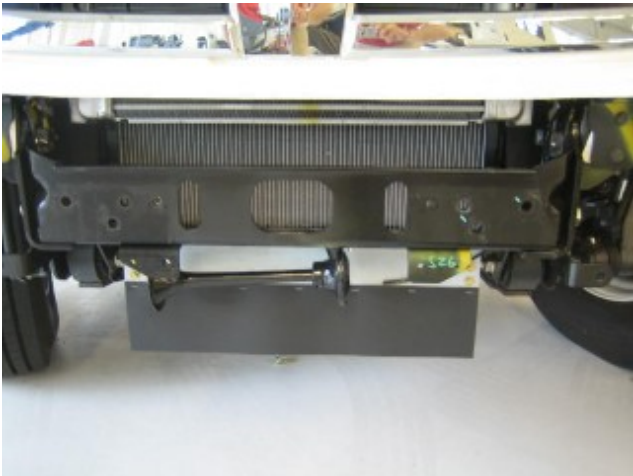
22. Reinstall the #1 crossmember.

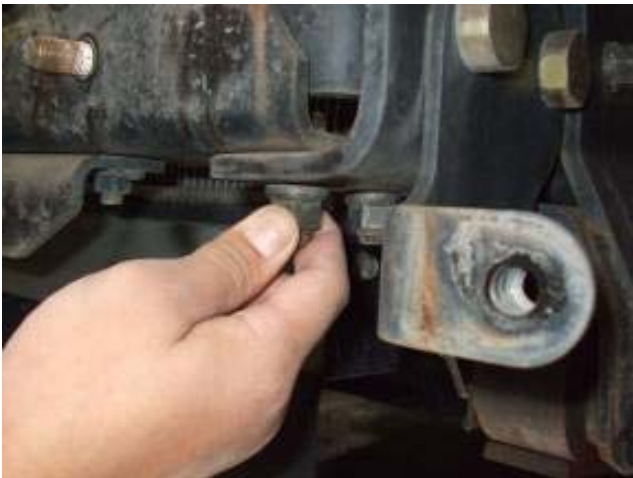
23. Install, **HAND TIGHTEN**, the original four vertical bolts and original four nuts onto the underside of the #1 crossmember right and left side of vehicle.

(pictures shows left side of vehicle)

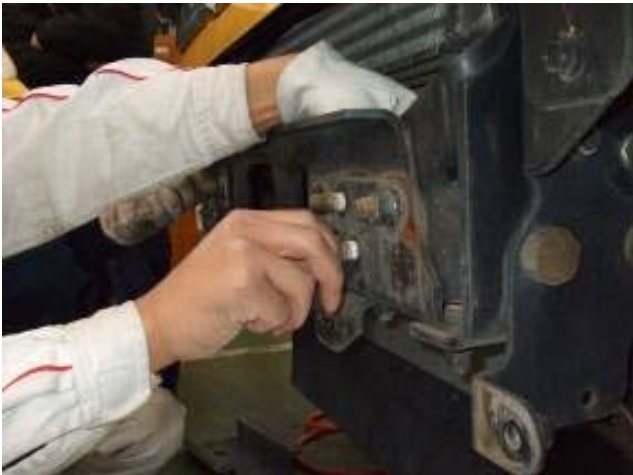
24. Re-install and **HAND TIGHTEN** the nuts for the front #1 crossmember.

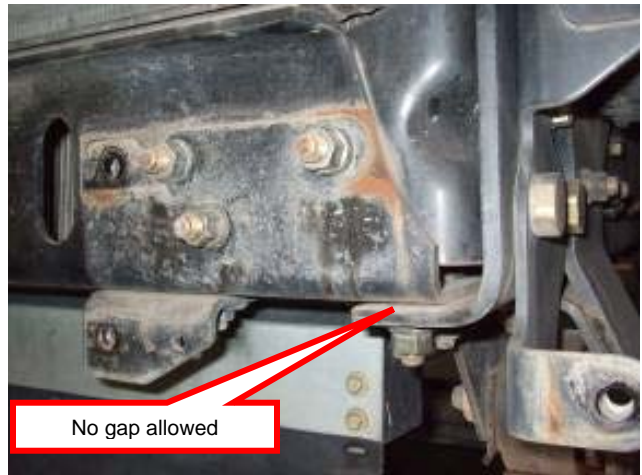
- 25. Check the contact of the #1 crossmember between the frame and the mounting brackets. Make sure that no light can be seen between the parts in these two areas.

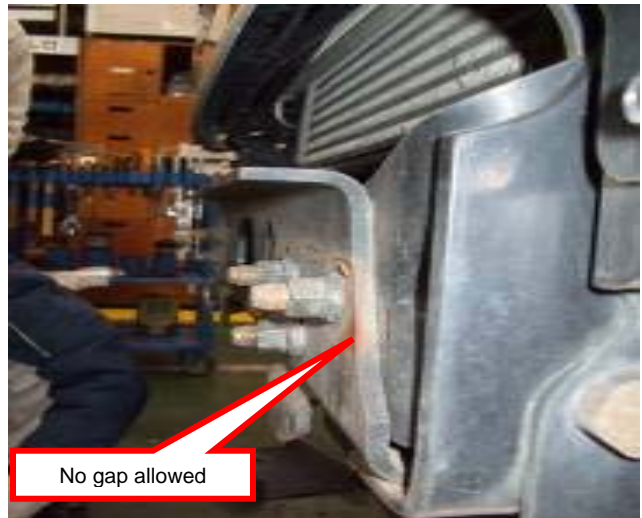
If light can be seen, use a wrench to tighten the nut/bolt until no light can be seen.

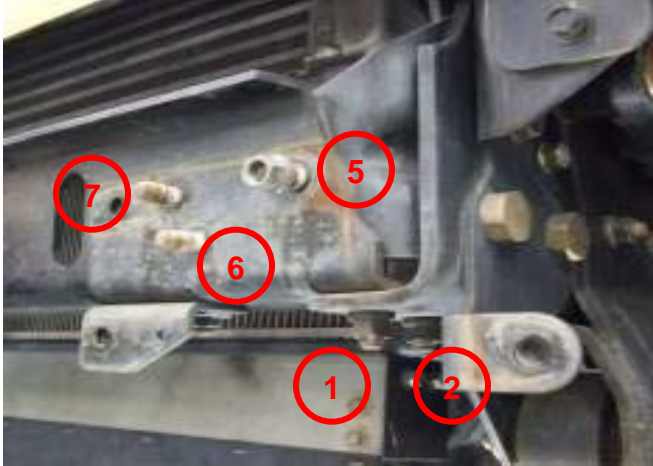
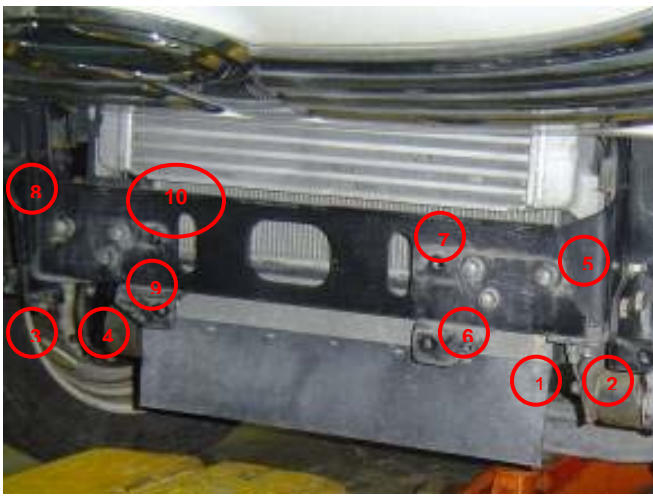
26. Tighten the ten #1 crossmember bolts and nuts to the specified torque in the order listed below.

- ① Left underside front
- ② Left underside rear
- ③ Right underside front
- ④ Right underside rear
- ⑤ Left front outside
- ⑥ Left front lower
- ⑦ Left front inside
- ⑧ Right front outside
- ⑨ Right front lower
- ⑩ Right front inside

70 +/- 6 ft.lbs. (94.5 +/- 8.1 Nm)

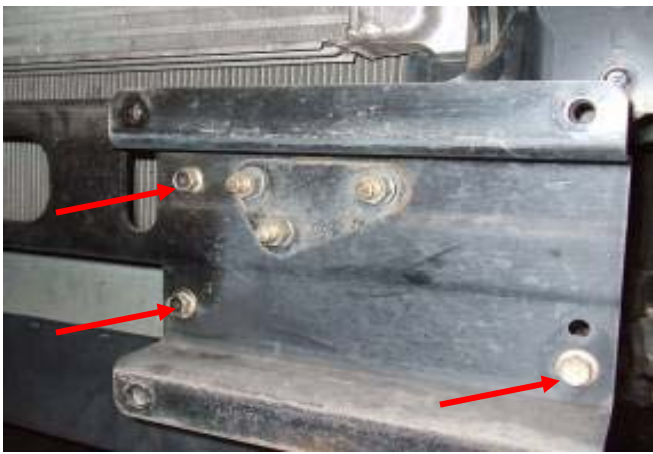
27. Re-install the bumper stay and tighten the three bolts to the specified torque. Do the same on the other side.

96 +/- 10 ft.lbs. (130 +/- 13.5 Nm)

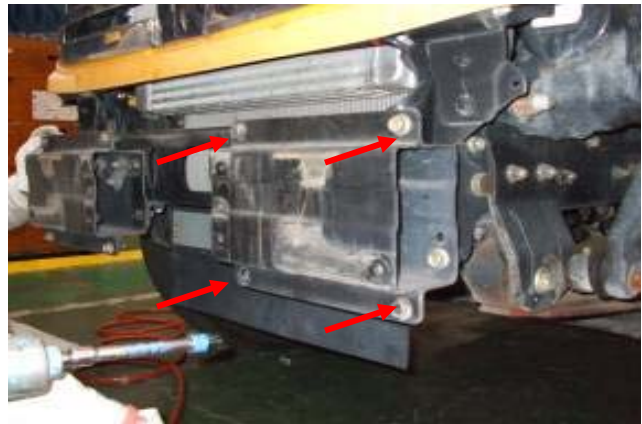
- 28. Re-install the front bumper extensions (if equipped) and tighten the four bolts to the specified torque. Do the same on the other side.

96 +/- 10 ft.lbs. (130 +/- 13.5 Nm)

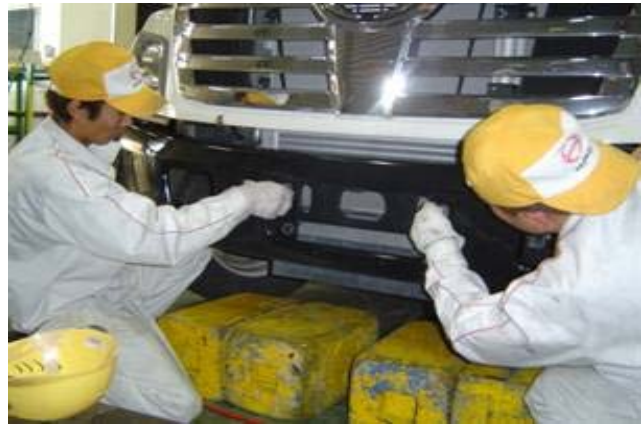
- 29. Re-install the bumper. Hand tighten the bolts until they contact the bumper.

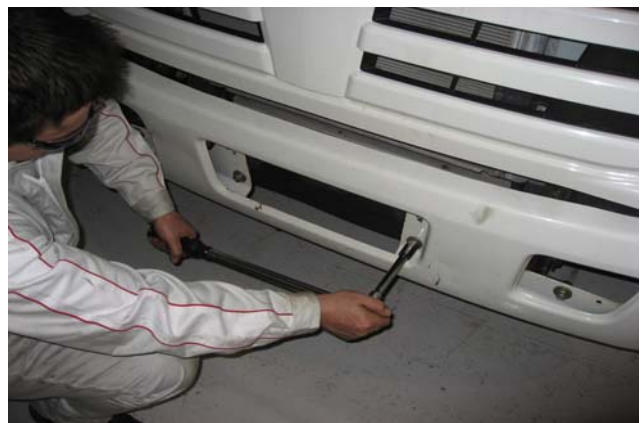
- 30. Tighten the bumper bolts to the specified torque.

96 +/- 10 ft.lbs. (130 +/- 13.5 Nm)
