TECHNICAL BULLETIN

No: P045
Issue: 1
Date: 22 July 2008

RECALL: Rotary Coupler Wiring Fracture

LR3 (LA)	VIN:	5A309377 - 6A376426
	Model Year:	2005 - 2006
Range Rover Sport (LS)	VIN:	6A900290 - 6A939921
	Model Year:	2006

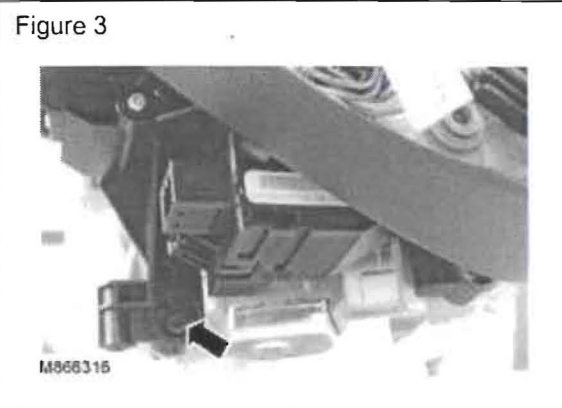
8. Rotate steering wheel for access as necessary.
9. Remove and discard the multi-function switch assembly's fourth fixing M5 x 14mm long screw (FYP500250). (Figure 3)

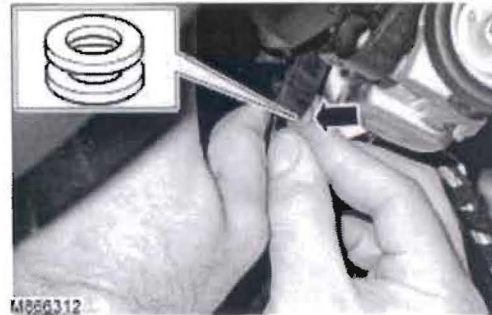
Figure 4

10. Insert two washers (**WC105002**) between the multi-function switch assembly fourth fixing point and column lock. (Figure 4)

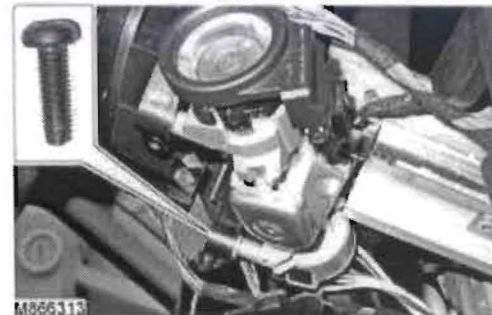
Figure 5

11. Insert **new** M5 x 16mm long screw (**W504696 - S424**) and tighten to **2N-m (1.5 lbf-ft)**. (Figure 5)

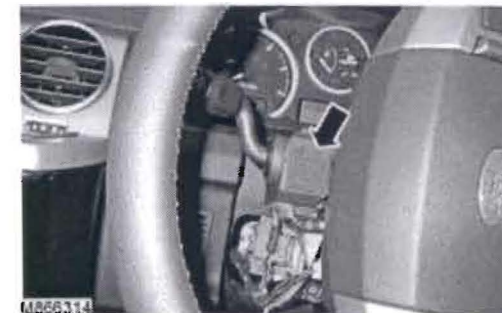
Figure 6

13. Attach one foam pad (**QZL500010**) to the front face of the direction indicator switch. (Figure 6)
14. Attach one foam pad (**QZL500010**) to the front face of the wiper switch.

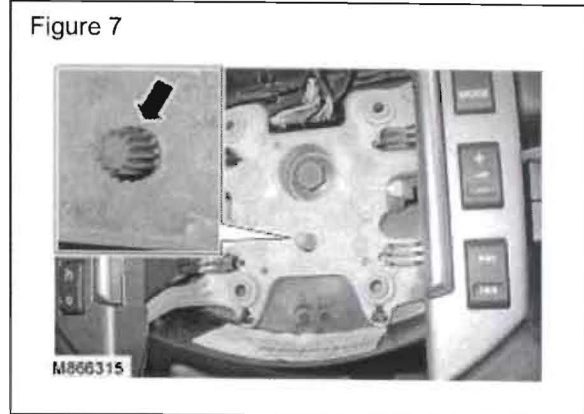
Figure 7

1. Refer to Workshop Manual (GTR) section 501-20B: Supplemental Restraint System (76.40.01) to remove the driver airbag module.
2. Rotate steering wheel to verify rotary coupler part number:
 - If rotary coupler part number **YRC500060** is fitted, replace the cylindrical drive peg sleeve with the ribbed sleeve provided in the kit, ensuring the sleeve is fully seated. (Figure 7)
 - If rotary coupler part number **YRC500060** is *not* fitted, continue to step 3
3. Refer to Workshop Manual (GTR) section 501-20B: Supplemental Restraint System (76.40.01) to install the driver's airbag module.

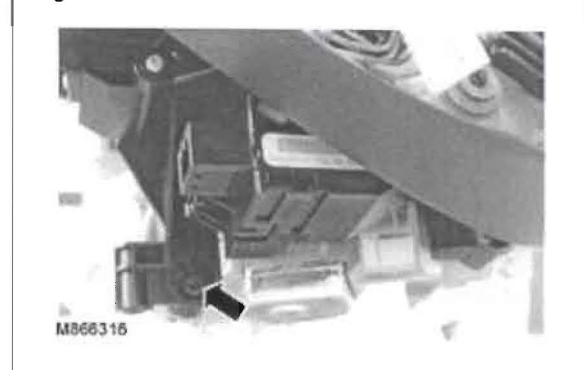
Figure 10

8. Rotate steering wheel for access as necessary.
9. Remove and discard the multi-function switch assembly's fourth fixing M5 x 14mm long screw (FYP500250). (Figure 10)

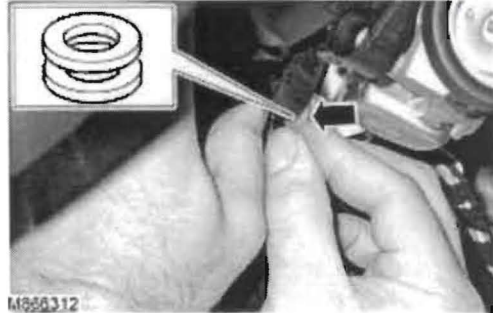
Figure 11

10. Insert two washers (**WC105002**) between the multi-function switch assembly fourth fixing point and column lock. (Figure 11)

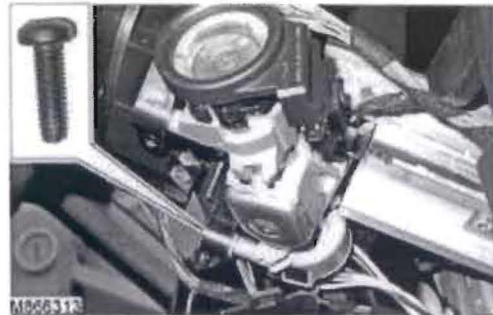
Figure 12

11. Insert **new** M5 x 16mm long screw (**W504696 - S424**) and tighten to **2N-m (1.5 lbf-ft)**. (Figure 12)

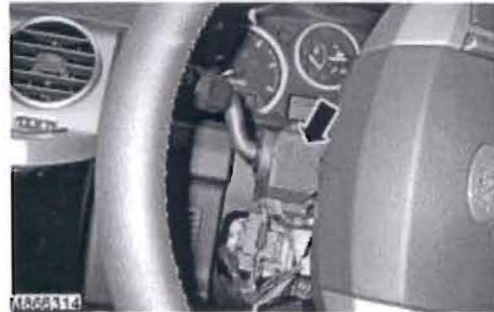
Figure 13

13. Attach one foam pad (**QZL500010**) to the front face of the direction indicator switch. (Figure 13)
14. Attach one foam pad (**QZL500010**) to the front face of the wiper switch.
15. Remove ignition key.
16. Install the steering column lower shroud.
17. Install the steering column upper shroud.
18. Connect positive and negative battery cables.

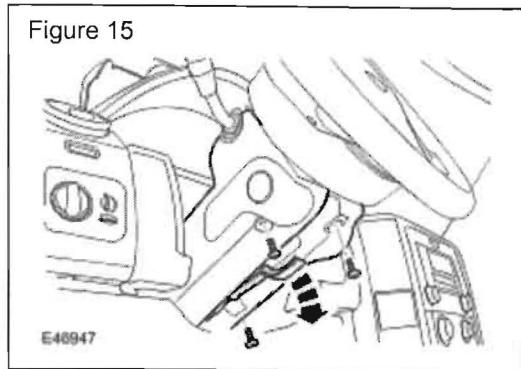
Figure 15

3. Remove the three Torx screws to remove the steering column lower shroud. (Figure 15)
4. Insert ignition key and turn to position 1.

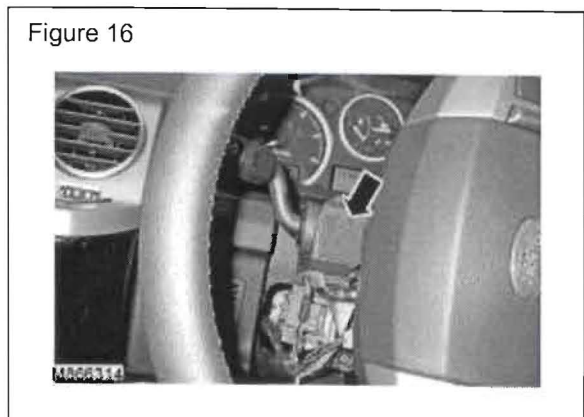
Figure 16

6. Attach one foam pad (**QZL500010**) to the front face of the direction indicator switch. (Figure 16)
7. Attach one foam pad (**QZL500010**) to the front face of the wiper switch.
8. Install the steering column lower shroud.
9. Install the steering column upper shroud.
