Suzuki Del Caribe, Inc.

Boletín de Servicio

Boletín GS/GSX/GSX-R No. 183

Campaña de Seguridad #2A05 ISNPECCIÓN DEL HARNEES DEL INTERRUPTOR DE ENCEDIDO

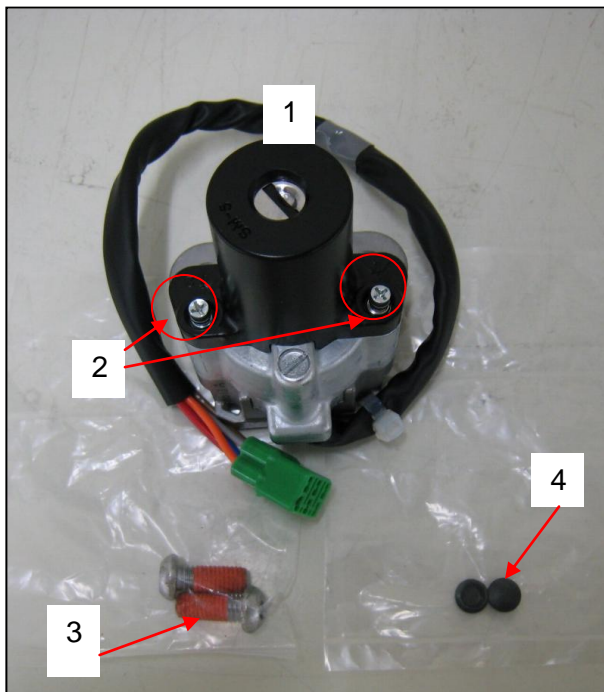
Part name	Qty	Note
IGNITION SWITCH SET (37100-15H30-X00)	1	IGNITION SWITCH	1	Using base part only
	2	SCREWS	2	Mounted on IGNITION SWITCH
	3	BOLT M8	2	Torx head, Pre-coat bolt
	4	CAP	2

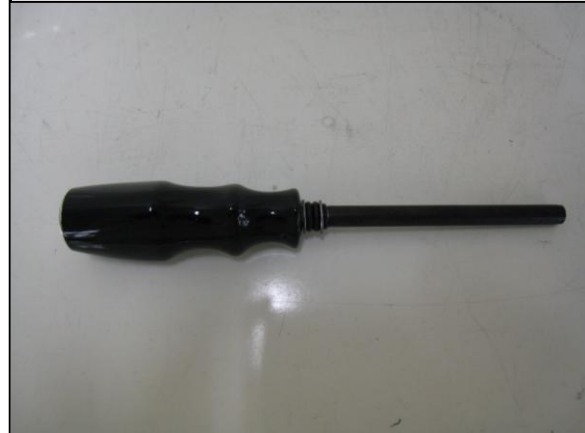
SCREW REMOVER (S050624-001)

SPECIAL TOOL This is not Suzuki genuine special service tool

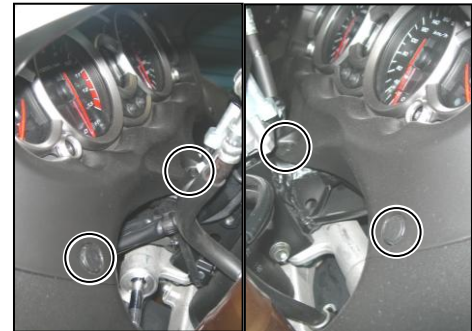
- 1) Remove the rear meter panel with removing the mounting screw and clips.

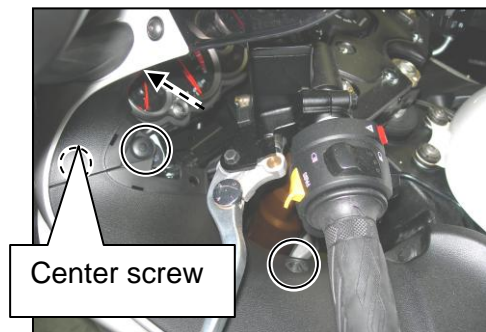
- 2) Remove the Meter left panel mounting clips.
- 3) Remove the clip which is located on meter panel left side.
- 4) Remove the center screws of the meter left panel with pulling edge of meter upper panel a little. Remove the meter left panel.

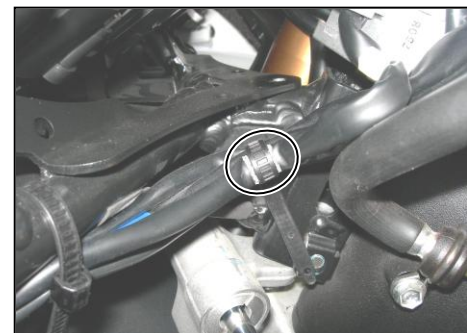
- 5) Confirm IG lead wire is clamped on gray tape position.

- Make sure both end of Gray tape should be visible at both side of clamp.

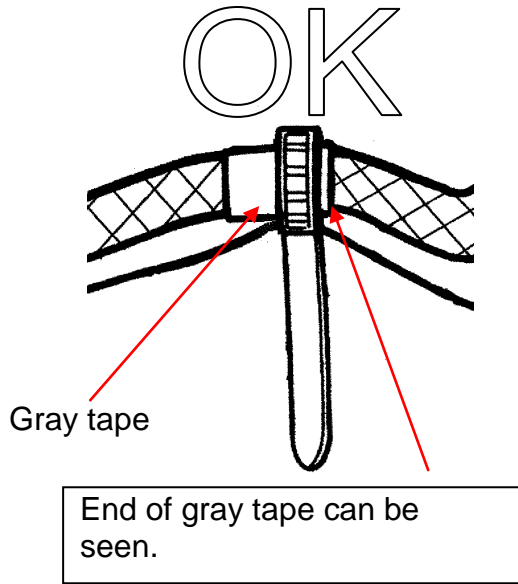
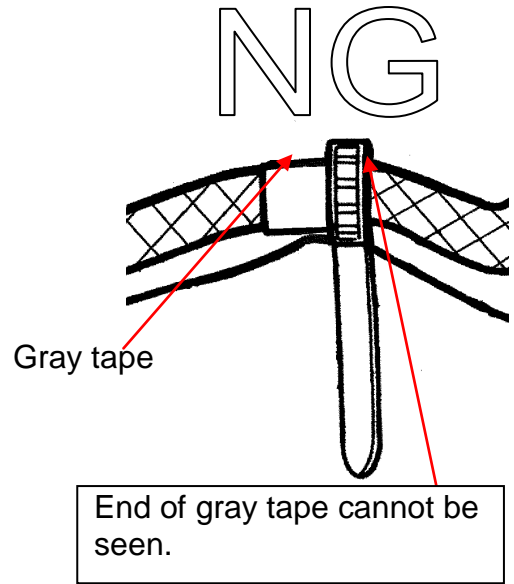
6) Make sure IG SW lead wire is routed most out side of other wiring harnesses when you inspected the unit from left side.

- IG SW lead wire must be not covered or pinched by other wiring harnesses.
- IG SW lead wire routeing position, please refer to below diagrams.

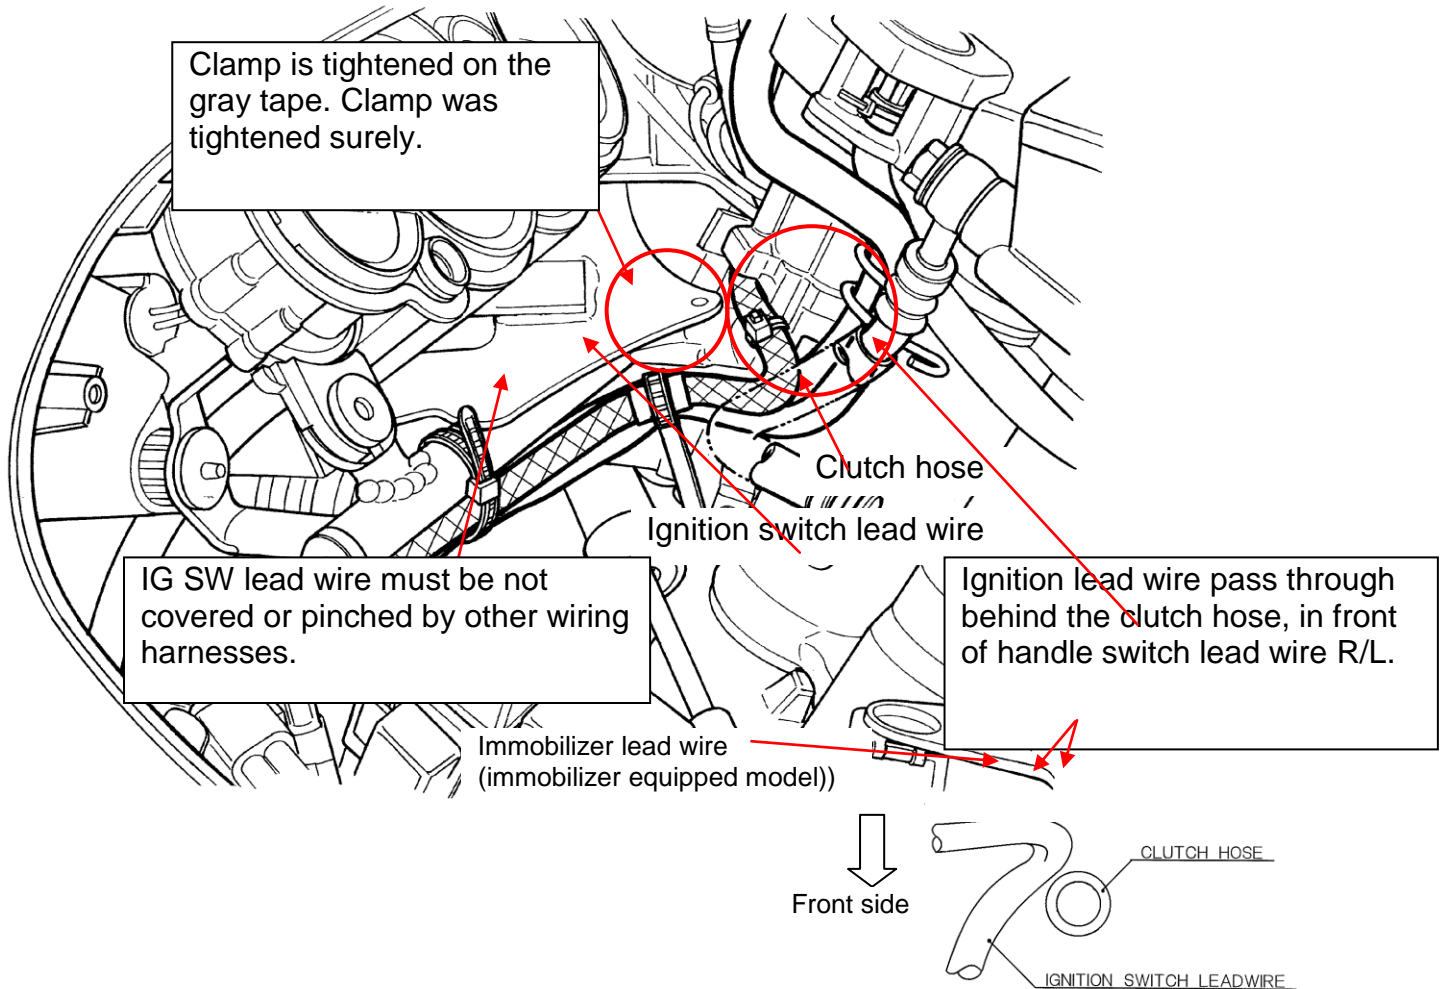
Ignition switch lead wire routing diagram

Ignition switch lead wire must be located out side the other lead wires, so that entire lead wire is visible from the following angle of direction as below.

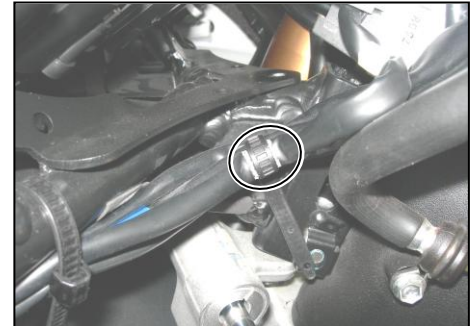
- 1) Loosen the clamps which are tightened the ignition switch lead wire with other wiring harness. Then re-route the ignition switch lead wire as correct routing.
- 2) Tighten the clamps and locating clamp on the center of gray tape.

- Make sure both end of Gray tape must be visible at both side of clamp.

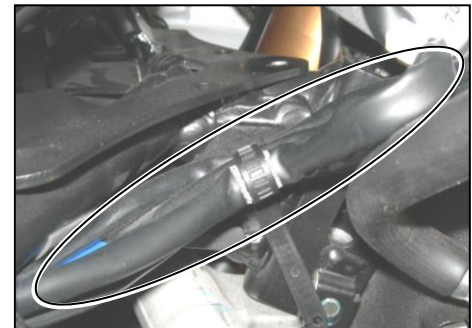
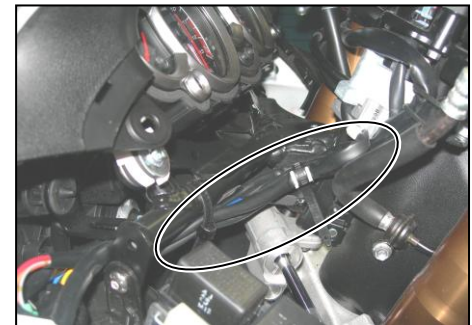
- 3) Install IG SW lead wire with routing most out side of other wiring harnesses when you inspected unit from left side.

- IG SW lead wire must be not covered by other wiring harnesses.
- Tighten the clamp surely.

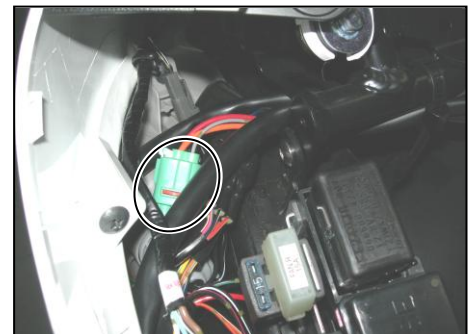
- 1) Disconnect the Battery minus terminal.
- 2) Make sure IG SW is turned off.
- 3) Disconnect the Ignition Switch lead wire coupler.

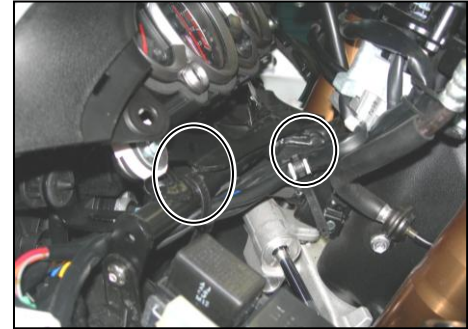
- 4) Release the clamps for ignition switch lead wire.

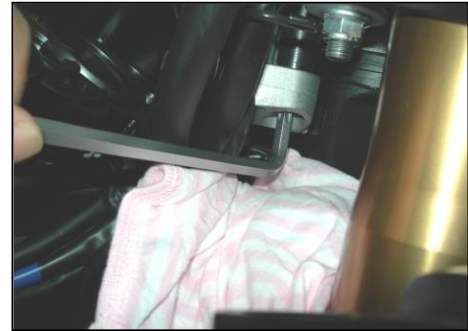
- 5) Remove the ignition SW with removing ignition switch mounting bolts. (Torx bolts)

- TORX BIT (JT40H) 09930-11920
- BIT HOLDER 09930-11940
- Protect the lower bracket with some cloth for avoiding scratch.
- Remove the meter right panel with same manner as meter left panel removal.

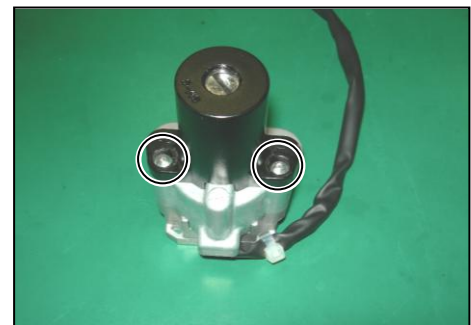
- 1) Remove the caps from the break off bolts head.
- 2) Hold the bottom part of ignition switch with vise.

- Turn the Ignition switch to off position and remove the ignition key form key cylinder before ignition switch dismantling.
- Removed caps are not re-used.

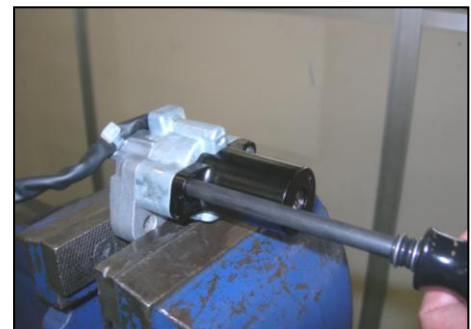
- 3) Remove the break off screws with special service tool.

- Set the special tool to the straight to the brake-off screw.
- Hit with a steel hammer to make minus groove on the

screw head, and consecutively without removing the special tool head from the screw head, turn the special tool anticlockwise to remove the screw.

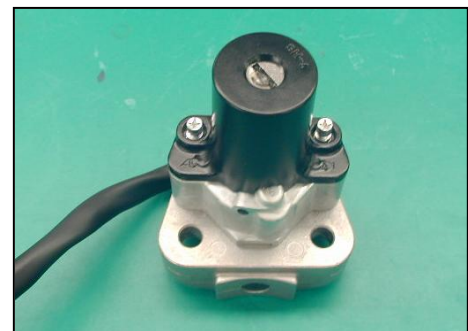
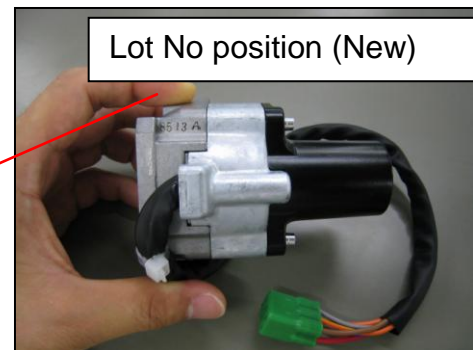
- 1) Remove the break off screws from new replacement part. (These screws are loose fit by hand)

- Keep removed break off bolts. They will be used for re-assembling the ignition switch.
- New ignition switch can be identified by lot No.
New: #####A
Original: #####

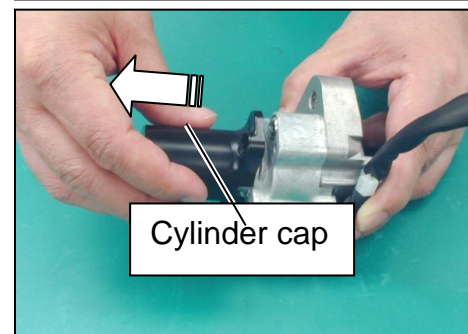
- 2) Remove the cylinder cap.

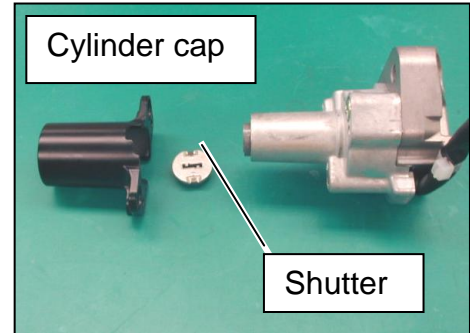
3) Remove the cylinder cap and shutter.

- The Shutter is came off when removing the cylinder cap.

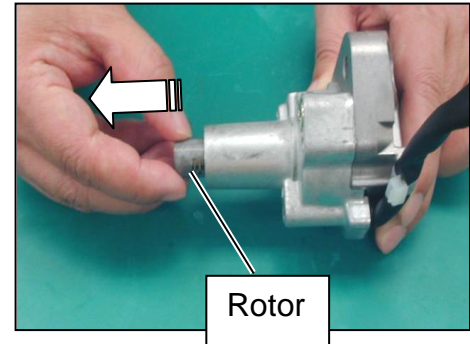
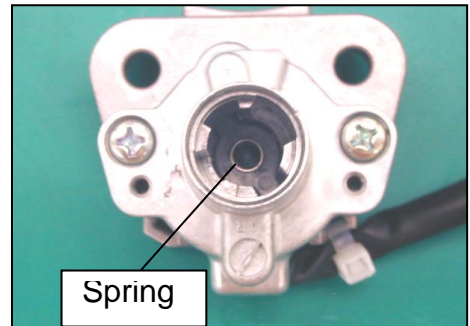
4) Remove the rotor.

5) Spring is come off when removing the rotor.

- If spring is not come off, spring is stuck at the bottom of key cylinder. Please check it.

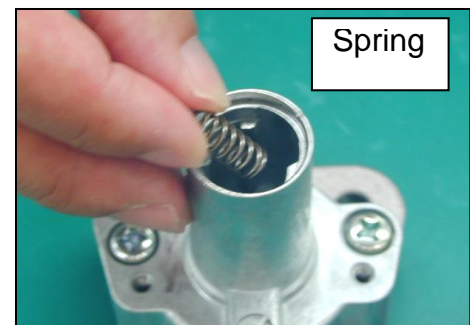
6) Remove the spring.

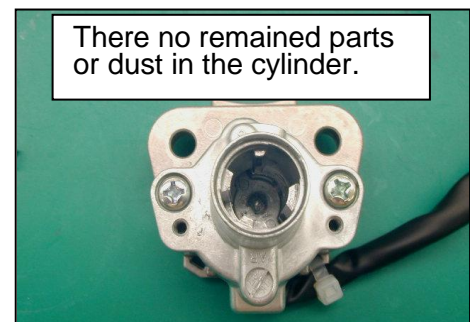
7) Make sure no dust in the key cylinder before reassembling. This main body of ignition switch is used for modification.

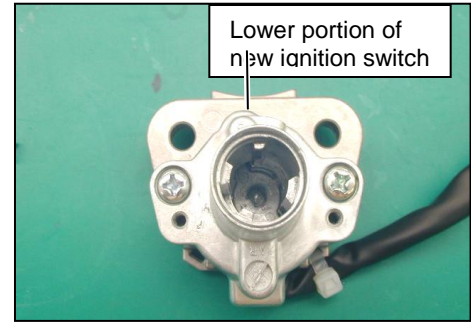
- 1) Make sure to use a main body of the new ignition switch.

- New ignition switch body has special lot number as ####A.

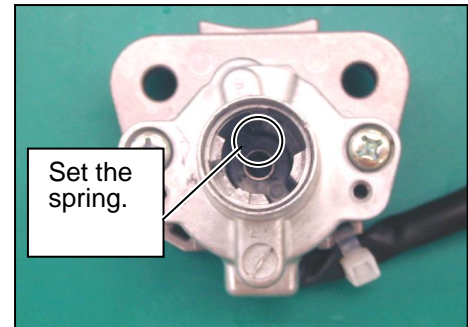
- 2) Set the spring to projection part at the bottom of key cylinder.

- Confirm spring was set to the projection.

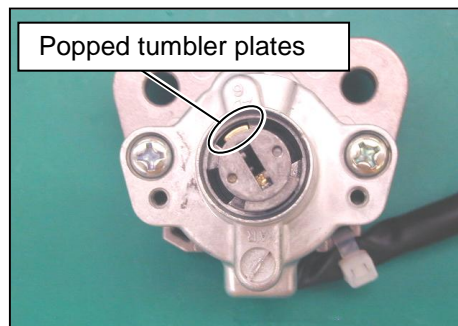
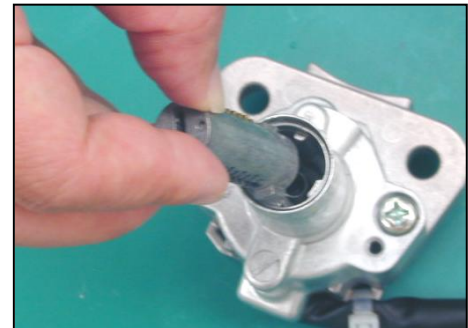
- 3) Install the original rotor to ignition switch key cylinder with aligning the tumbler position as shown below.

- Rotor cannot be installed fully if rotor set position is wrong.

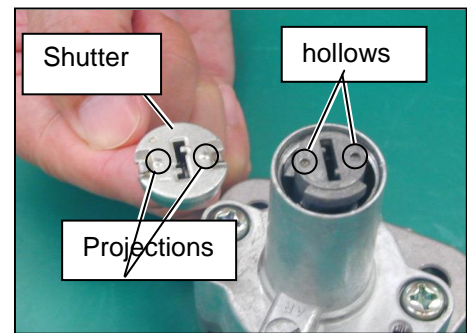
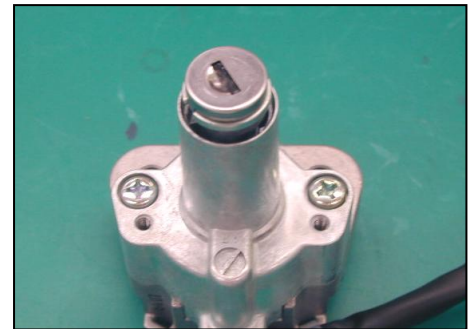
- 4) Put the shutter to the rotor with aligning projection and hollow.

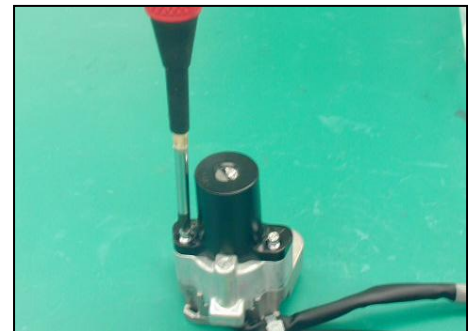
- 5) Install the cylinder cap to key cylinder and fixed it with tightening break off screws.
- 6) Tighten the screws until screw head break off.

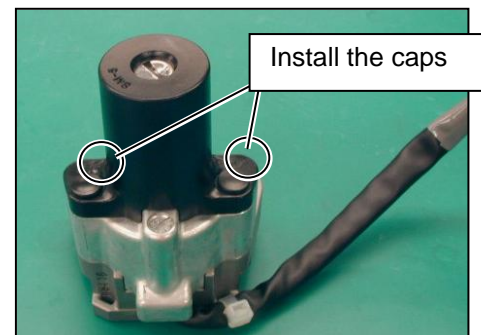
- 7) Put the cap to hole for break off screw.
- 8) Check smooth key rotation.

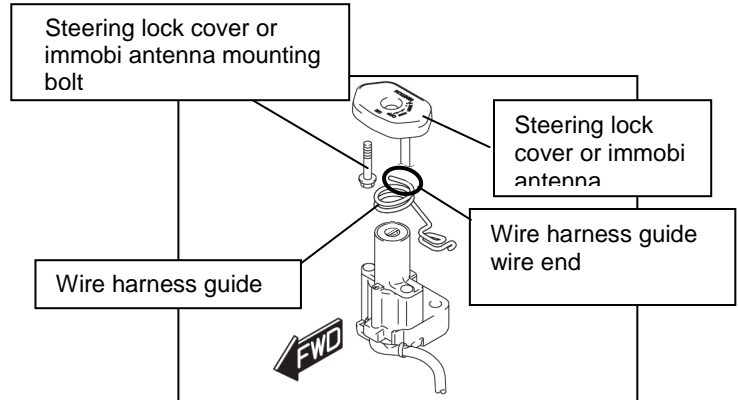
- 1) Install the wire harness guide as wire harness guide wire end located behind the steering lock cover mounting bolt.

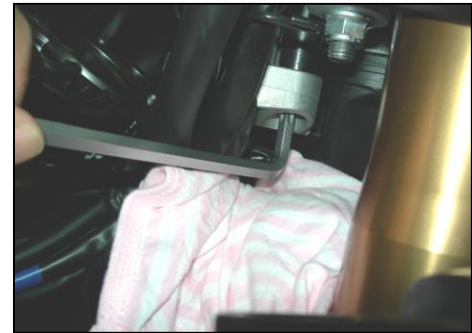
- 2) Mount the ignition switch to upper bracket with tightening new bolt.

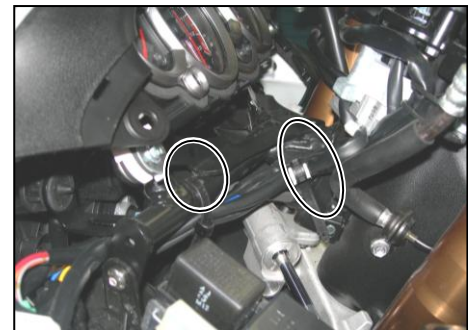
- 3) Clamp the ignition switch lead wire as correct position.

- Refer to 2-2 for detail of ignition switch lead wire routing.

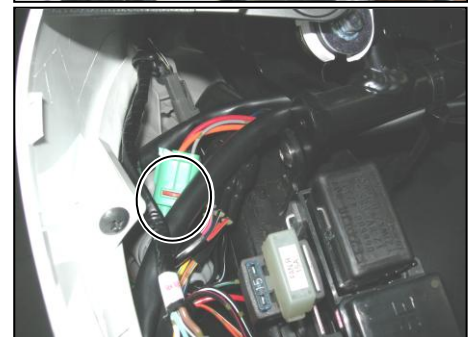
- 4) Connect the ignition lead wire coupler.

- When connecting the coupler, make sure to push it until a click is felt.

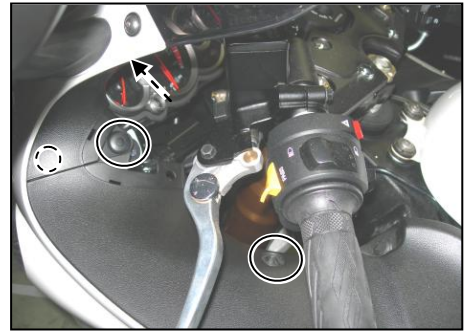
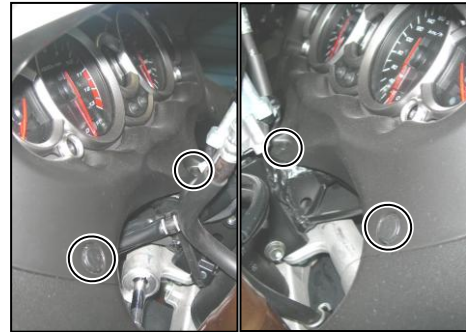
- 1) Install the meter left panel with put the center screw and clip.
- 2) Install the meter right panel as same procedure as meter left panel.

- 3) Install the meter rear panel with put the screws and clips.

- 4) Connect the battery minus terminal.
