# Campaign Service BULLETIN

BULLETIN NUMBER:  
CB08-J-001

## SUPPLY PUMP CONNECTING PIPE FUEL LEAK SAFETY RECALL CAMPAIGN 08V-251

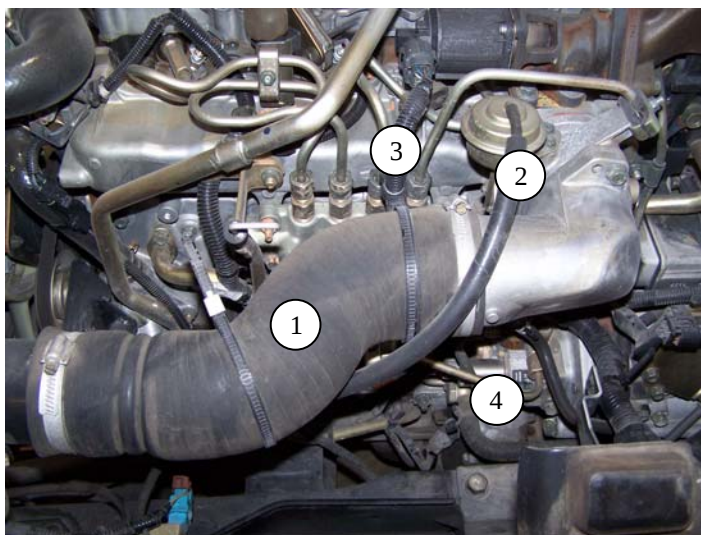
Figure 1

1. Tilt up the cab. Insert the lock pin. (**For Crew Cab Model**-Remove the driver's seat cushion and inspection panel to access the engine compartment.)
2. Remove the intake duct for access. See figure 1.

#### Legend:

1. Intake Hose
2. Throttle Valve Vacuum Hose
3. EGR Valve Harness
4. Supply Pump

4. If no leak is found, go to step 5. If a leak is found, replace the supply pump as outlined in the appropriate service manual. After replacing the supply pump go to “Applying the Campaign Label”.
5. Disconnect the Throttle Valve vacuum hose. See figure 1.
6. Remove shield mounting bolts and lower the shield for required clearance. See figure 3. (Three mounting bolts)

14. Install intake duct. Be sure to secure EGR valve harness and Throttle Valve vacuum hose into retaining clips. See figure 1.

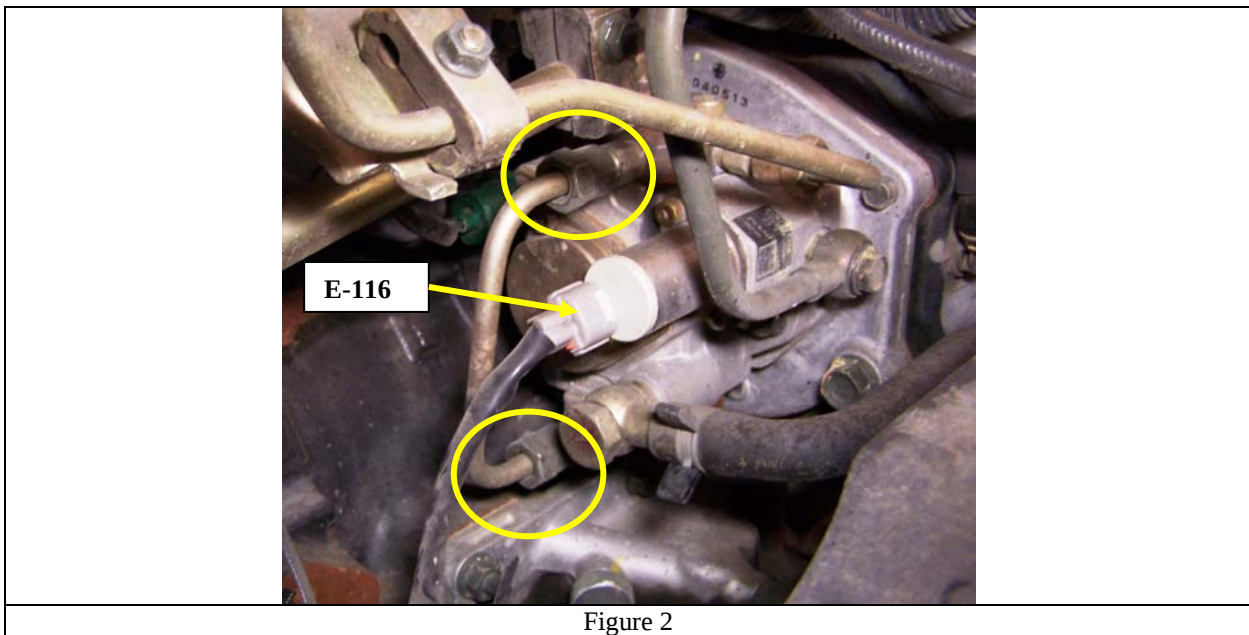
3. Inspect connecting pipe fittings for leaking fuel. See figure 2

7. Disconnect the Fuel Rail Pressure (FRP) Regulator connector E-116. See figure 2.
8. **For Crew Cab Model-** Remove the driver side inner fender panel. See figure 4.

9. Using the special tool 3300FN pipe socket, tighten both connecting pipe fittings to 22 lb-ft (30Nm). The torque wrench operation angle should not be greater than 30 degrees. If the operation angle of the special tool is too wide, the tool may interfere with and scratch the pipe. To prevent accidental scratches, apply vinyl tape to the tool. Repeat tightening, alternating sides, until reaching the specified torque.

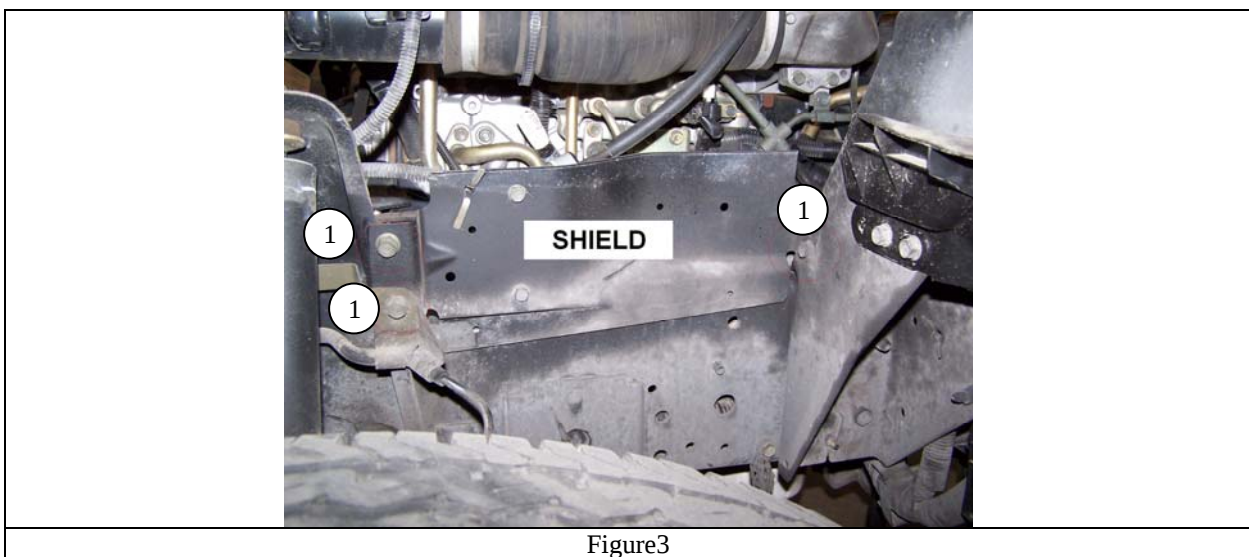
Legend:

1. 1. Mounting Bolt

10. **For Crew Cab Model-**install the driver side inner fender panel.
11. Connect the Fuel Rail Pressure (FRP) Regulator connector.
12. Install shield.
13. Connect Throttle Valve Vacuum hose.
