# Campaign Service BULLETIN

BULLETIN NUMBER:  
CB08-J-001A

## SUPPLY PUMP CONNECTING PIPE FUEL LEAK SAFETY RECALL CAMPAIGN 08V-251

- 2006-2007 Isuzu N-Series
  - 2006-2007 GMC W-Series
  - 2006-2007 Chevrolet W-series
- Equipped with 5.2L diesel engine and a production date between June 2006 and March 2007

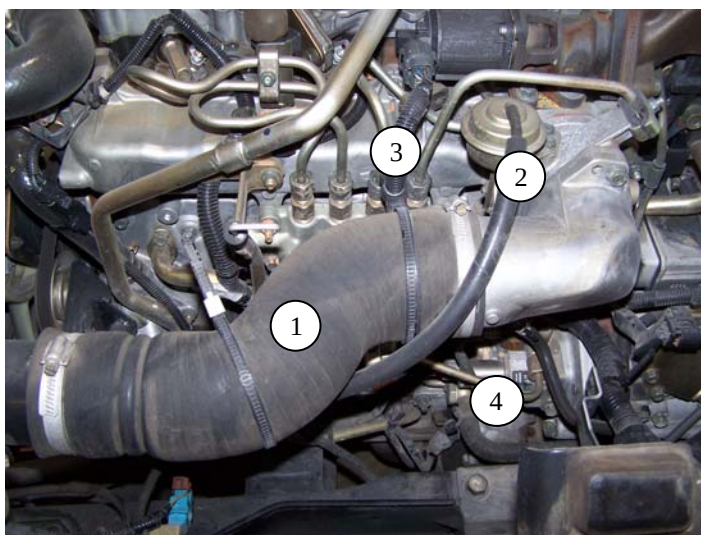
Figure 1

1. Tilt up the cab. Insert the lock pin. (**For Crew Cab Model**-Remove the driver's seat cushion and inspection panel to access the engine compartment.)
2. Remove the intake duct for access. See figure 1.

1. Intake Hose

2. Throttle Valve Vacuum Hose
3. EGR Valve Harness
4. Supply Pump

4. If no leak is found, go to step 5. If a leak is found, replace the supply pump as outlined in the appropriate service manual. After replacing the supply pump go to “Applying the Campaign Label”.
5. Disconnect the Throttle Valve vacuum hose. See figure 1.
6. Remove shield mounting bolts and lower the shield for required clearance. See figure 3. (Three mounting bolts)

12. Install shield.
13. Connect Throttle Valve Vacuum hose.
14. Install intake duct. Be sure to secure EGR valve harness and Throttle Valve vacuum hose into retaining clips. See figure 1.
15. Remove the lock pin and lower the cab. (**For Crew Cab Model**-Install inspection panel and secure the driver's seat cushion)

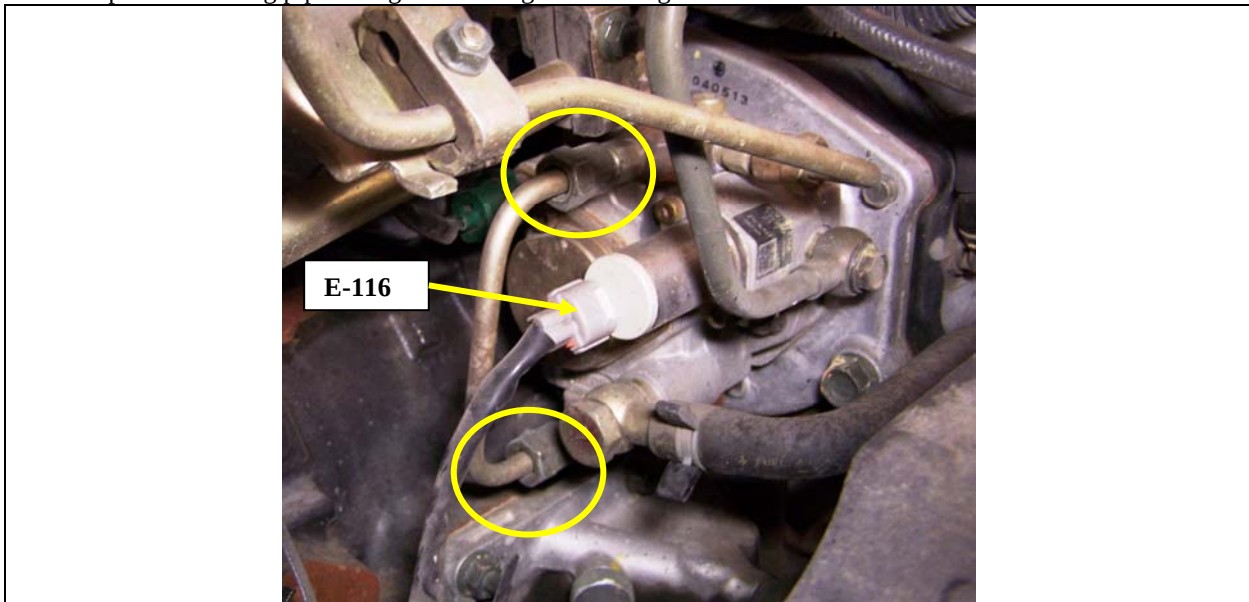
Figure 2

3. Inspect connecting pipe fittings for leaking fuel. See figure 2

7. Disconnect the Fuel Rail Pressure (FRP) Regulator connector E-116. See figure 2.
8. **For Crew Cab Model-** Remove the driver side inner fender panel. See figure 4.
9. Using the special tool 3300FN pipe socket (SnapOn FRXM 17 or an equivalent), tighten both connecting pipe fittings to 22 lb-ft (30Nm). The torque wrench operation angle should not be greater than 30 degrees. If the operation angle of the special tool is too wide, the tool may interfere with and scratch the pipe. To prevent accidental scratches, apply vinyl tape to the tool. Repeat tightening, alternating sides, until reaching the specified torque.
10. **For Crew Cab Model-**install the driver side inner fender panel.
11. Connect the Fuel Rail Pressure (FRP) Regulator connector.

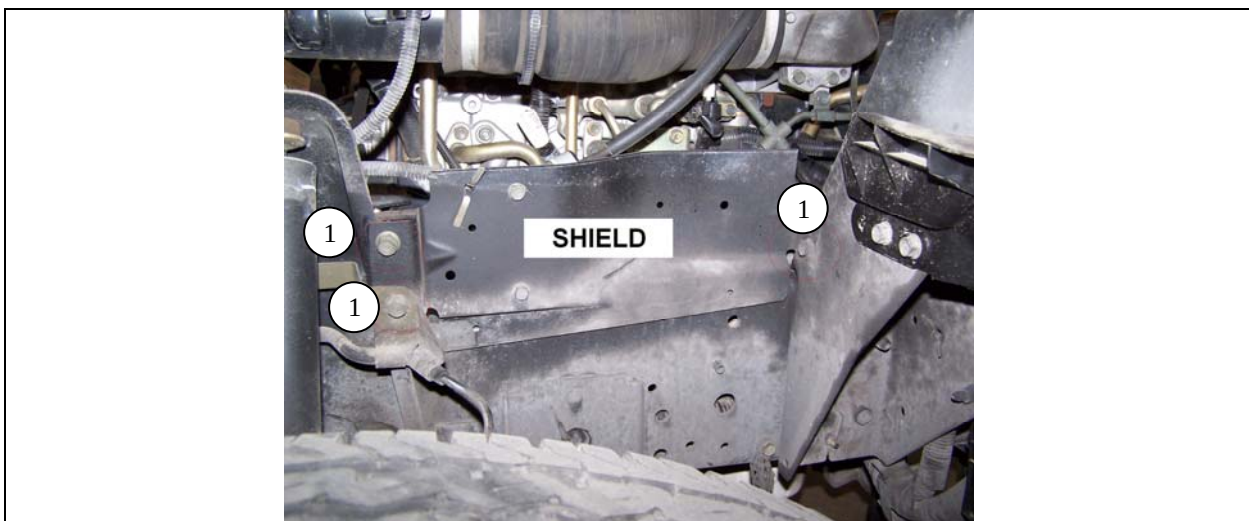
Figure3

1. 1. Mounting Bolt

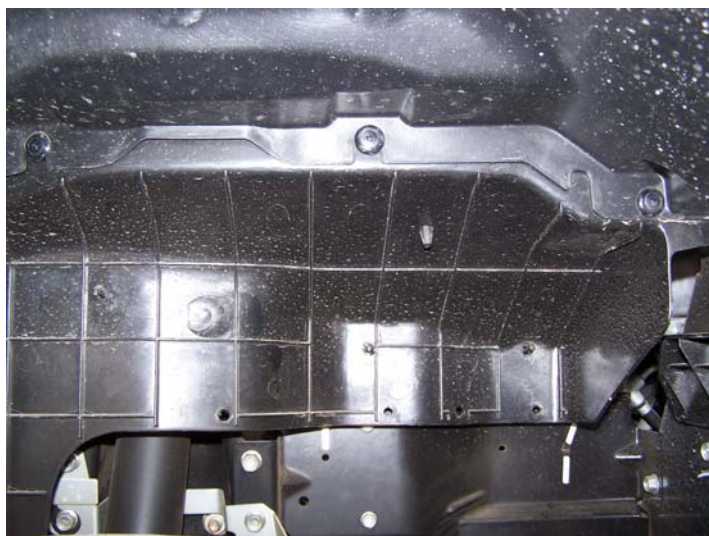
Figure 4

Inner fender panel
