RECALL CAMPAIGN BULLETIN

NTB08-068b

VOLUNTARY RECALL CAMPAIGN 2004 - 2006 NISSAN TITAN AND ARMADA AIR CONDITIONER CONDENSER FAN

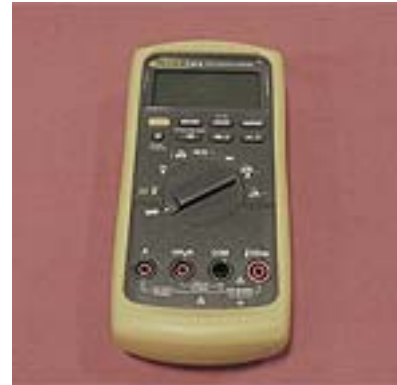
Fluke 73 Digital Multimeter and Test Leads (Fluke 73 Digital Multimeter is part of the J-48602 QR25 Engine Kit).

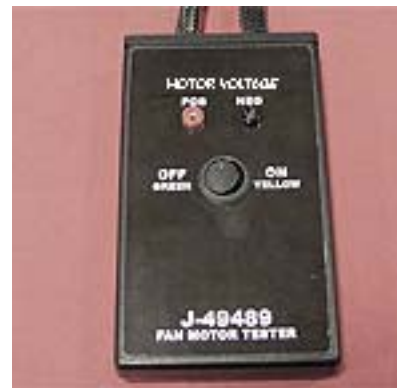
Fan Motor Tester: Part of test kit J-49489

- Part number for Fan Motor Tester – J-49489-1

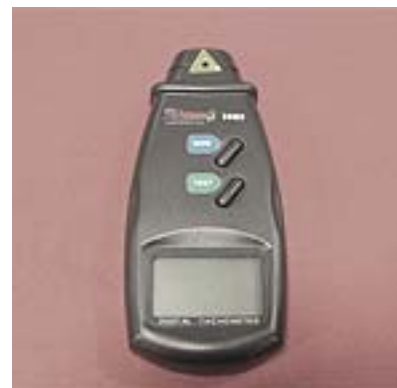
Phototach (OTC 3660) Digital Tachometer: Part of test kit J-49489

- Part number for Phototach – 3660

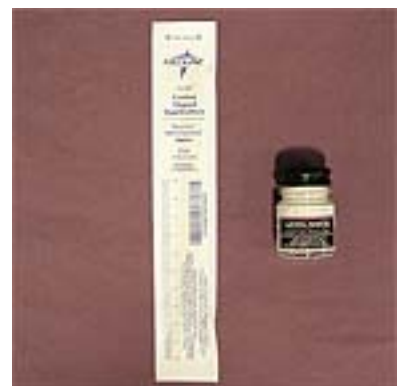
Reflective Paint: Part of test kit J-49489

- Part number for reflective paint – 550197

Applicator: Part of test kit J-49489

- Part number for Applicators (100 pack) - 550223

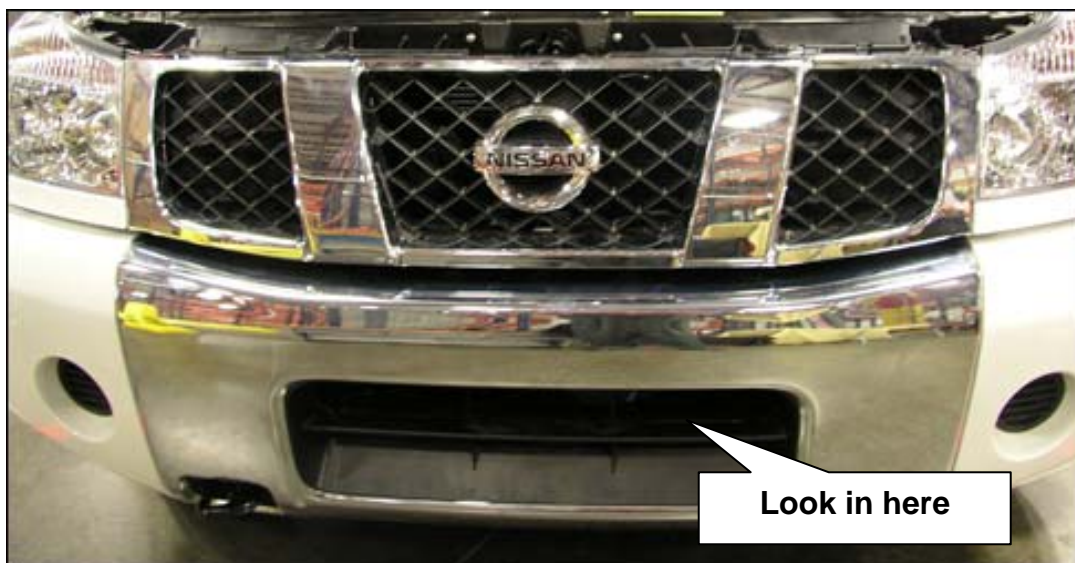
Figure A-1

1. Look in the lower bumper area and locate the condenser fan motor.

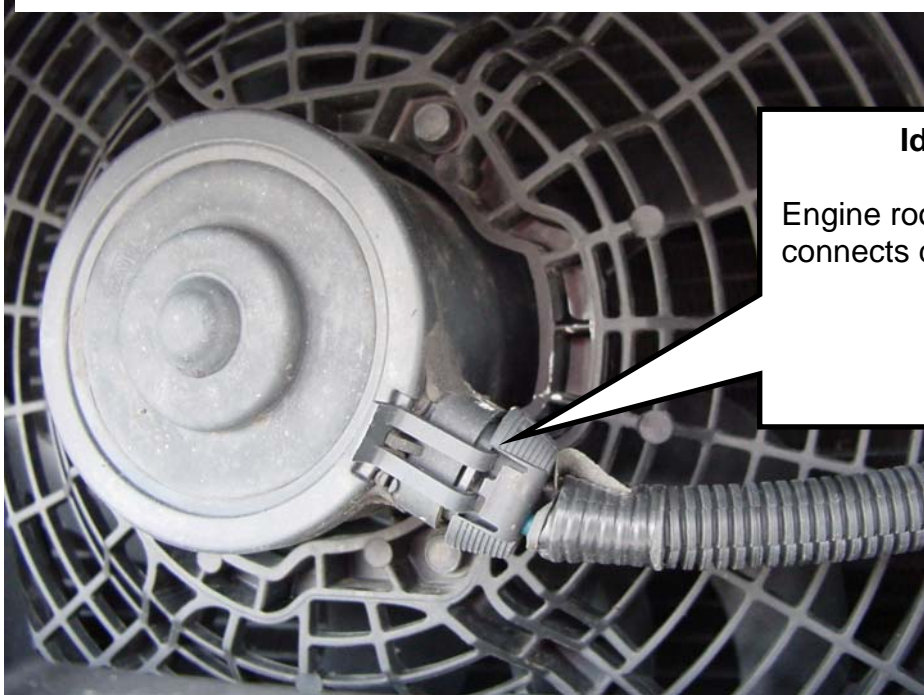
Figure A-2

Type 3 Fan - 140 watt motor

Identification
Engine room harness
connects directly to fan motor.

No action required

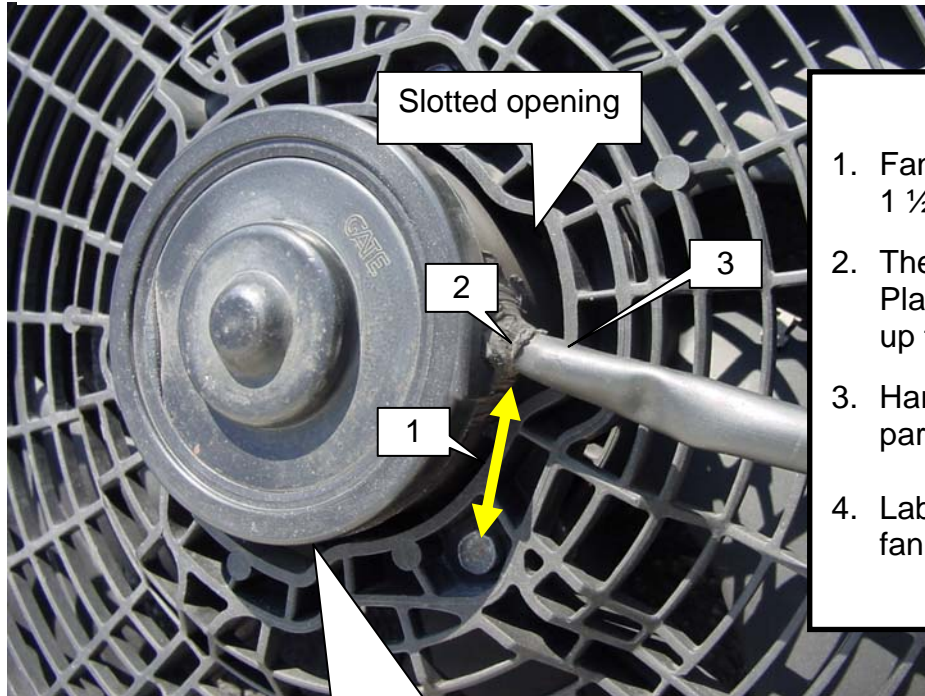
Figure A-3

Type 1 Fan - 90 watt motor

1. Fan motor harness position is 1 ½" from mounting bolt.
2. There are no exposed wires. Plastic harness cover goes right up to the motor.
3. Harness goes across the lower part of the slotted opening.
4. Label on the lower side of the fan motor has the word "GATE".

4: Label has the word "GATE"

No action required

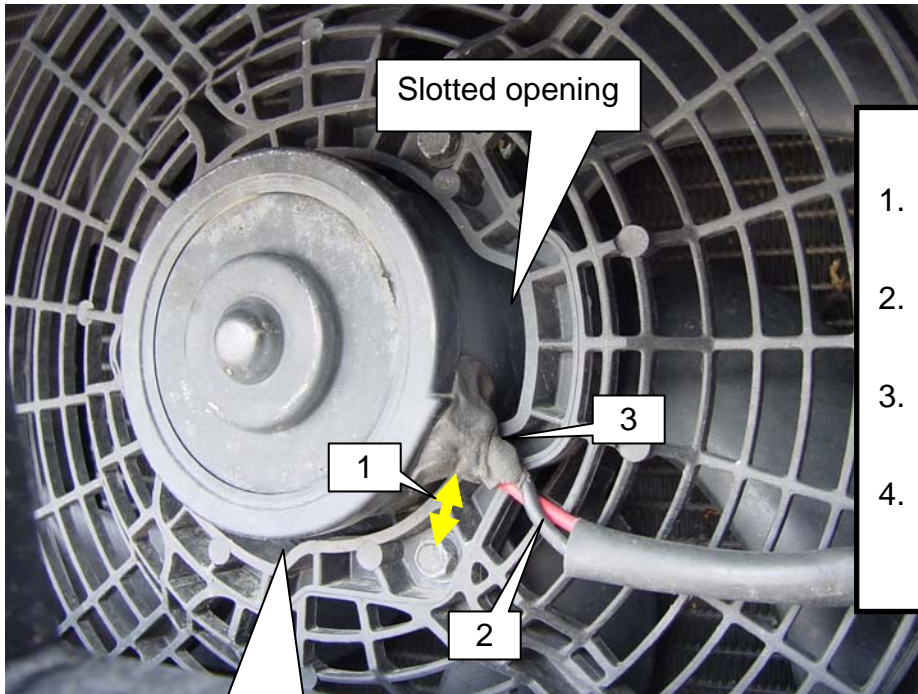
Figure A-4

Type 2 Fan - 90 watt motor

- Identification:**
1. Fan motor harness position is 1/2" from mounting bolt.
 2. Red and Black wires are exposed.
 3. Wire harness is below slotted opening.
 4. Label on the lower side of the fan motor does not have the word "GATE".

4: Label does not have the word "GATE"

Go to Procedure B - Cooling Fan Motor Inspection

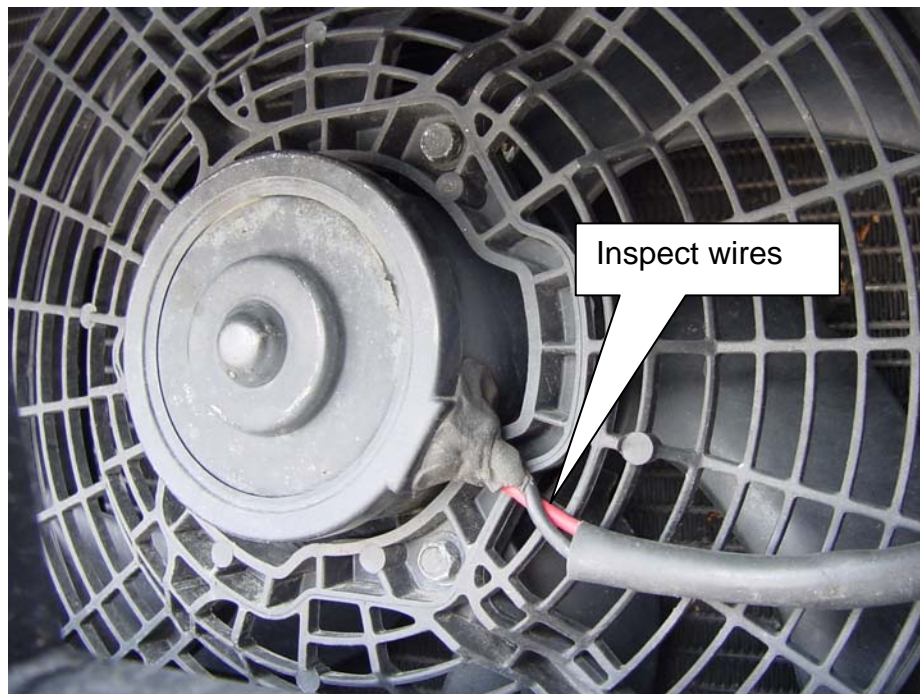
Figure B-1

1. Inspect the wires near the condenser fan motor:

- Make sure there is no damage to the wire insulation and the wires are in good condition.
- **If the wires are damaged** (cracked or missing insulation), STOP; no more testing is needed. Go to Procedure C on page 17 and replace the condenser fan assembly.

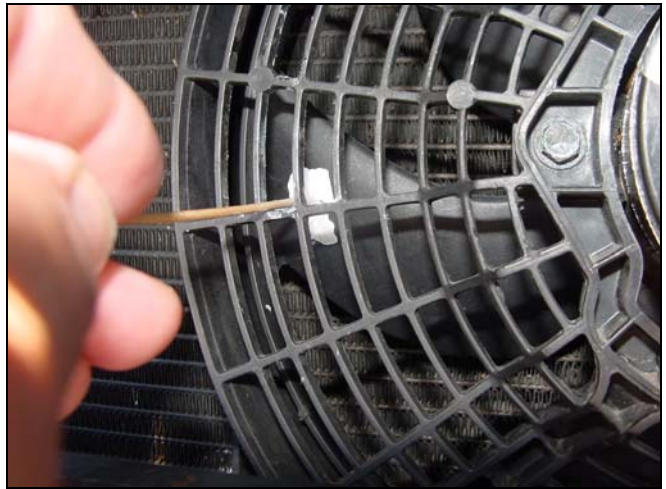
Figure B-2

4. Paint a “dime sized” area on the outer portion of one fan blade.

- Make sure the painted area is completely filled in (no unpainted spots or thin paint in the dime sized area).
- Allow the paint to dry—about 5 minutes.

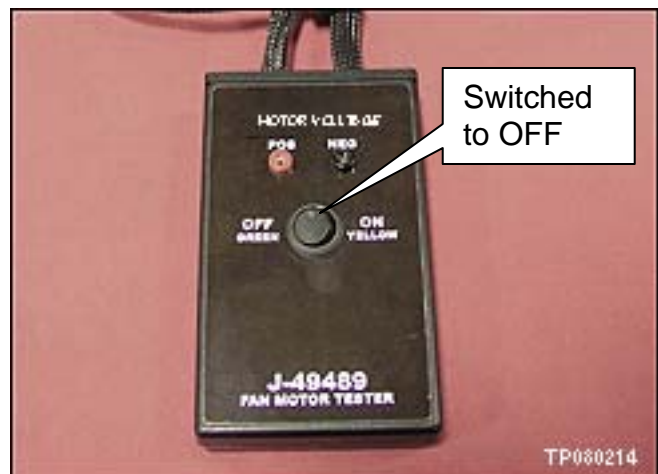
Figure B-3

5. Before connecting to the vehicle battery, make sure the Fan Motor Tester is switched OFF.

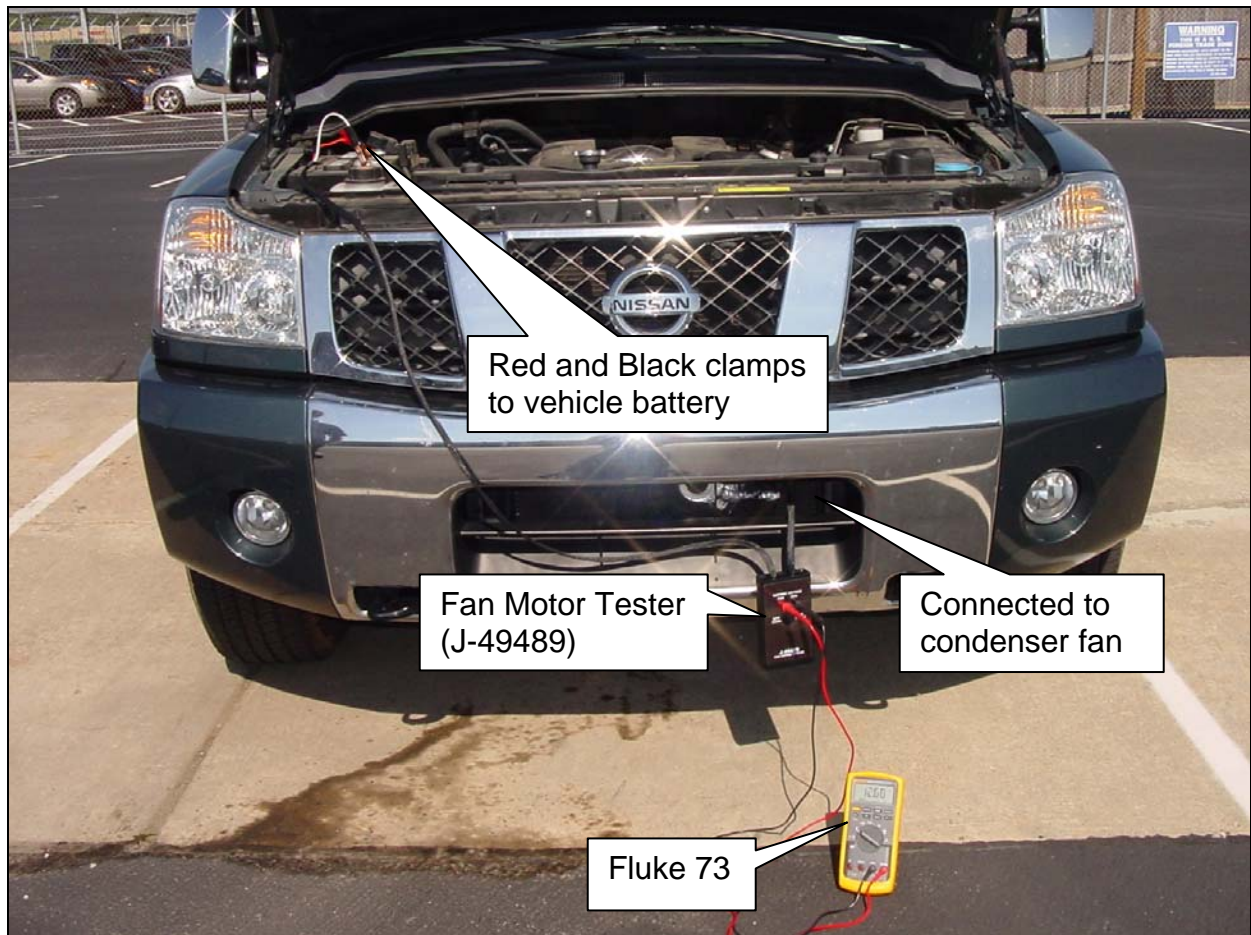
Figure B-4

6. Connect the Fan Motor Tester and the Fluke 73 Digital Multimeter (using the fluke meter test leads) as follows (see Figure B-4):
- Connect Fan Motor Tester harness connector to the condenser fan.
 - Connect Fan Motor Tester to the vehicle battery; Red clamp to + (positive) / Black clamp to – (negative).
 - Connect the Fluke 73 digital multimeter to the MOTOR VOLTAGE test ports on the Fan Motor Tester; V+ red probe to POS / COM black probe to NEG.

NOTE: When connected as above with the Fan Motor Tester switched OFF, the LED on the switch will illuminate green; this indicates the tester has battery power.

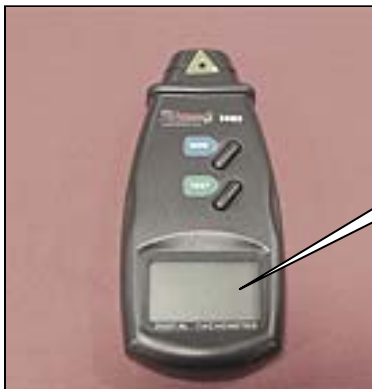
Figure B-5

8. Prepare the Fluke 73 and the Phototach Digital Tachometer for the next test as follows.
 - a. Switch the Fluke 73 to read DC Volts.

- b. Remove the Phototach Digital Tachometer from its case and have it ready to check the fan RPM.

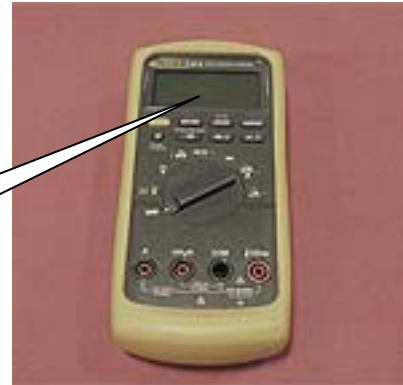
Figure B-6

Fan RPM

Fan Motor Voltage

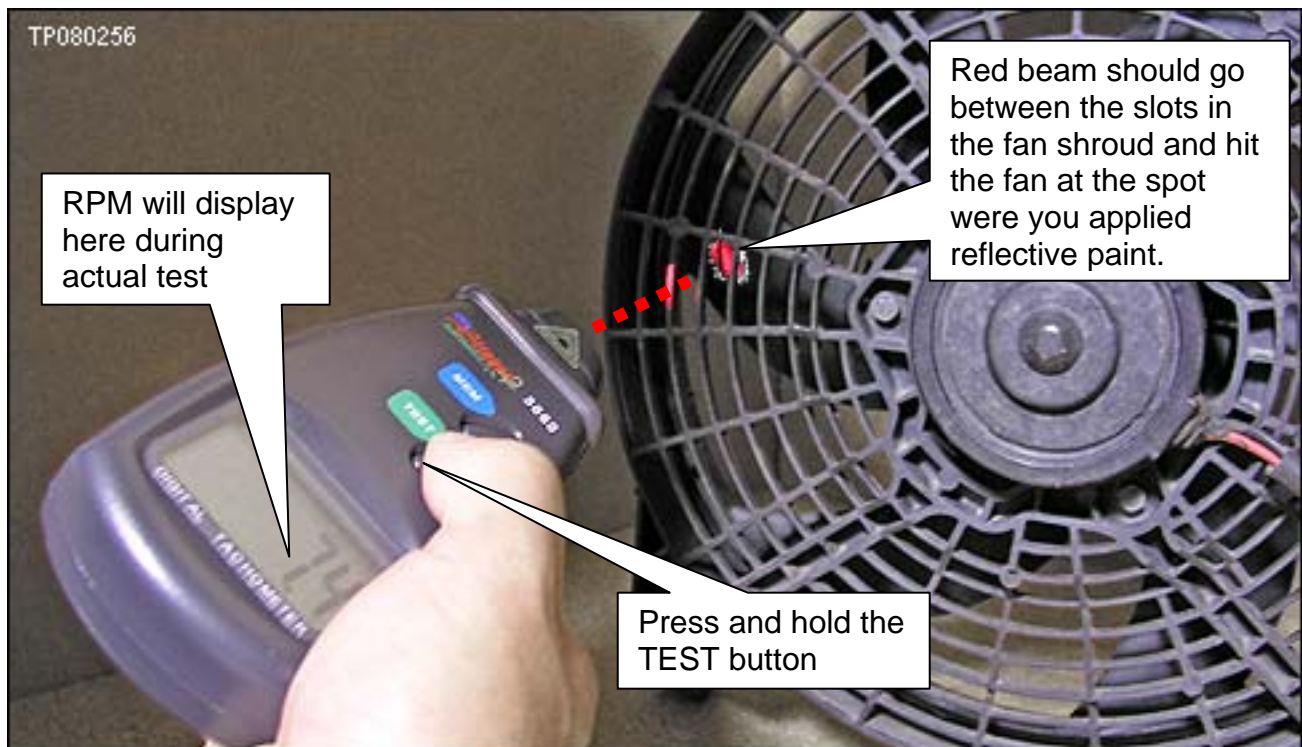
Figure B-7

3. Hold the digital tachometer about 4 inches away from the condenser fan.
4. Aim the red beam at the painted area on the fan blade.
 - The beam should be aimed between / through the slots in the fan shroud.

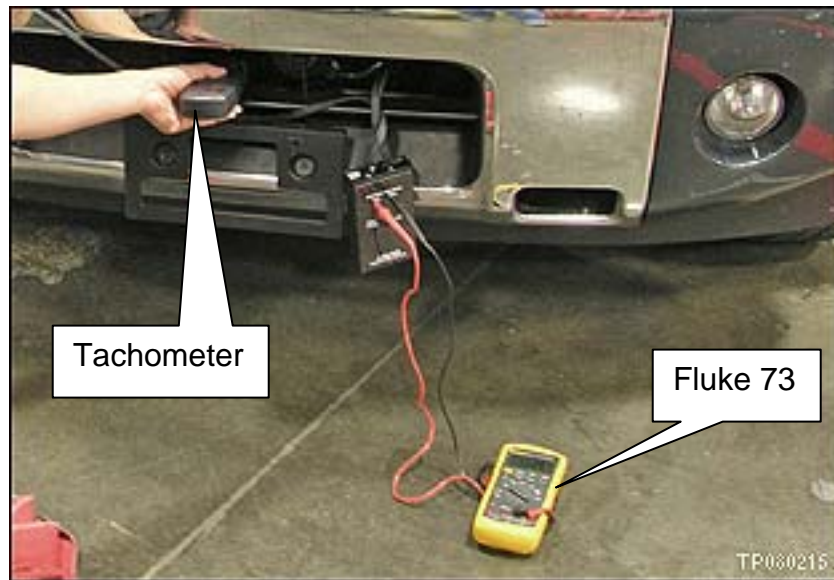
Figure B-8

WARNING: Do not shine or point the red light beam from the Phototach Digital Tachometer into anyone's eyes (including your own).
 - b. Hold the digital tachometer about 4 inches away from the condenser fan.
 - c. Aim the red beam at the painted area on the fan blade.
 - The beam should be aimed between / through the slots in the fan shroud.

- d. Observe the RPM reading on the tachometer and the volt reading on the Fluke 73 meter.

IMPORTANT: The RPM and voltage reading should be observed **at the same time** with the fan motor running.
10. Record / write down the RPM and Volt readings you observed in step 9 d.

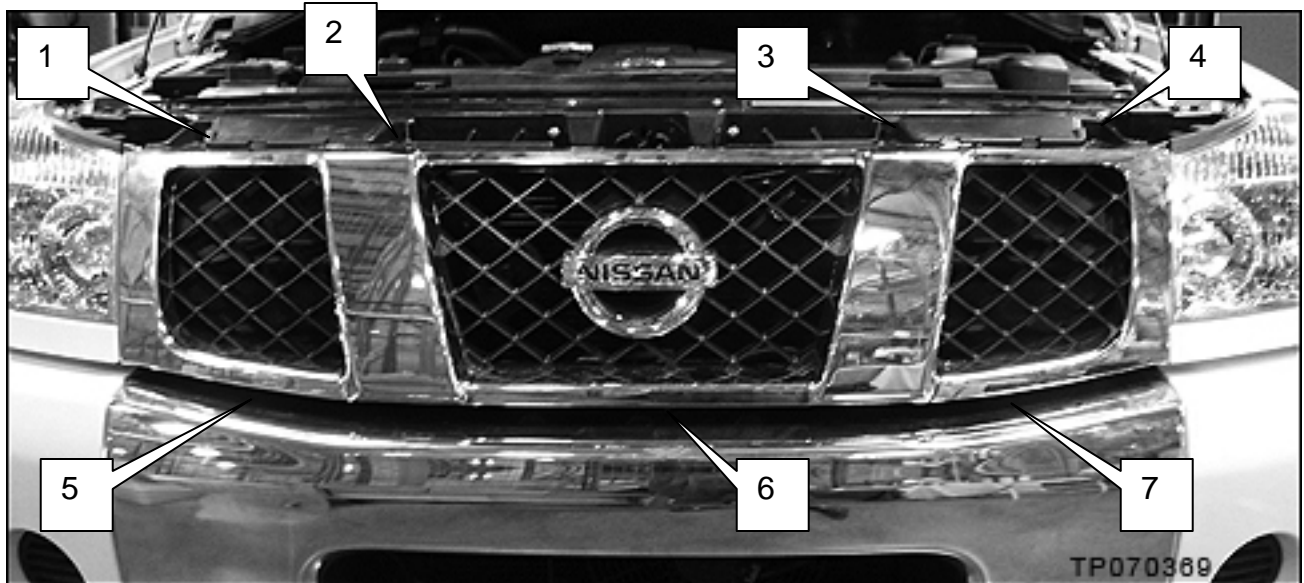
Figure C-1

- a. Use a long screwdriver to twist and release 7 clips shown in Figure C-1.

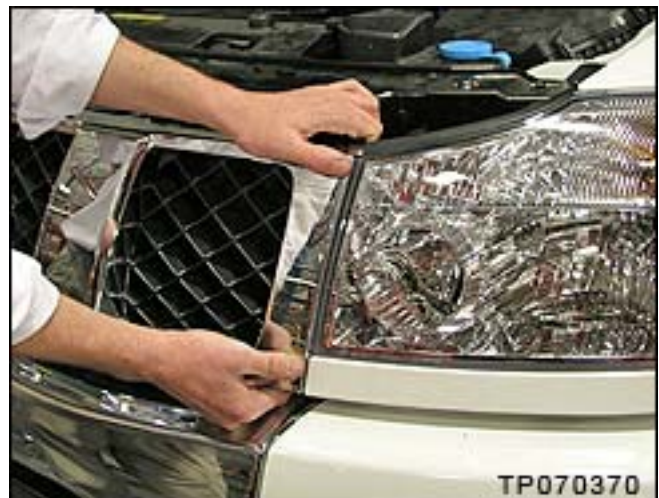
Figure C-2

- b. **IMPORTANT:** Make sure all 7 clips are released prior to the next step.
- c. Hold the grill as shown and give it a sharp pull.
- Do this for both sides.

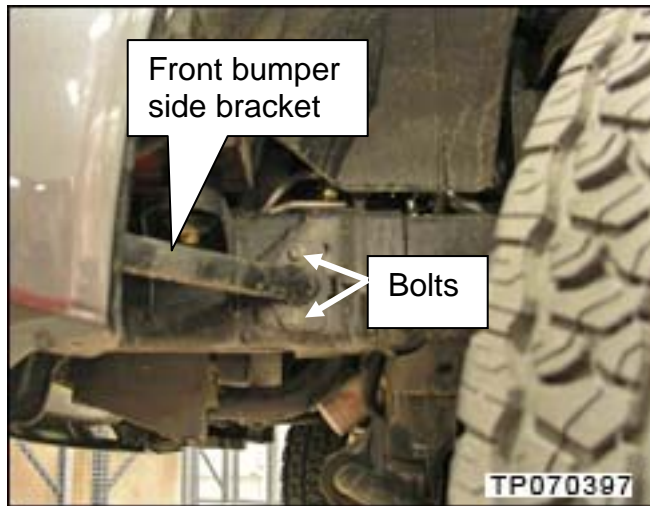
Figure C-3

4. Remove 2 bolts from the front bumper side bracket.

- Left side (driver side) only.

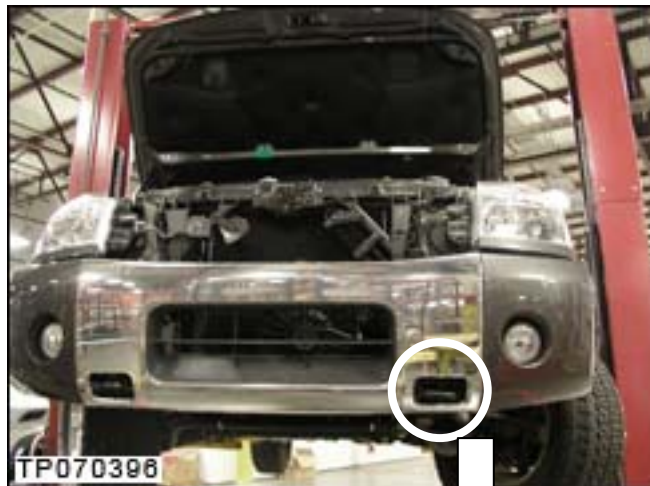
Figure C-4

a. Remove 1 bumper bolt shown in Figures C-4 and C-5:

- Driver side only.

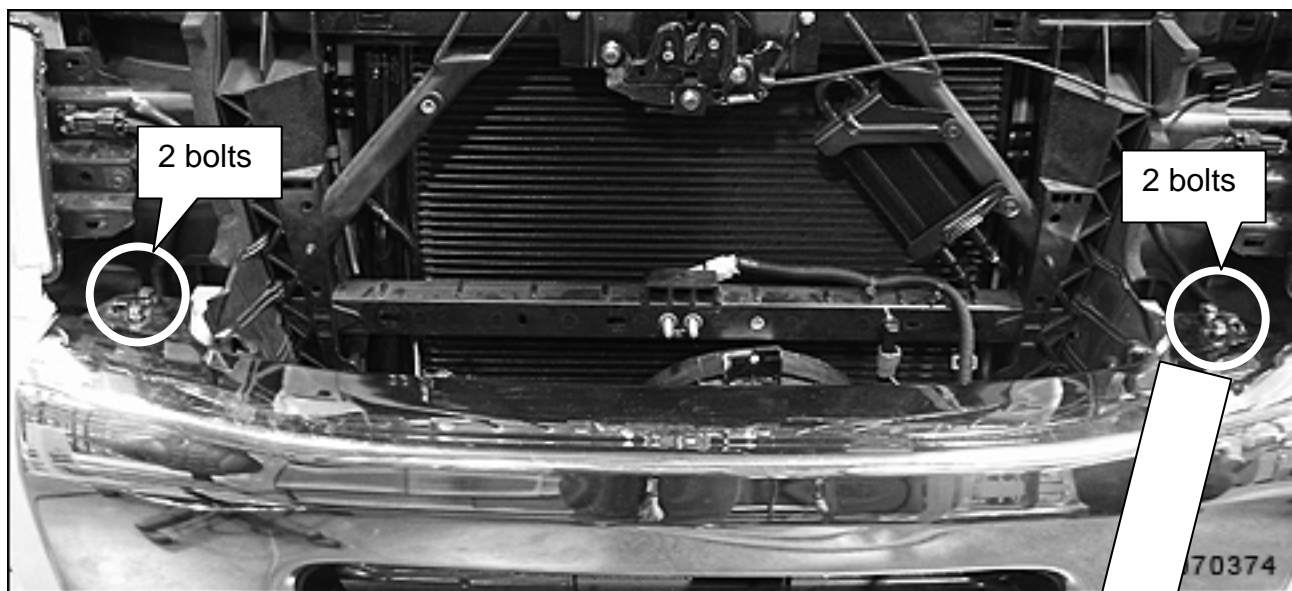
Figure C-6

b. Remove the 4 bumper bolts shown below.

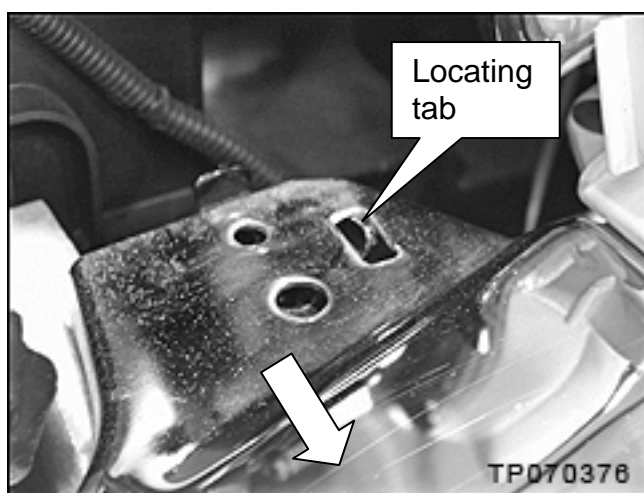
Figure C-7

c. Lift the bumper OFF of the locating tabs; both sides.

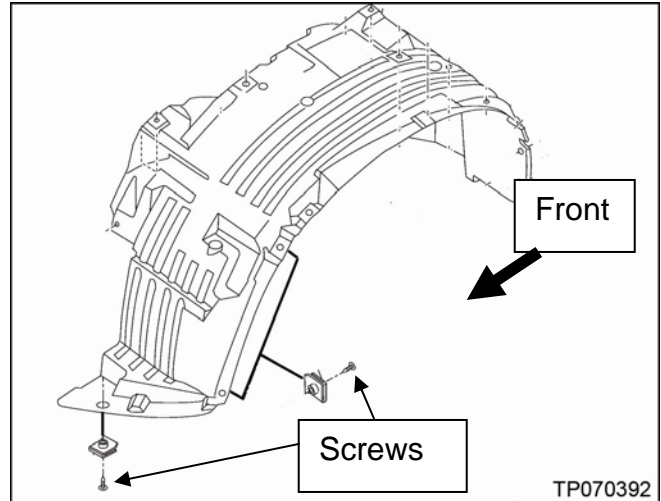
Figure C-8

- a. Remove 3 screws from the front of the fender protector.
 - Driver side only.

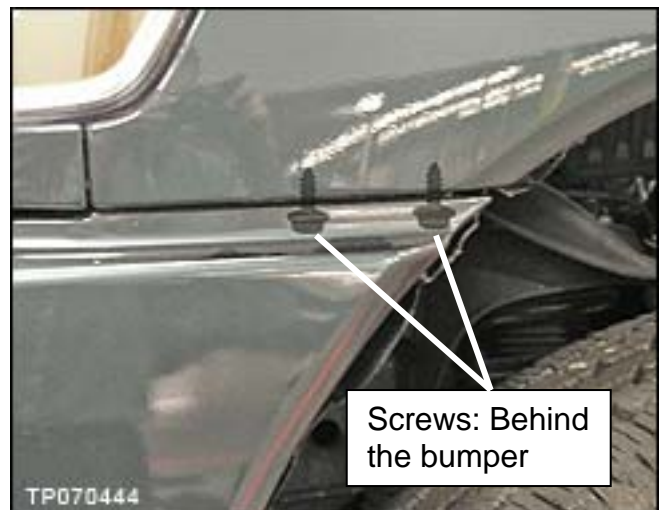
Figure C-9

- b. Remove 2 bumper to fender screws.
 - Driver side only.

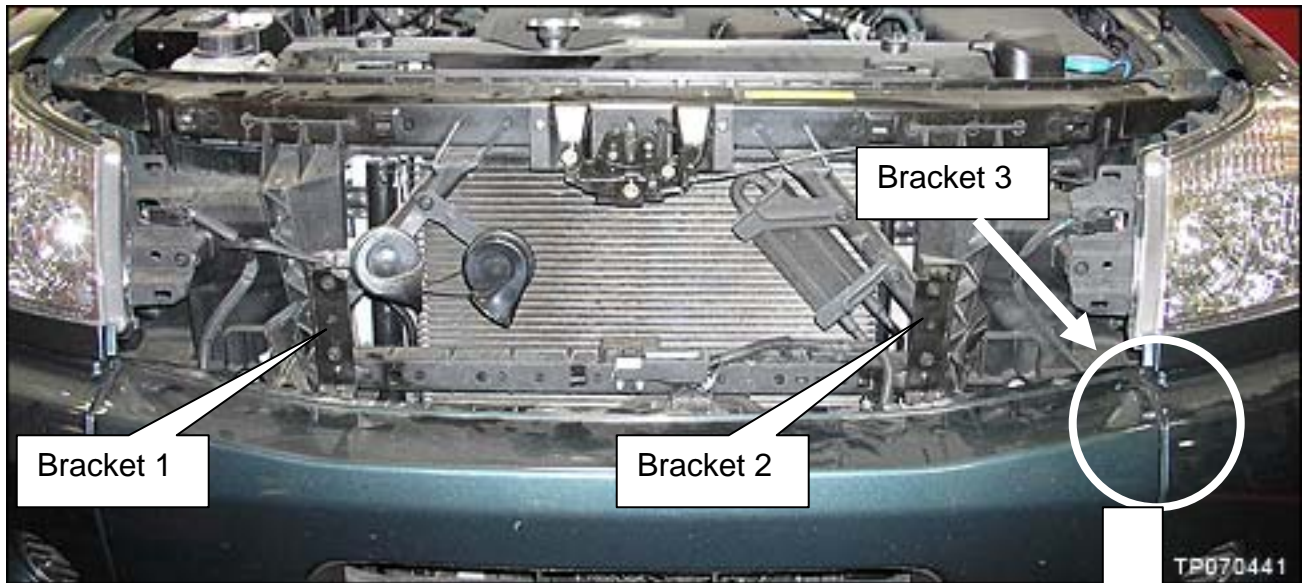
Figure C-10

c. Remove 2 bolts from each of the 3 bumper brackets shown in Figures C-10 and C-11.

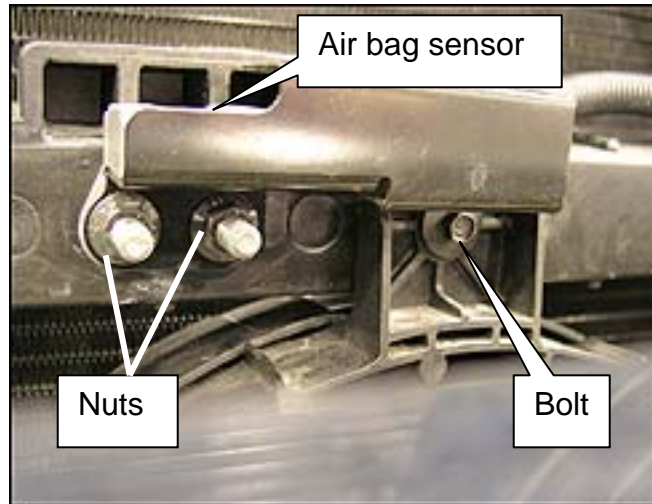
Figure C-12

8. Remove the condenser fan mounting bolt.

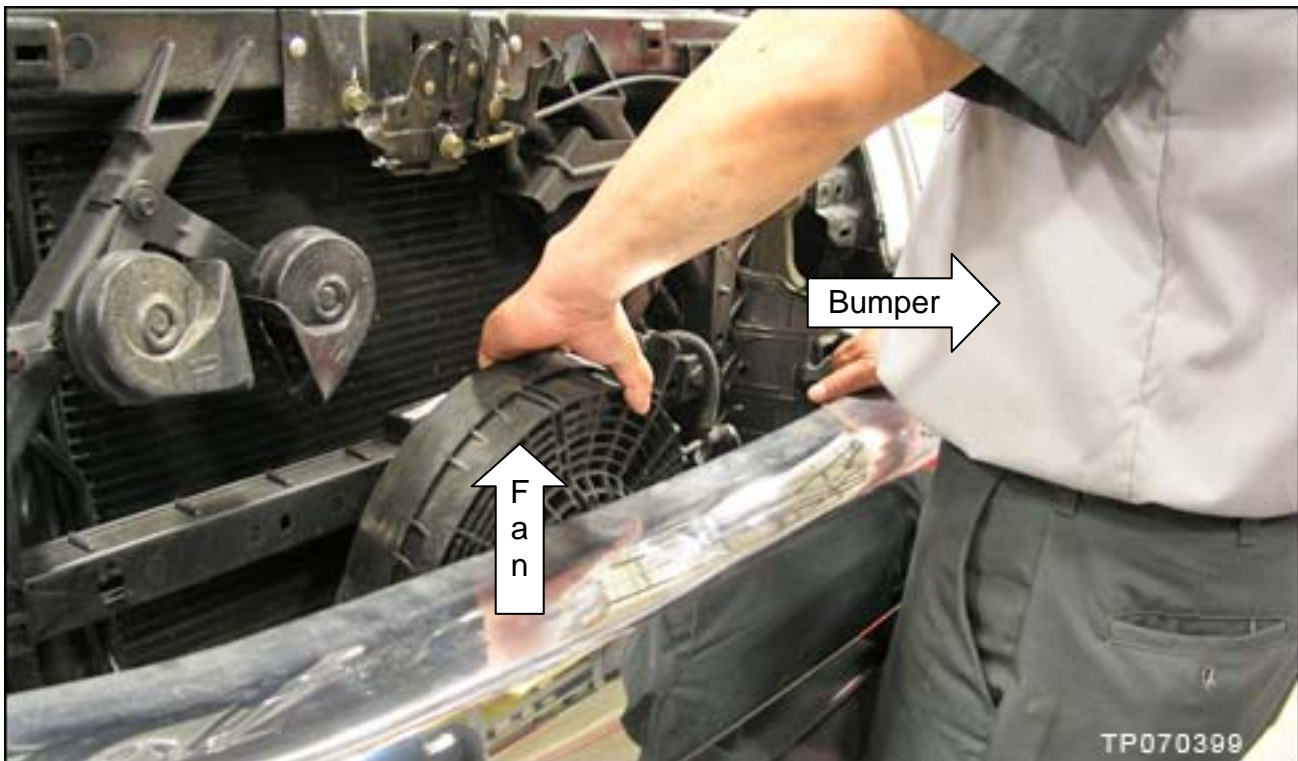
Figure C-13

9. Pull the bumper forward and remove the fan.

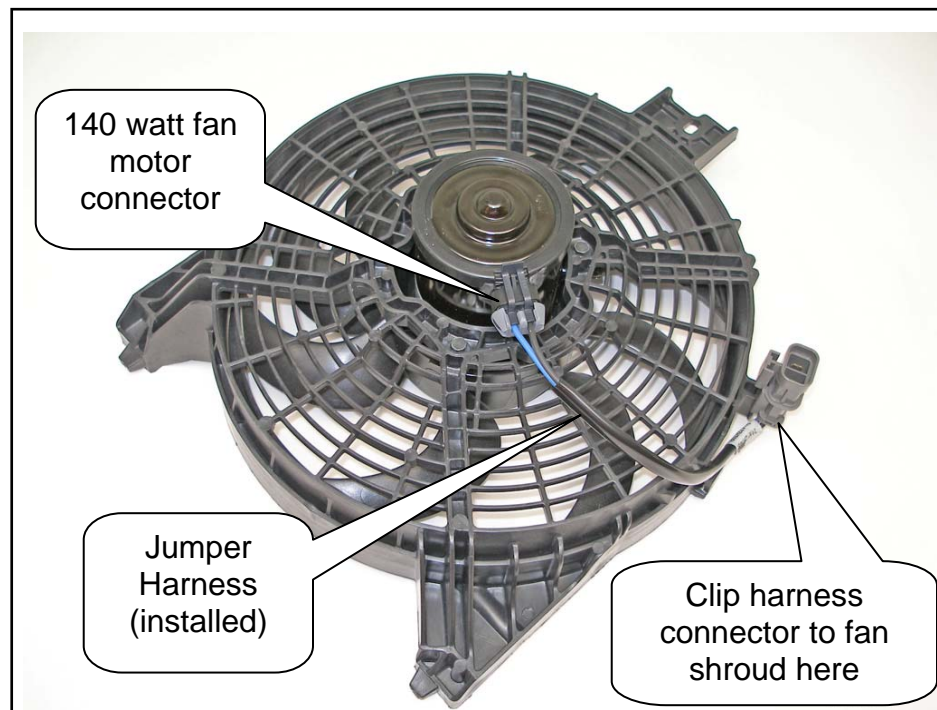
Figure C-14

- a. Install the jumper harness on the new fan motor as show below.
 - New fan assembly and harness kit are listed in the Parts Information.
- b. Go to the next page for installation of the fan assembly.

Jumper harness installation on NEW 140 watt fan assembly

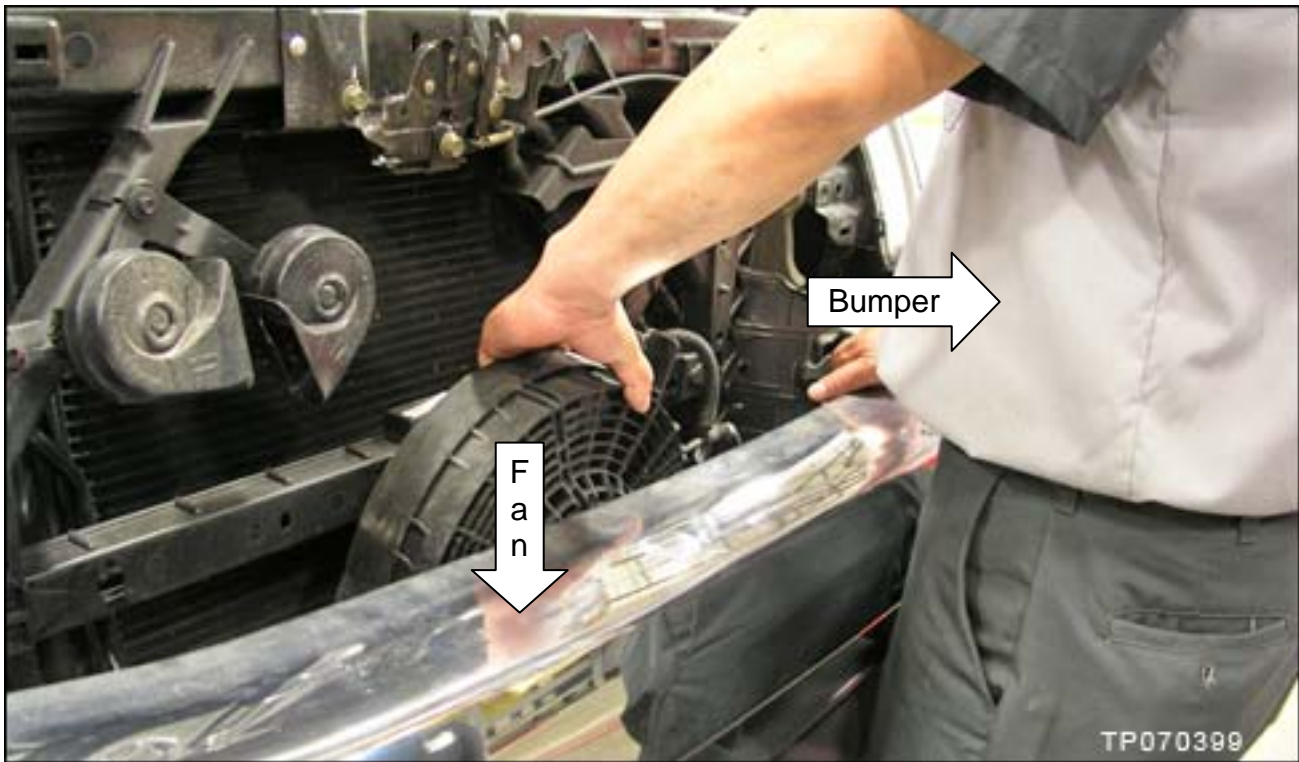
Figure C-15

10. Pull the bumper forward and install the fan assembly.

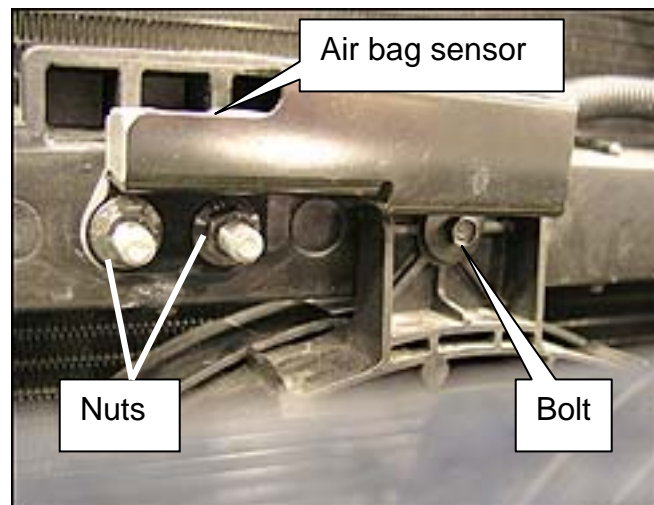
Figure C-16

12. Install and torque 2 nuts to the air bag sensor.

- Torque:
15 N.m (1.52 Kg-m, **11 ft-lb**)
- Apply medium strength thread-locker to the studs (Nissan P/N 999MP-AM005P or equivalent).

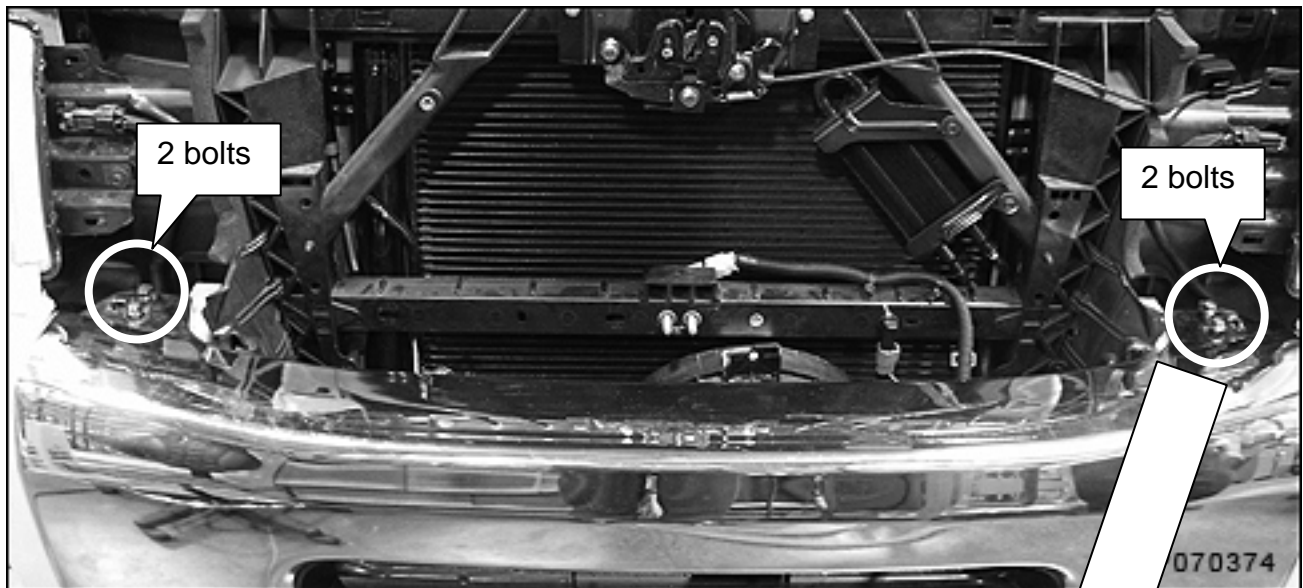
Figure C-17

- a. Lift bumper ON the locating tabs; both sides (see Figure C-18).
- b. Install and Torque 4 bumper bolts (see Figure C-17).

Torque: 14.2 N.m (1.45 kg-m, **10 ft-lb**)

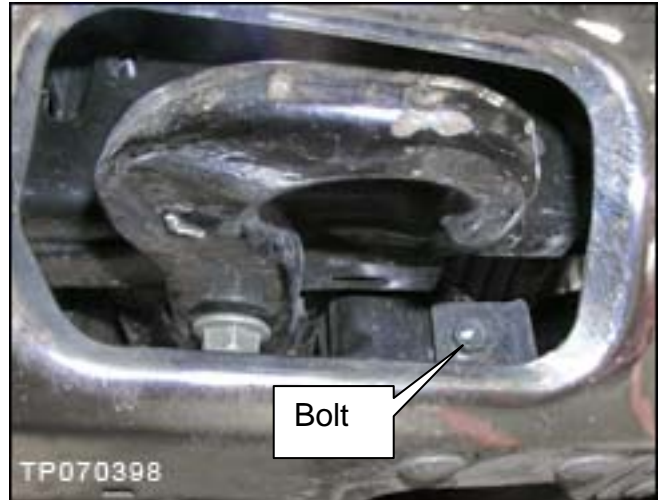
Figure C-19

c. Install and Torque the bumper bolt shown in Figure C-19.

Torque:
14.2 N.m (1.45 kg-m, **10 ft-lb**)

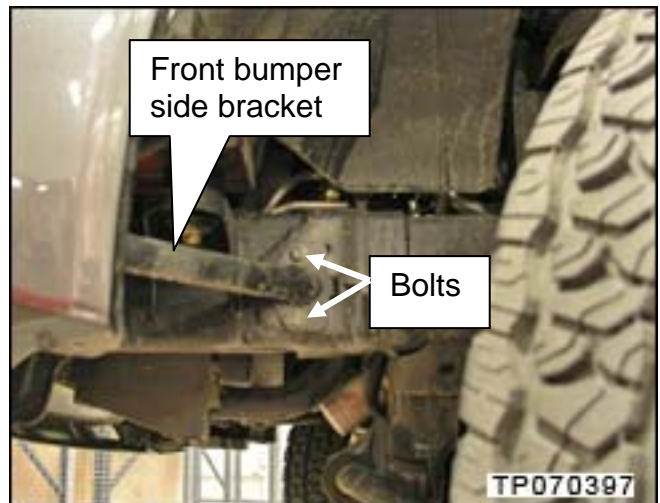
Figure C-20

- Driver side only.

Torque:
14.2 N.m (1.45 kg-m, **10 ft-lb**)

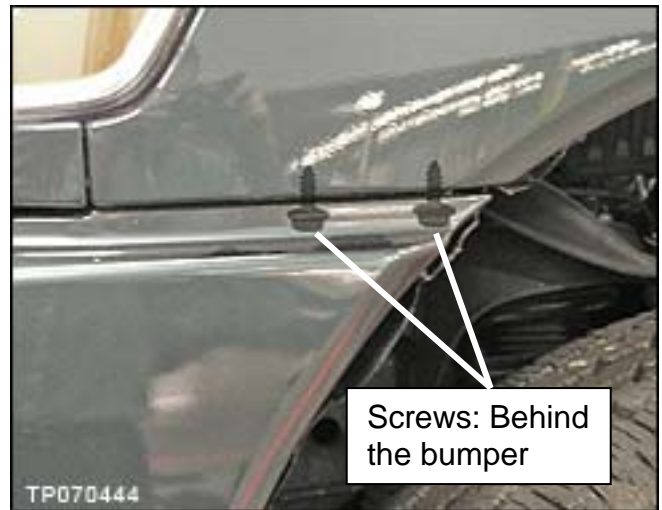
Figure C-21

- a. Install 2 bumper to fender screws.
 - Driver side only.

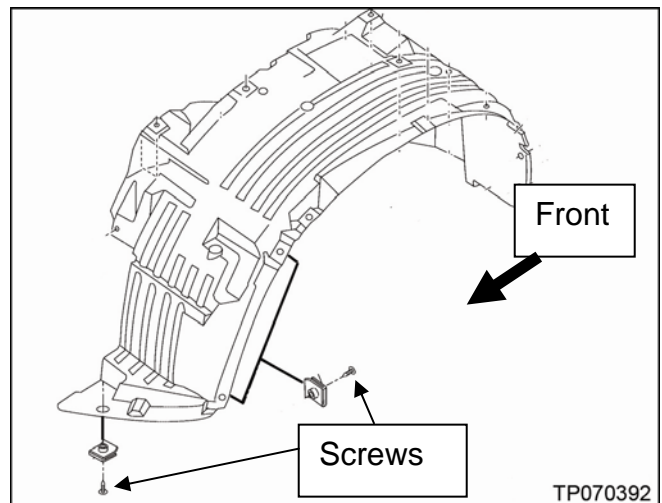
Figure C-22

- b. Install 3 screws at the front of the fender protector.
 - Driver side only.

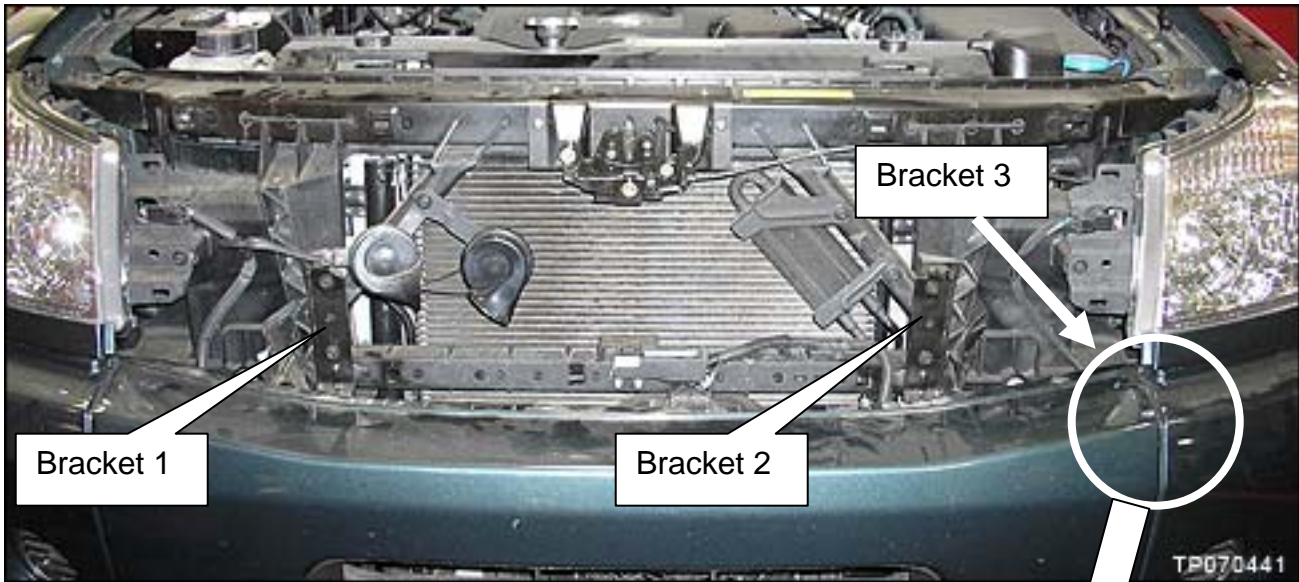
Figure C-23

- c. Install and Torque 2 bolts at each of the 3 bumper brackets as shown (see Figures C-23 and C-24).

Torque for bolts on brackets 1, 2, & 3:
9.6 N.m (0.97 kg-m, **85 in-lb**)

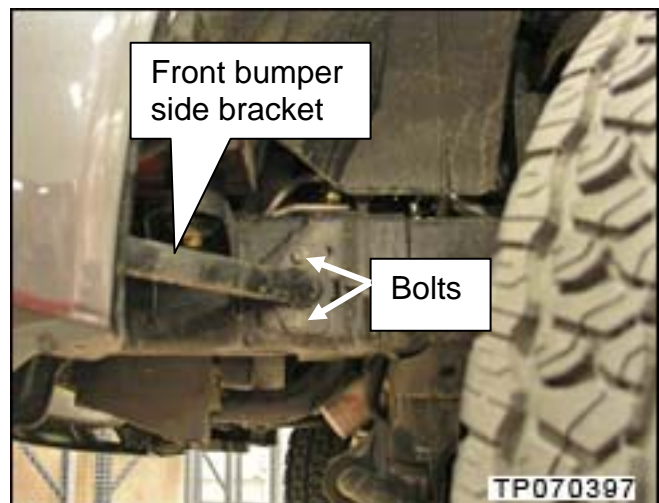
Figure C-25

- d. Install and torque 2 bolts for the front bumper side bracket.

- Driver side only.

Torque:
14.2 N.m (1.45 kg-m, **10 ft-lb**)

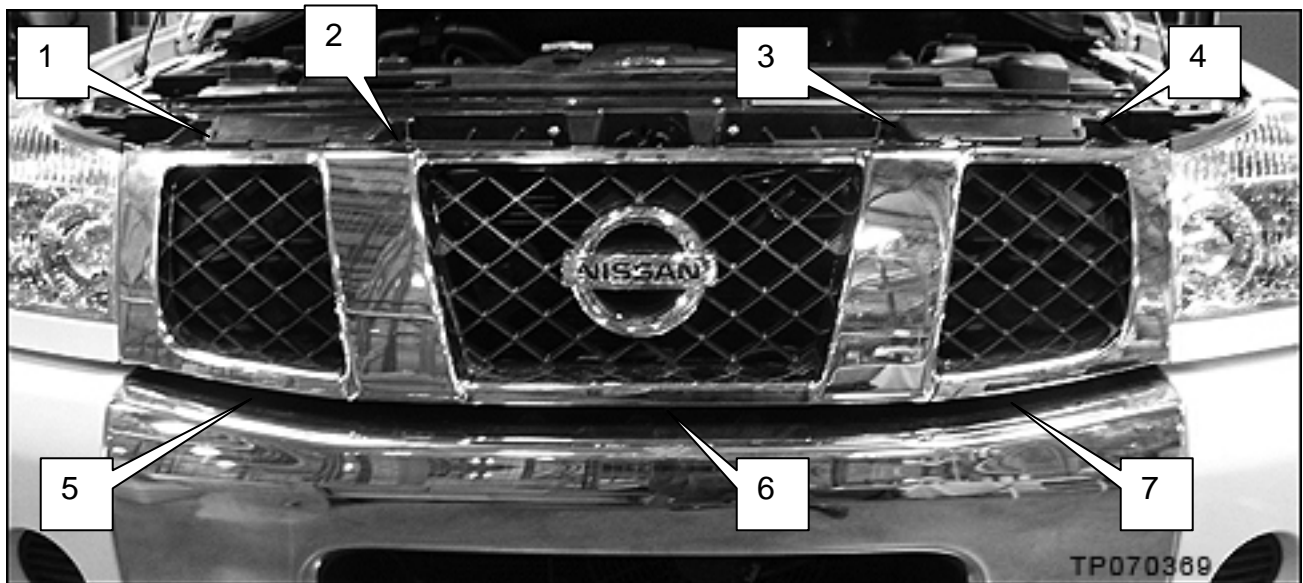
Figure C-26

15. Install the grill.

IMPORTANT: Make sure all 7 clips are properly located in the grill before installing.

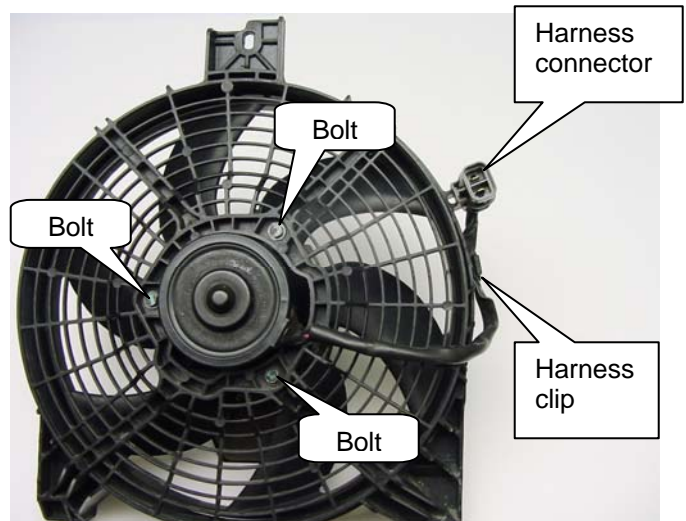
Figure D-1

1. Remove the fan motor from the shroud as follows:
 - a. Disconnect the harness connector from the shroud.
 - b. Disconnect the harness from the shroud clip.
 - c. Remove the fan motor bolts x 3.
 - Discard the bolts; they will not be reused.
 - d. Carefully separate the motor from the shroud:
Don't damage the fan harness.

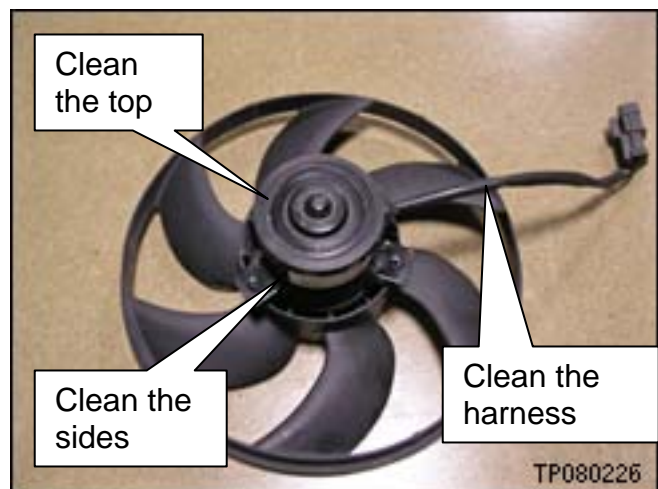
Figure D-2

2. Thoroughly clean all dirt and debris from the top and sides of the fan motor and the fan motor harness.
 - Use a locally approved brake cleaner and a clean rag.
 - The areas indicated must be completely clean to insure proper adhesion of the self adhesive protectors.

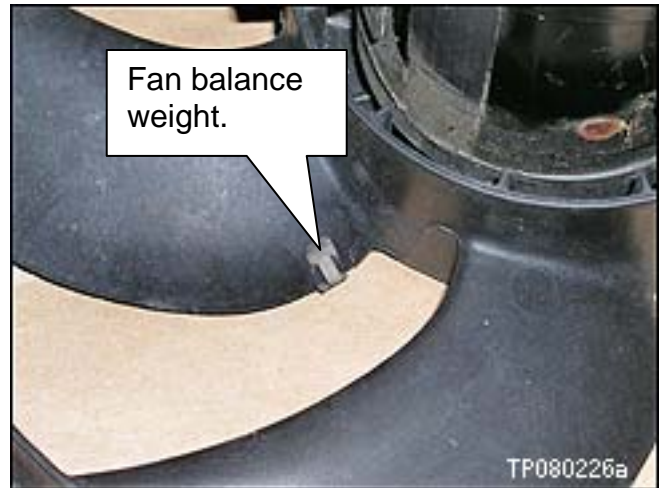
Figure D-2A

NOTE: You may see clips (fan balance weights) on the fan blades. **DO NOT** move or remove the fan balance weights.

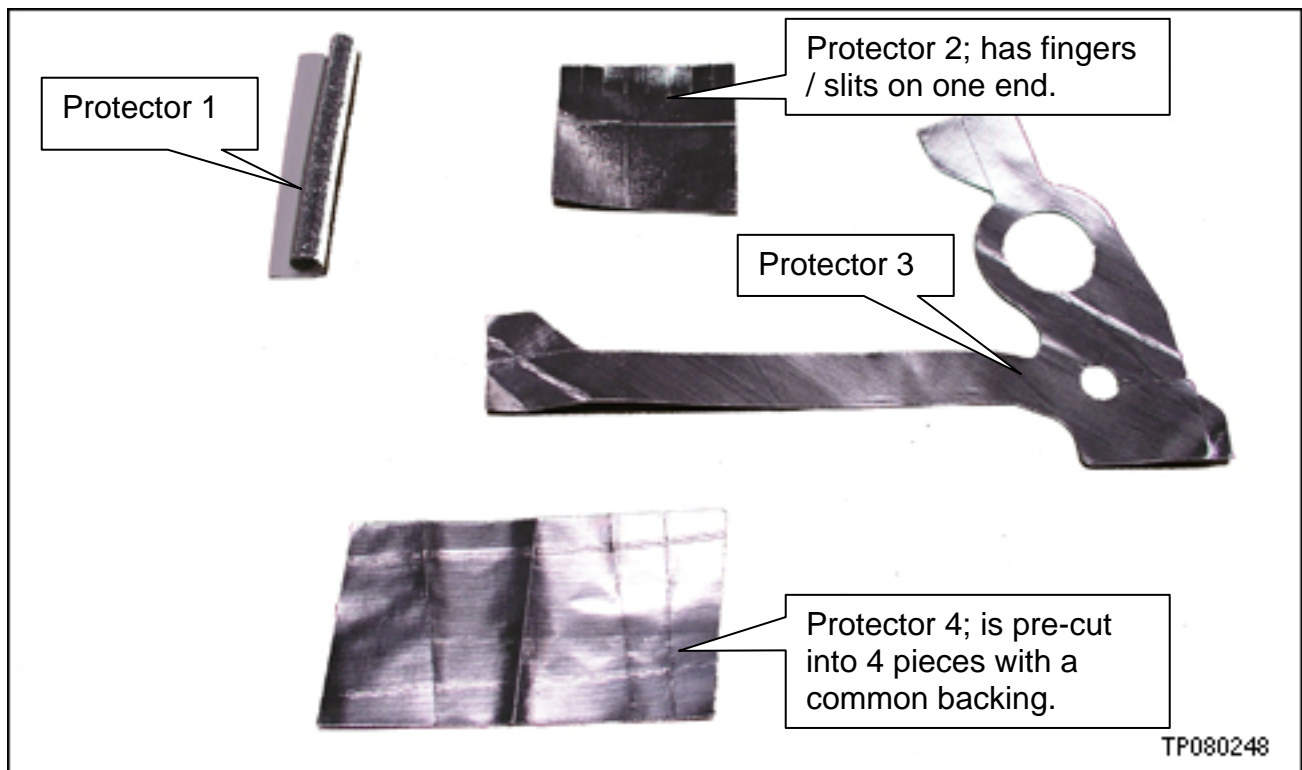
Figure D-3

In the next few steps you will be installing these four self adhesive protectors.

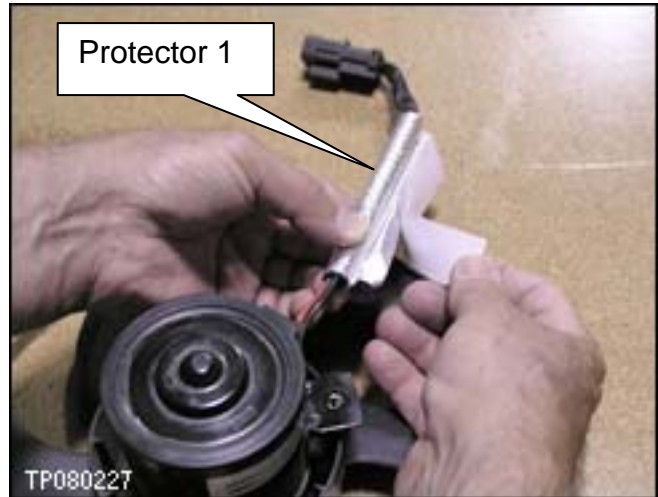
Figure D-4

- Wrap / roll the protector tightly around the harness.
- While holding the protector rolled tightly, remove the adhesive backing and secure the protector.

NOTE: The protector should slide on the harness.
