RECALL CAMPAIGN BULLETIN

NTB08-068b

VOLUNTARY RECALL CAMPAIGN 2004 - 2006 NISSAN TITAN AND ARMADA AIR CONDITIONER CONDENSER FAN

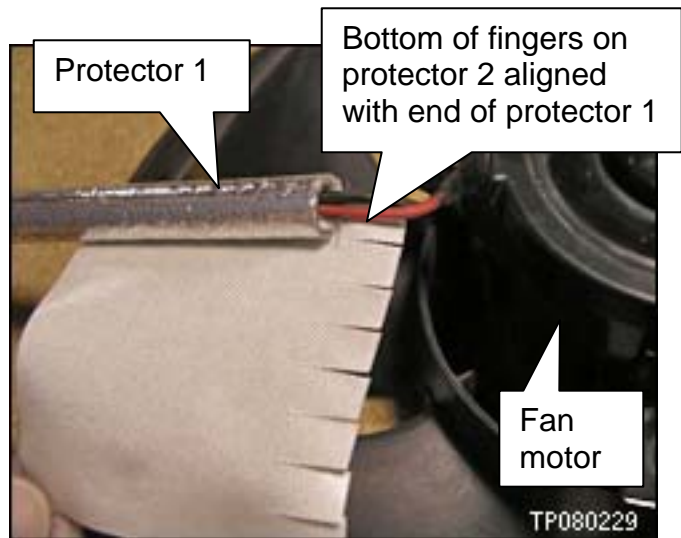
Figure D-5

4. Remove the adhesive backing from **Protector 2** and install it around protector 1:

- Fingers / slits on protector 2 must be facing the fan motor.
- Align the bottom of protector 2 fingers with the end of protector 1.

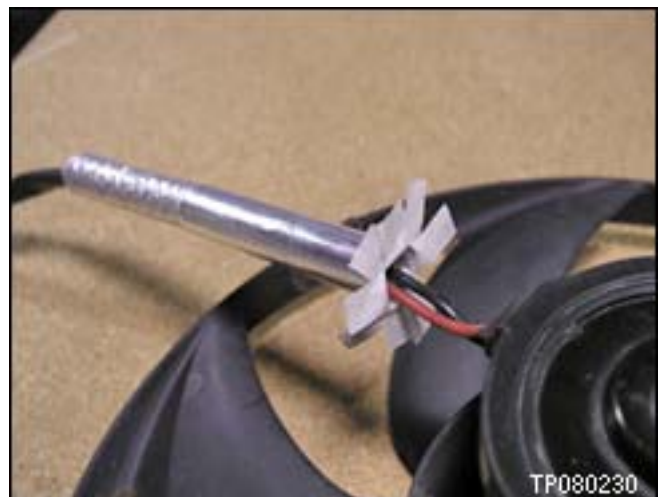
Figure D-6

- Wrap protector 2 around protector 1 and fold the fingers back as shown.

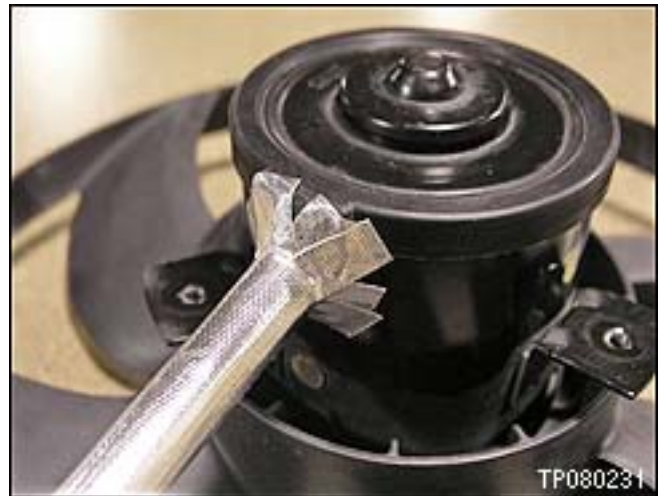
Figure D-7

5. Slide protector 2 against the fan motor and press / stick the fingers to the fan motor as shown.

- Make sure to press and smooth the fingers so they are completely stuck to the fan motor.

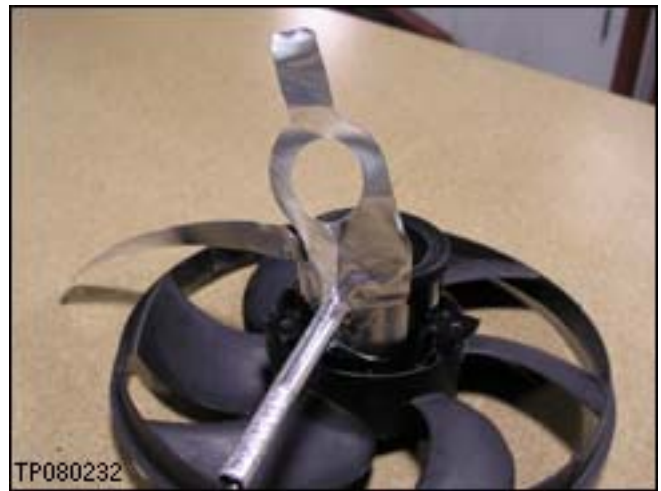
Figure D-8

6. Remove the adhesive backing from **Protector 3** and stick it to the fan motor as shown.

- Make sure the harness is routed through the harness hole in Protector 3 (refer to Figure D-8A).

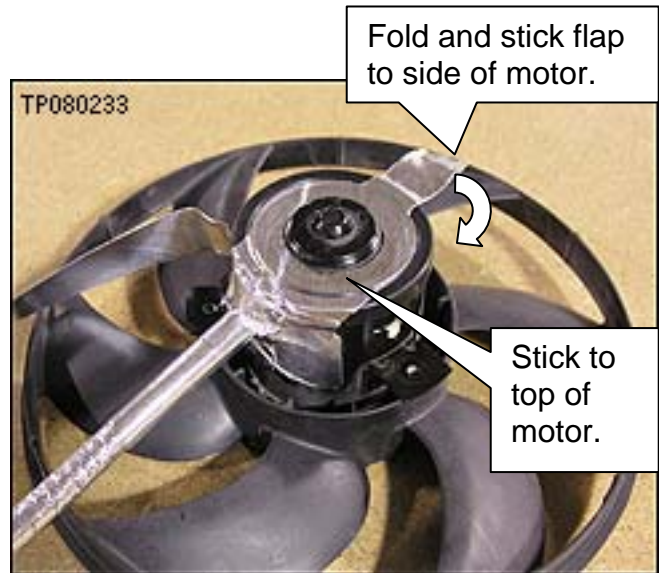
7. Fold and stick protector 3 to the top of the fan motor as shown.

Fold and stick the flap shown in Figure D-9 to the side of the fan motor.

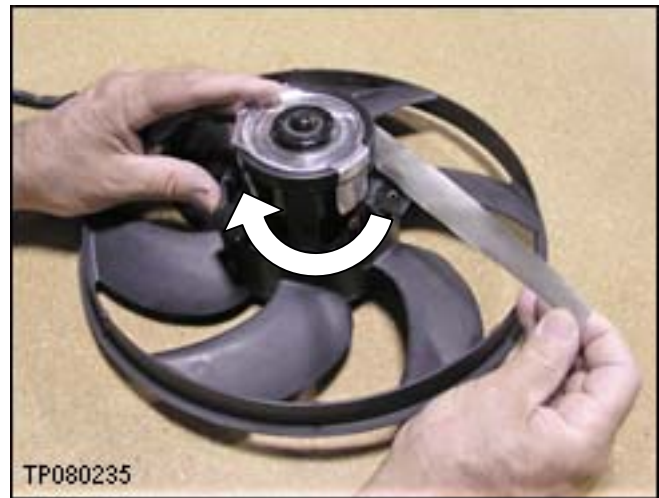
Figure D-10

8. Wrap the long strip of protector 3 completely around the motor.

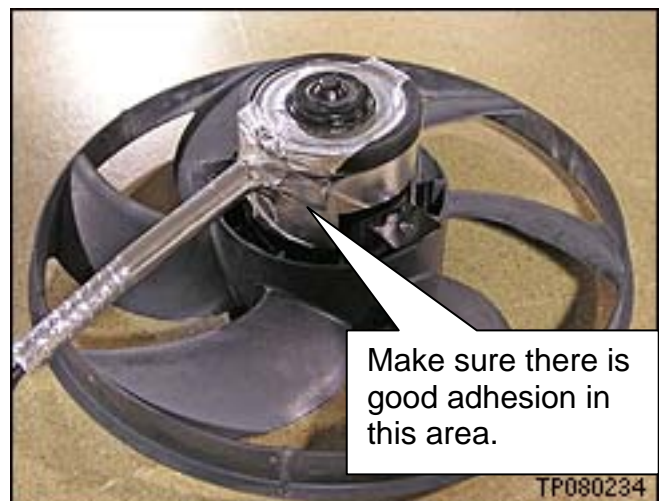
Figure D-11

9. Press and smooth all parts of protector 3. Make sure it is completely stuck to the fan motor.

- Pay special attention to the area shown in Figure D-11. Make sure there is good adhesion in this area.

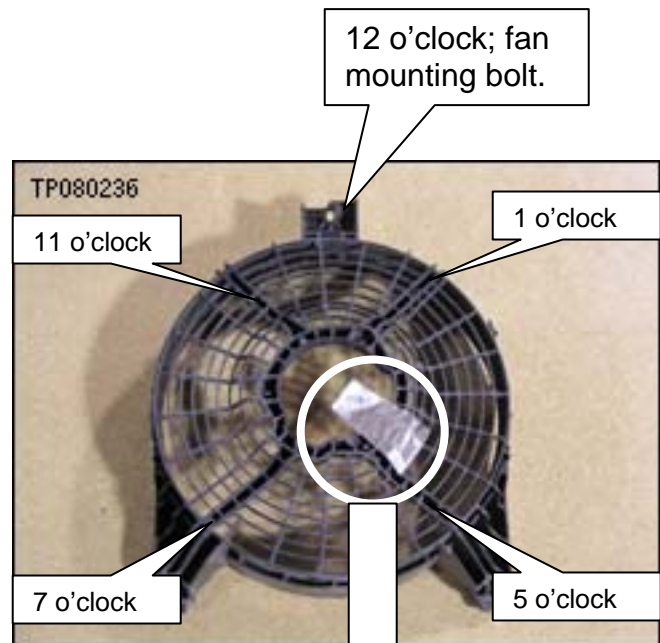
Figure D-12

11. Install Protector 4 on the fan shroud.

- Remove 1 of the 4 sections from protector 4 adhesive backing.
- Stick the 1st section next to the 5 o'clock support rib.

Fold and stick under the shroud

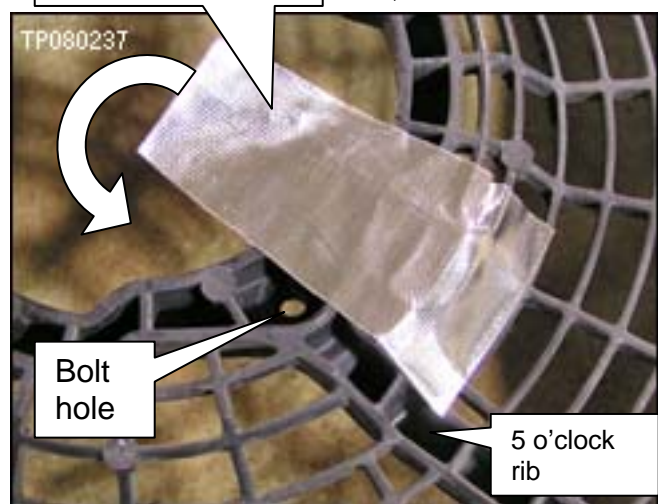
Figure D-13

- Align the protector along the 5 o'clock rib as shown.
- Don't cover up the bolt hole.
- Fold and stick the protector under the shroud.

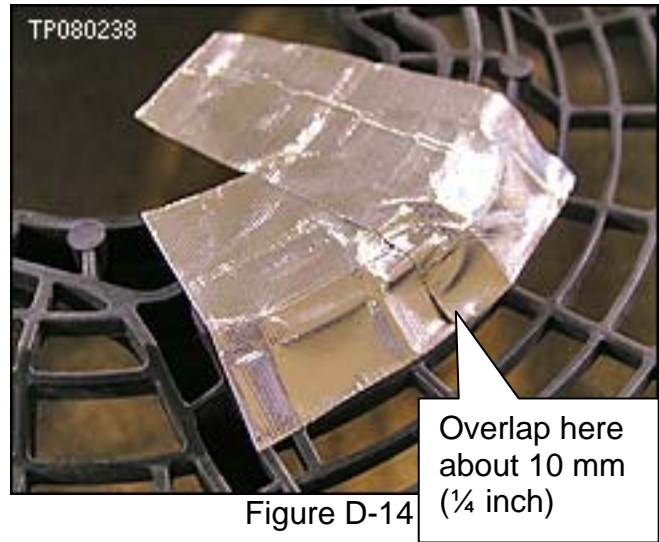
Figure D-14

- c. Stick the 2nd piece of protector 4 on the fan shroud as shown.
- Overlap the 2nd piece on top of the 1st piece at the spot shown.
 - Overlap about 10 mm (¼ inch) but not less than 5 mm (1/8 inch).
 - Fold and stick the protector under the shroud.

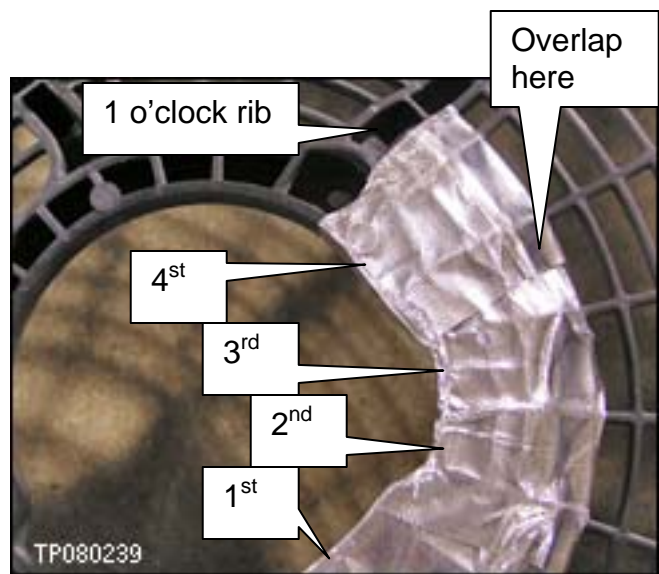
Figure D-15

- e. Install the 4th piece of Protector 4 as shown.
- Align the protector along the 1 o'clock rib as shown.
 - Don't cover up the bolt hole.
 - Overlap the 4th piece on top of the 3rd piece at the spot shown.
 - Overlap must be at least 5 mm (1/8 inch).
 - Fold and stick the protector under the shroud.

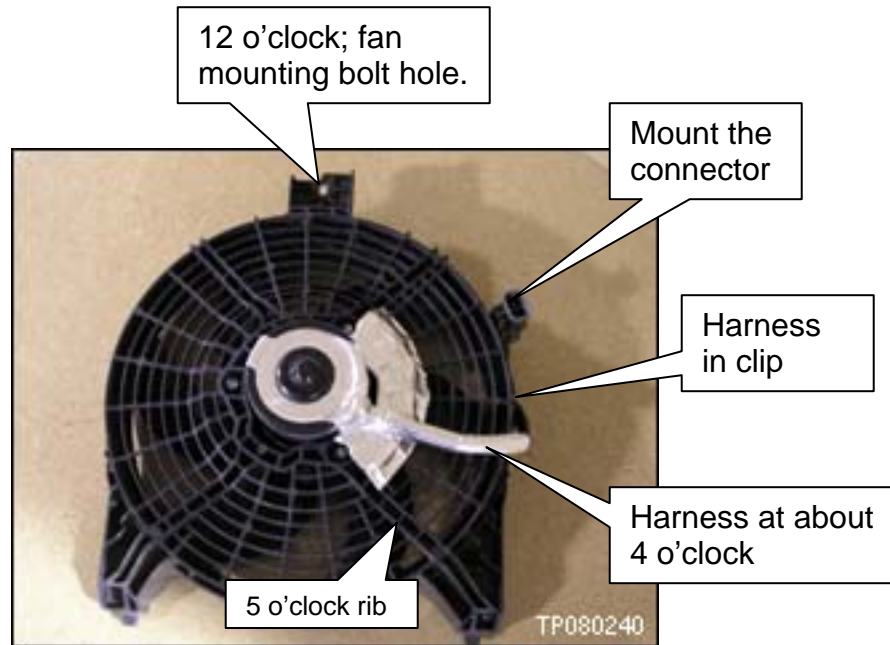
Figure D-16

- Use new bolts from the Fan Protector Kit. Bolt torque: 4.5 N.m (0.45, kg-m, **40 in-lb**)
- Mount the harness connector and clip the harness in place.

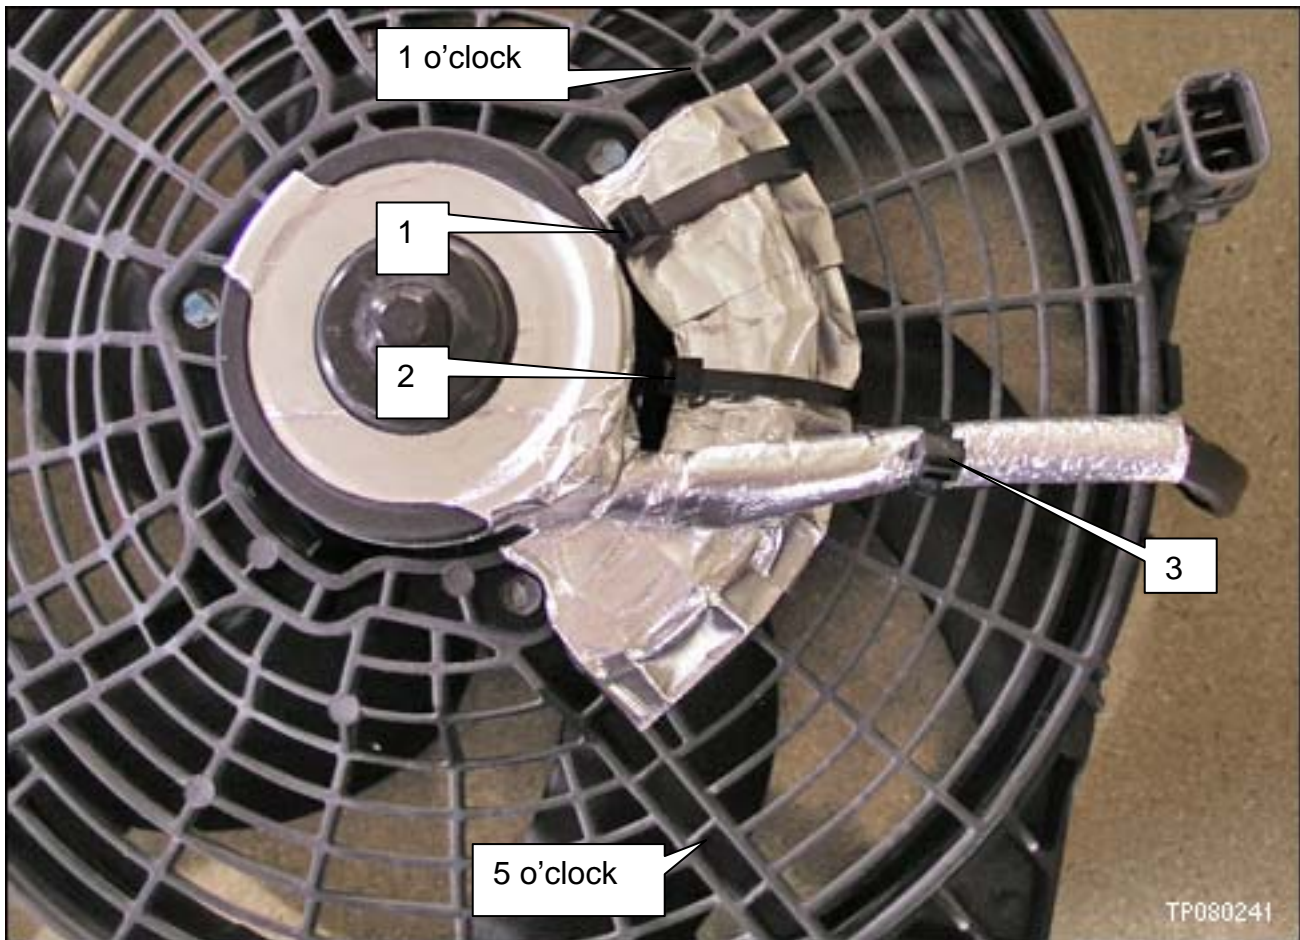
Figure D-17

- Use 7½ inch (19.5 cm) tie-wraps from the protector kit.
- Use the large 1 o'clock and 5 o'clock ribs for reference.
- **Pay close attention to the tie wrap locations.** Count the slots in the fan shroud to confirm correct tie-wrap locations.

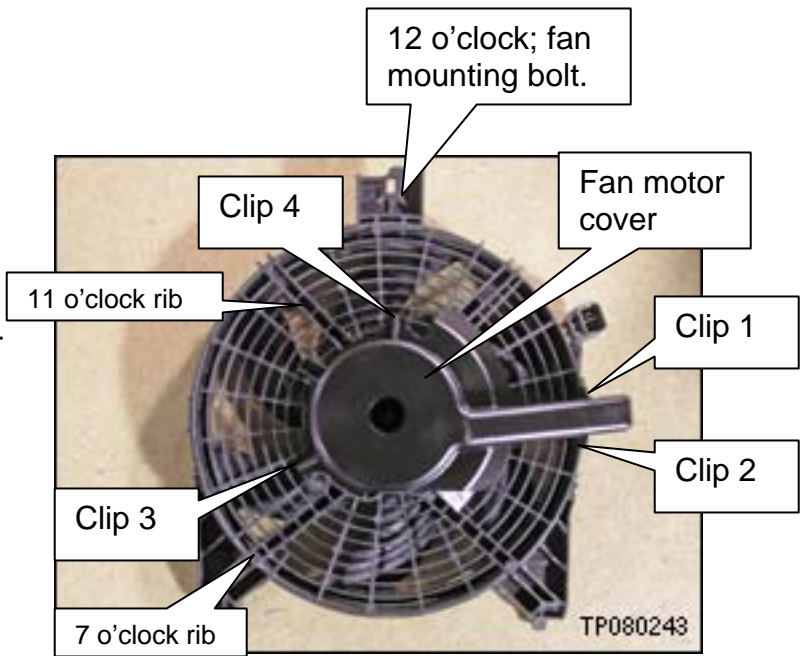
Figure D-18

- Make sure the 4 clips are installed in the correct locations.
- Refer to Figures D-18 through D-21 for clip locations.
- Use the large 7 o'clock and 11 o'clock ribs for reference.
- Count the slots in the fan shroud to confirm locations for clips 3 and 4.

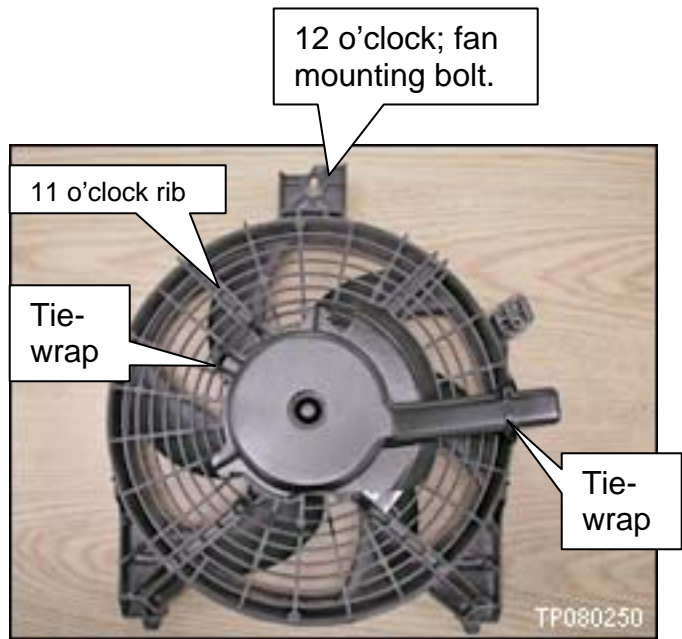
Figure D-22

- Use 11 inch (28 cm) tie-wraps from the protector kit.
- Refer to Figures D-22 through D-24 for tie-wrap locations.
- Use the large 11 o'clock rib for reference.
- Count the slots in the fan shroud to confirm locations as needed.

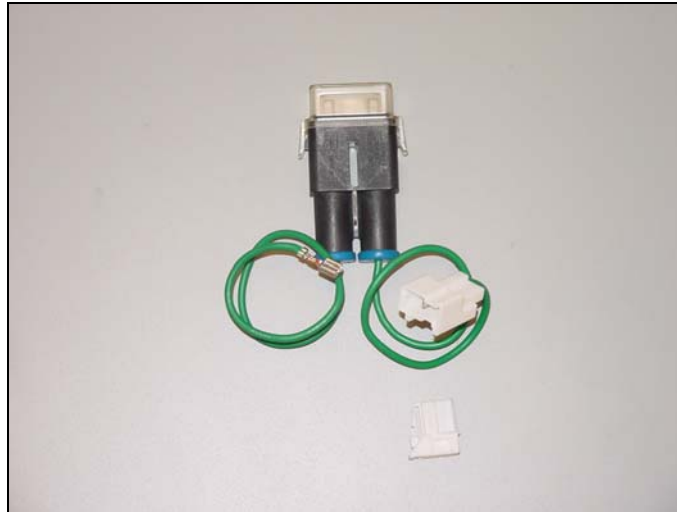
Figure E-1

NOTE: Maxi Fuse is installed only when replacing the fan motor assembly with a new one. The battery should already be disconnected and the radio station presets should have been recorded before removing the fan motor at the beginning of procedure C.

1. Remove the IPDM E/R upper cover.
 - IPDM E/R = Intelligent Power Distribution Module, Engine Room.
2. Remove the relay and fuse cover.

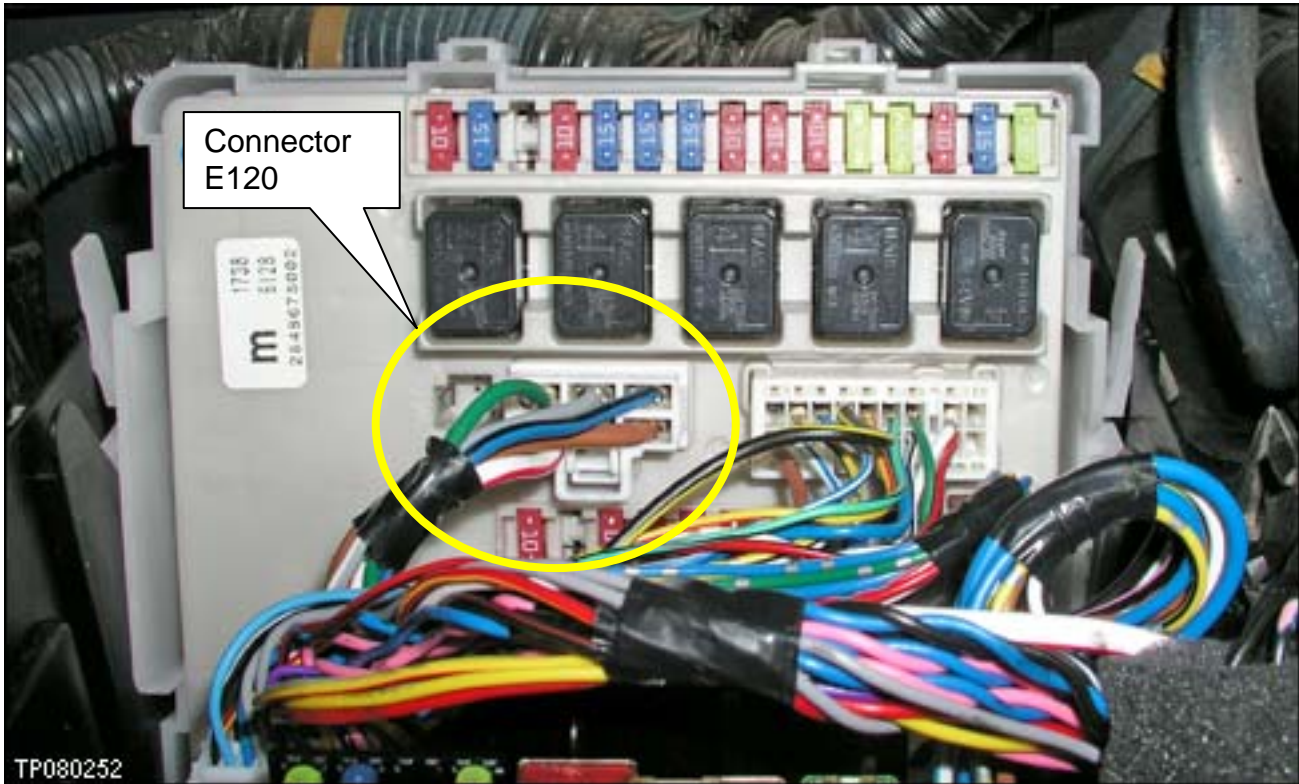
Figure E-3

- This is connector E120.
- This connector has 6 terminal slots with only 5 filled.

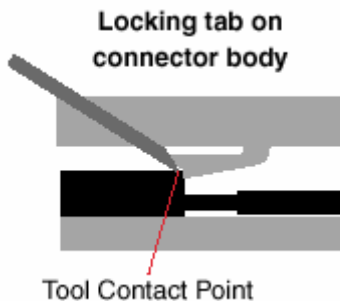
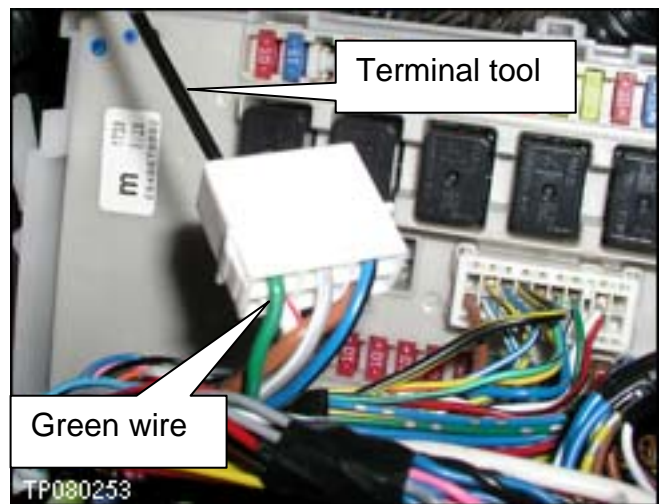
Figure E-4

4. Remove the green wire from connector E120.

- Use pin terminal tool J-38751-305 from Pin Tool Set J-38751-3, or equivalent.

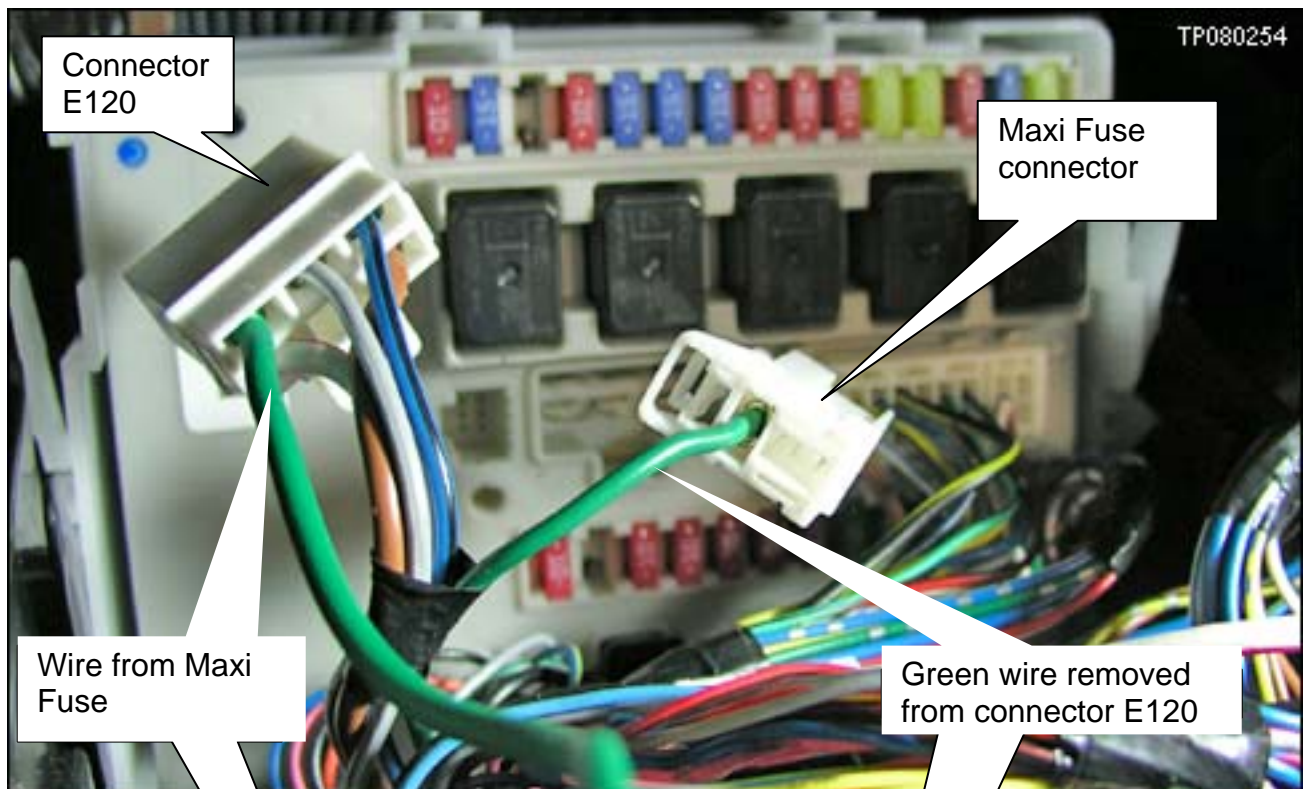
Figure E-5

5. Take the wire you removed from connector E120 and put it into the Maxi Fuse connector. Make sure to put it in the correct slot as shown in Figure E-5.
6. Insert the wire from the Maxi Fuse into the slot of connector E120 (see Figure E-5).

- The terminals will not snap in upside down.
- If the terminal won't snap-in, you are trying to put it in upside down; turn it over.

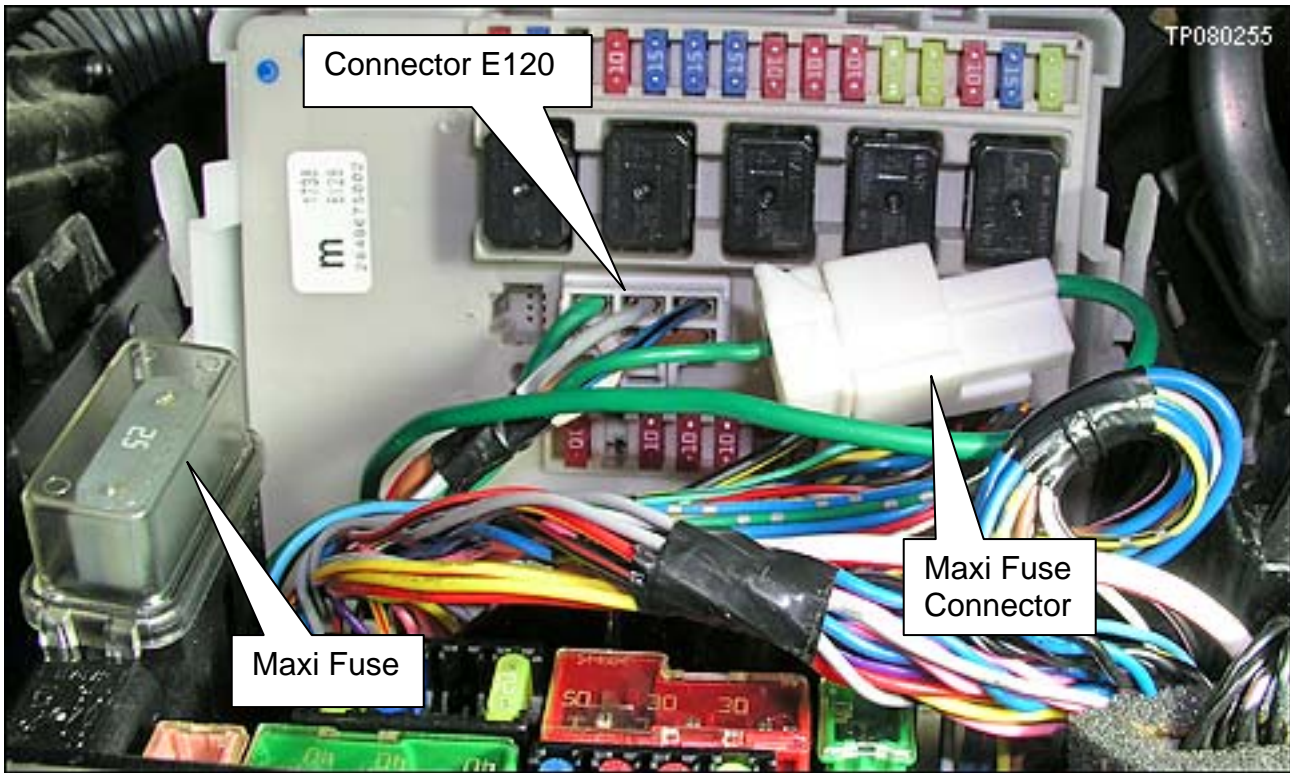
Figure E-6

7. Reconnect connector E120.
8. Connect the Maxi Fuse connector.
9. Position the Maxi Fuse, wires, and connector into the IPDM E/R box as shown in Figure E-6.

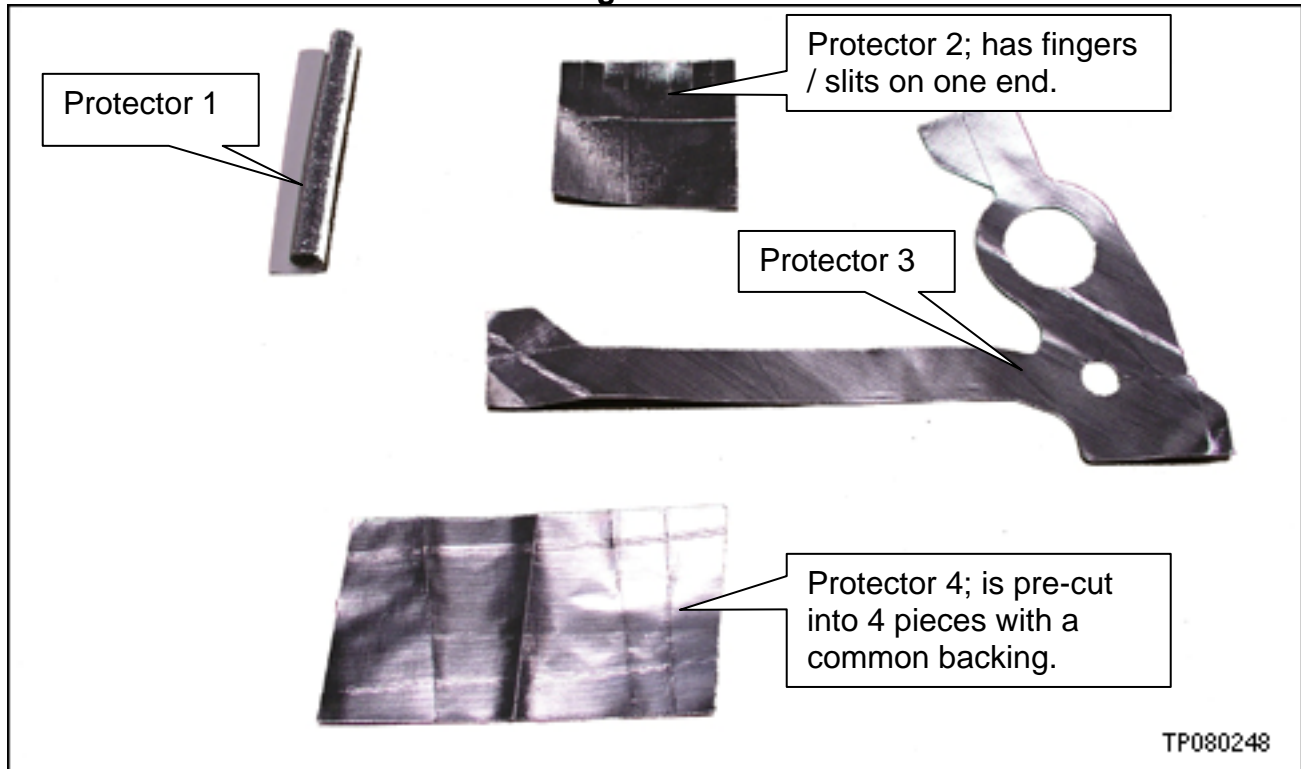
Adhesive Covers in Protective Covering Kit

DESCRIPTION	PART #	FAN MOTOR TEST	QUANTITY
Protective Covering Kit	27239-7S00A	OK	1
Fan & Motor Assy	92120-ZJ00A	NG	1
Harness Kit (contains Maxi Fuse with harness and sub harness for new fan motor)	24009 - 7S00A		1
Medium Strength Thread Locker	999MP-AM005P	N/A	Shop supply
