RECALL CAMPAIGN BULLETIN

NTB08-067

VOLUNTARY RECALL CAMPAIGN 2007 – 2008 SENTRA BRAKE MASTER CYLINDER

CAMPAIGN ID #: PM813
NHTSA # 08V-311
APPLIED VEHICLES: 2007 – 2008 Sentra (B16)

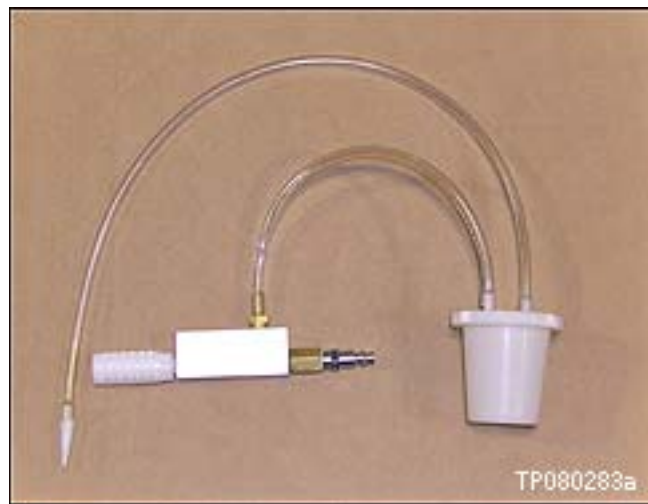
Figure A

REQUIRED SPECIAL TOOL J-49749

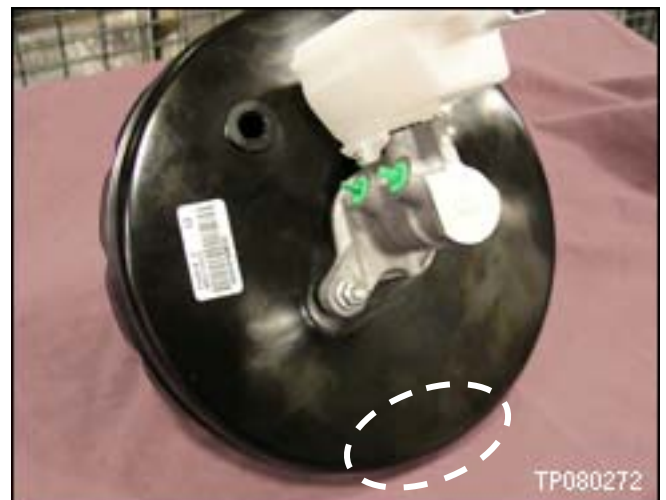
Figure 4

6. Move/position the suction tube inside the brake booster so that any fluid in the lower area of the brake booster is sucked into the collection container.

NOTE: If there is fluid in the lower area of the booster:

- Keep the collection container upright.
- If the collection container fills to within $\frac{1}{2}$ inch of the top, empty it and then continue.
- Continue suction until all of the fluid is removed.

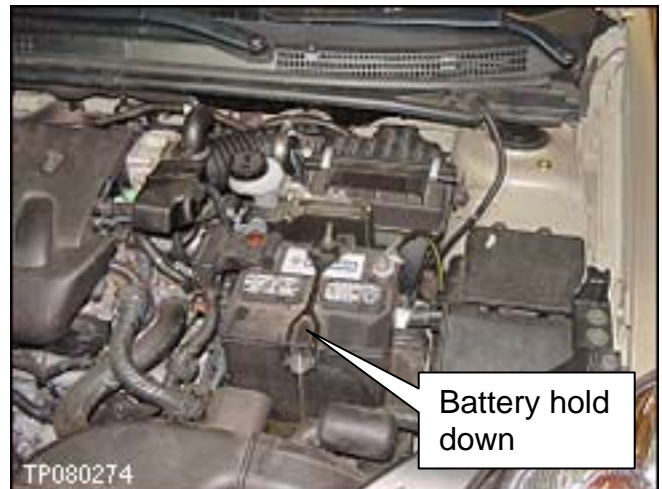
Figure 6

2. Remove the battery from the vehicle.
 - a. Disconnect the battery cables (negative cable first).
 - b. Remove the battery hold down.
 - c. Lift the battery from the vehicle.

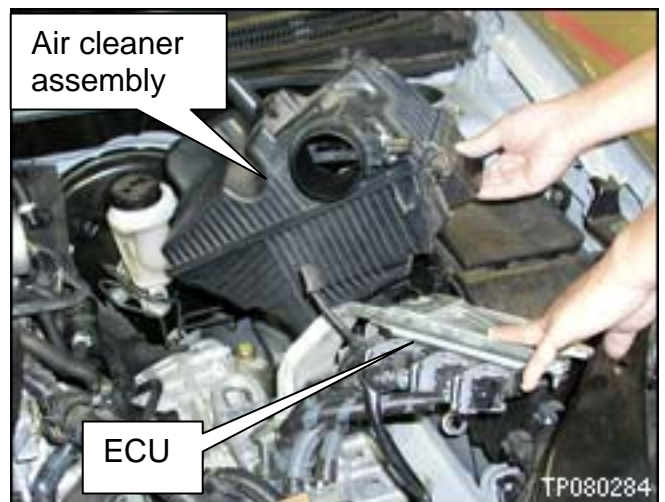
Figure 12

9. Hold the ECU forward and carefully remove the air cleaner assembly.

NOTE: Don't lose the rubber mount bushings for the air cleaner assembly.

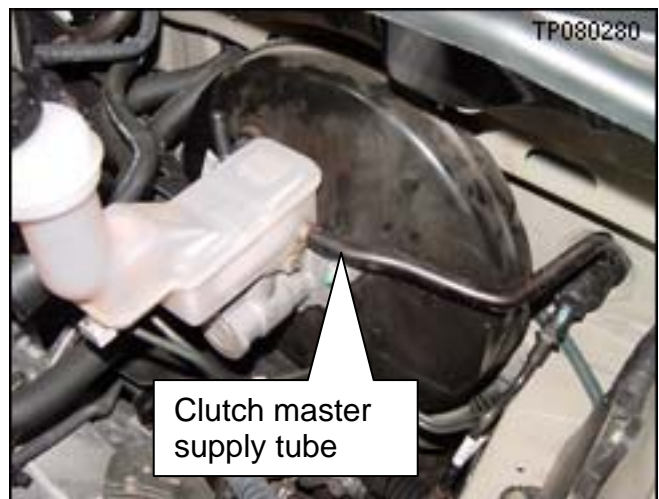
Figure 14

11. If equipped with manual transmission; remove the fluid supply tube for the clutch master cylinder.

CAUTION: Do Not push the clutch pedal when the reservoir is empty or you will need to bleed the clutch system.

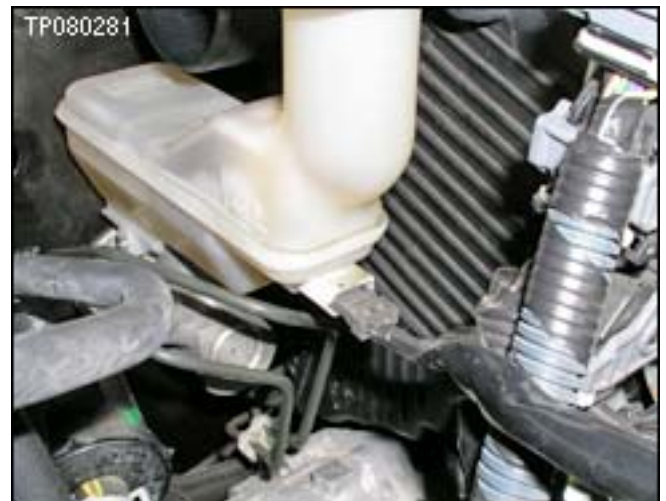
Figure 19

19. Connect the brake fluid level sensor.
