Recall Bulletin 80724

PRODUCT(S) AFFECTED:
Terra, Fiesta,
With Unit Serial
Numbers Listed
in this Bulletin

SUBJECT:
Inspection/
Correction of
Wiring Harness
Clearance

ISSUE DATE:
August 2008

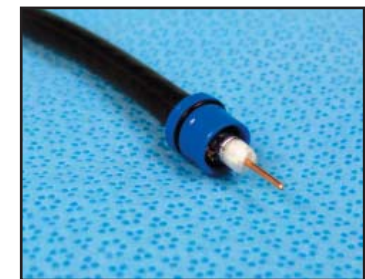
Figure 3

23. Slip the sleeve of a new "F" weather-resistant crimp-style connector over the stripped end of the cable, with the narrow end of the sleeve facing the cut end of the cable. Position it over the exposed woven outer conductor that was folded over the cable's jacket insulation in Step 21. See Figure 3.

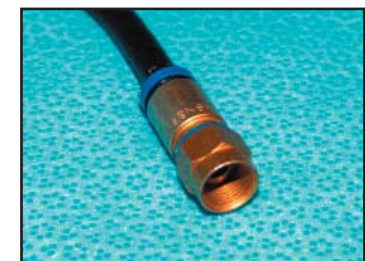
Figure 4

24. Slide the barrel (non-threaded end) of the metal portion of the "F" connector onto the collar until the inner conductor protrudes through the hole in the threaded end of the "F" connector. See Figure 4.

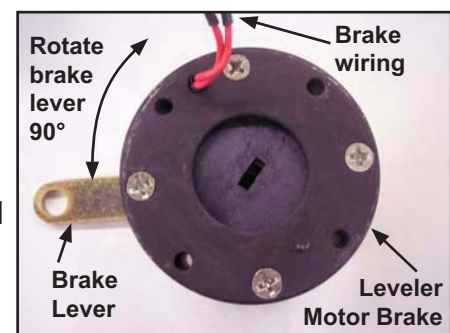
Figure 6

29. Cut the metal clamp securing the rubber boot over the leveler motor brake on the uninstalled jack; remove the boot and retain for reinstallation. Discard the clamp.
30. Note the current orientation of the brake lever to the motor.
31. Remove the 4 screws and washers fastening the leveler motor brake to the motor. Retain hardware for reassembly.
32. Release the brake lever to disengage the brake and allow it to be rotated.
33. Rotate the leveler brake 1/4 turn (90°). See Figure 6.

Note: After the leveler brake is rotated, it will be oriented toward the front of the motor home once the leveling jack is installed.

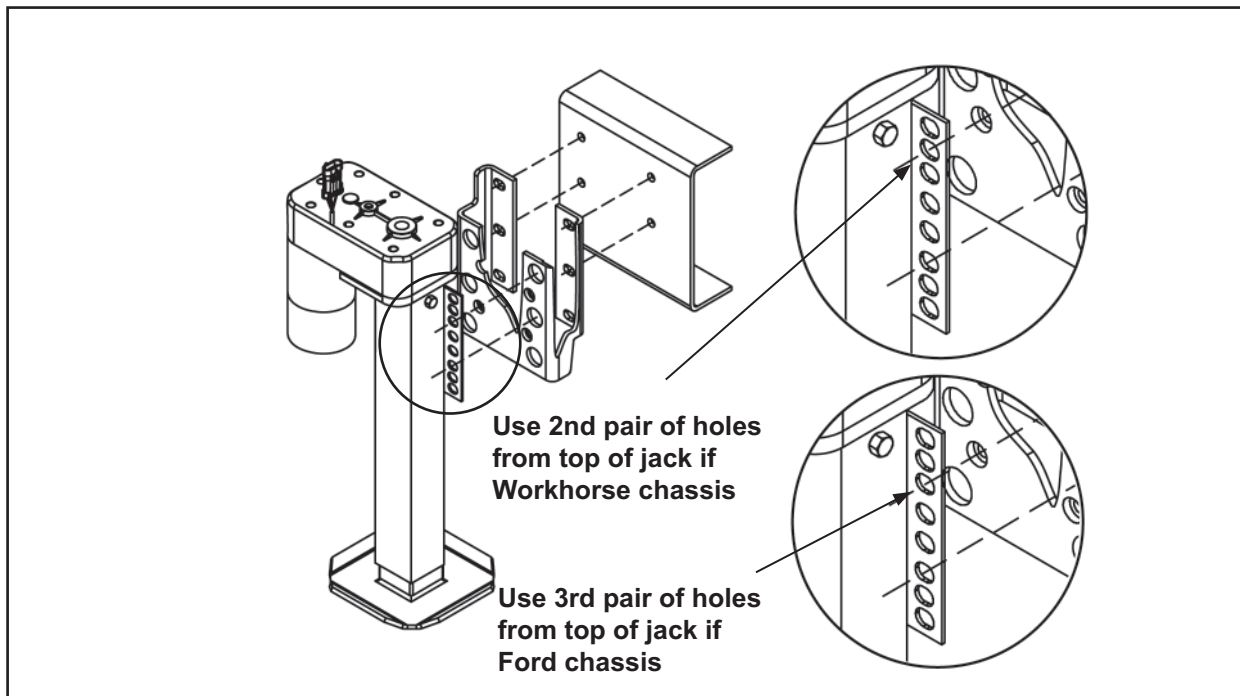
Figure 7

- If utilizing an existing slot in the chassis rail as one of the four holes for the new jack mounting bracket location, use a washer of sufficient size to keep the bolt head stationary.
- Position the leveling jack motor housing facing the front of the motor home.
- Mount the jack in the 2nd pair of holes from the top of the jack leg if a Workhorse chassis, or the 3rd pair of holes from the top if a Ford chassis. See Figure 7.

38. Make a new drilling template in order to re-locate the front roadside jack forward by 2”, using the original leveling jack mounting bracket holes in the chassis rail as a guide.
- Note: If an existing slot in the chassis rail is located in the area where the jack is to be relocated, it may be used as one of the four holes for mounting the jack bracket.
39. Position the drilling template, created according to Step 38, against the chassis rail. Verify drilling locations are square and are at the same level as the original mounting holes. Drill 1/8” diameter pilot holes through the chassis rail at each drilling location marked on the template.
40. Drill 1/2” holes for bolts, on center with the pilot holes drilled in Step 39.
