GROUP Safety Recall Campaign	MODEL 2008-2009MY Rondo LX / EX w/2.4L (I-4)
	NUMBER SC 074	DATE September 2008
SAFETY RECALL CAMPAIGN TECHNICAL SERVICE BULLETIN		
SUBJECT: RONGO FUEL PUMP SUB-ASSEMBLY REPLACEMENT

This bulletin provides information relating to a safety recall campaign to replace the fuel pump motor sub-assembly in 2008-2009MY Rondo LX / EX vehicles with the 2.4L (I-4), built between 11/5/2007 ~ 7/12/2008. All of these vehicles must have their fuel pump motors replaced, unless they have previously been repaired at the port or under this campaign. For information purposes, you should know that these vehicles may exhibit the illumination of the check engine warning lamp for P2191 (System too lean at higher load) / P2187 (System too lean at idle) diagnostic trouble codes or may exhibit a longer than normal start-up time. The cause of the check engine warning lamp illumination / extended cranking is due to poor internal contacts within the electric fuel pump motor, which will result in a reduction of fuel volume over time. Kia is replacing the electronic fuel pump sub-assembly to correct this condition.

RONDO FUEL PUMP SUB-ASSEMBLY REPLACEMENT

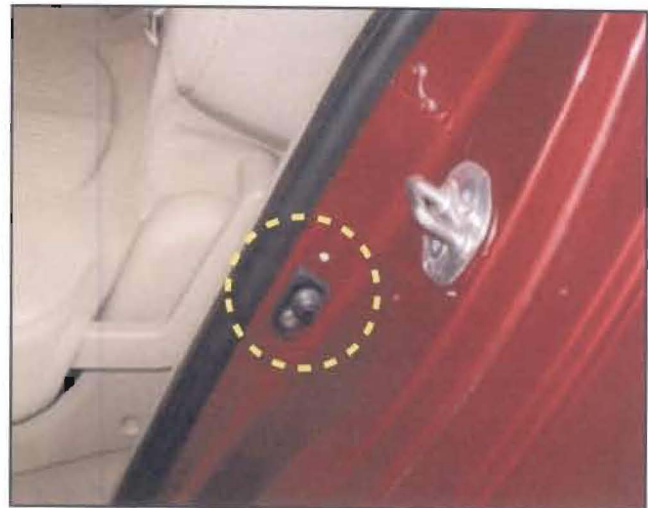
2. Open the left rear door and inspect the area above the door check switch for a yellow paint mark. If a yellow paint mark is present above the door check switch, install an SC074 campaign completion sticker on the inner panel above the under hood fuse box. **NO FURTHER ACTION IS REQUIRED.**

If there is no SC074 campaign completion label or yellow paint mark above the left rear door check switch, continue with the remainder of this service procedure for fuel system depressurizing and disassembly of the five / seven passenger options.

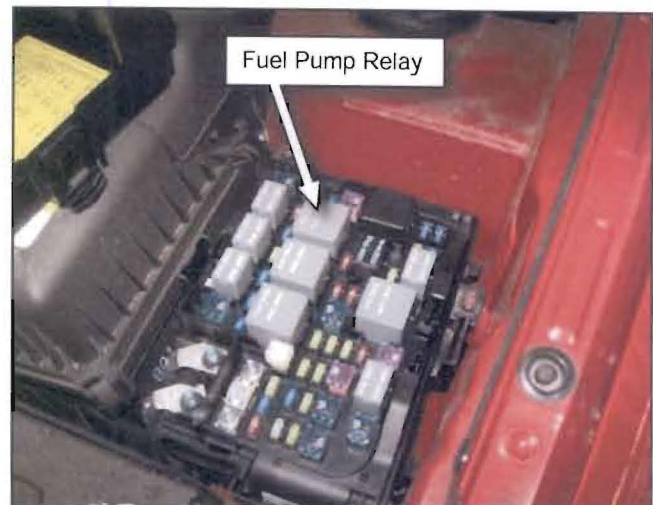
1. Open the hood and remove under hood fuse box cover.

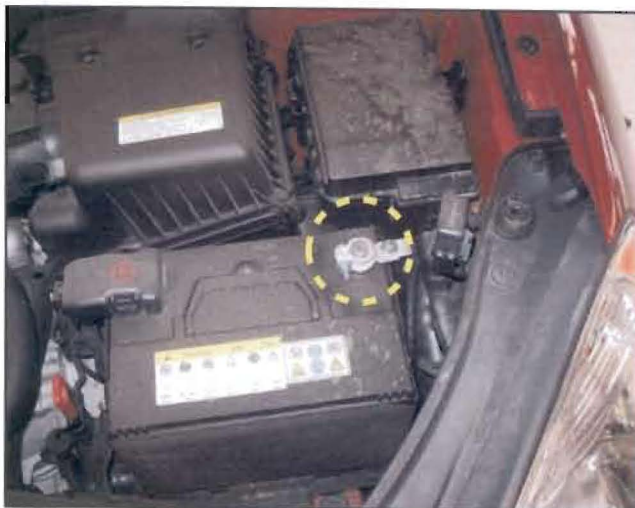
- Record radio presets and disconnect the negative battery cable.

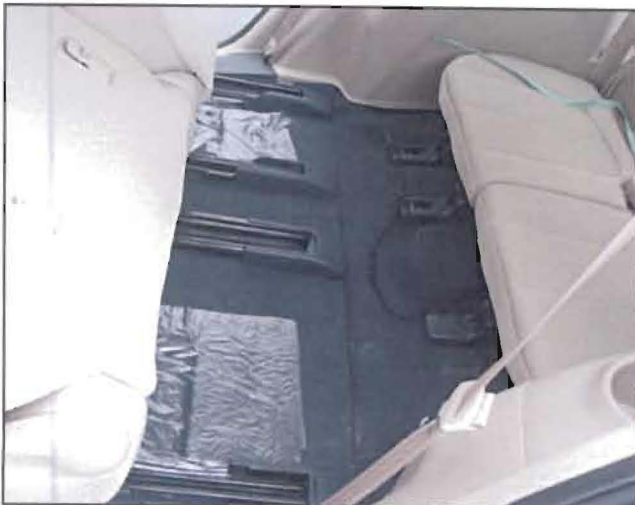
- Open the second row door(s) and rear hatch. Slide the second row seat(s) forward.

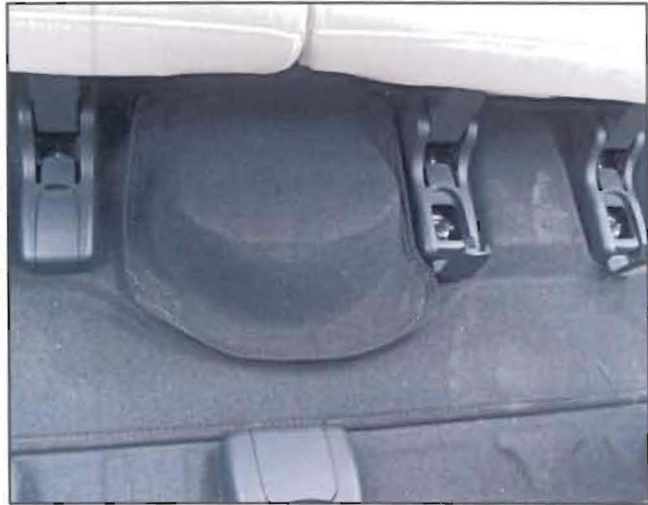
2. Remove the fuel pump cover interior trim.

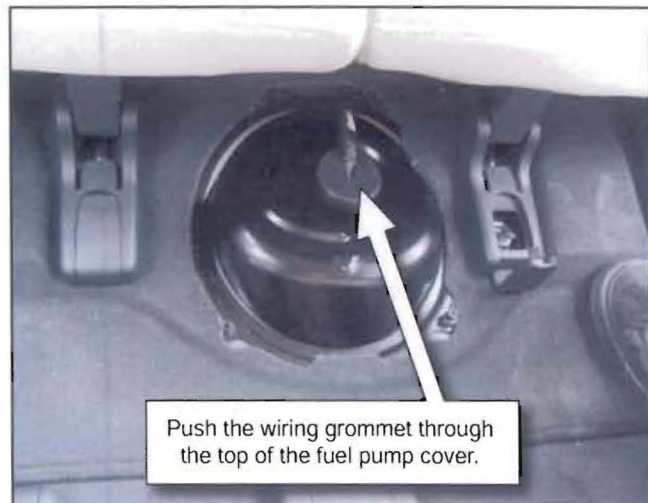
3. Remove the four (4) fuel pump cover retaining bolts. Push the wiring grommet through the top of the fuel pump cover. Relocate any rear interior floor mat(s). **Continue with the *Fuel Pump Service Procedure* in this document.**

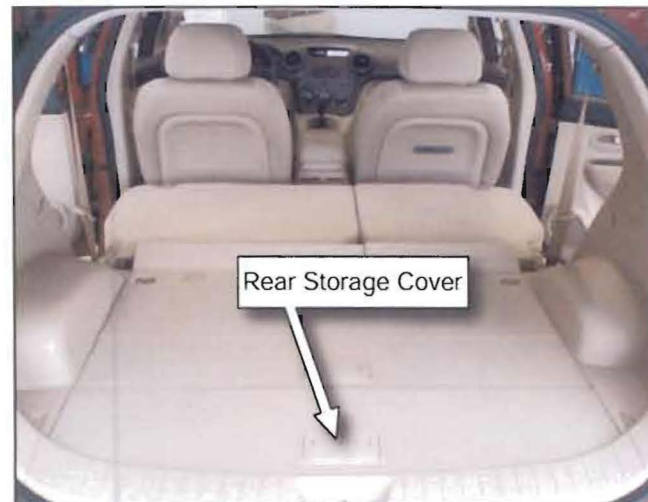
1. Slide the second row seat(s) forward in the collapsed position. Open the rear storage cover.

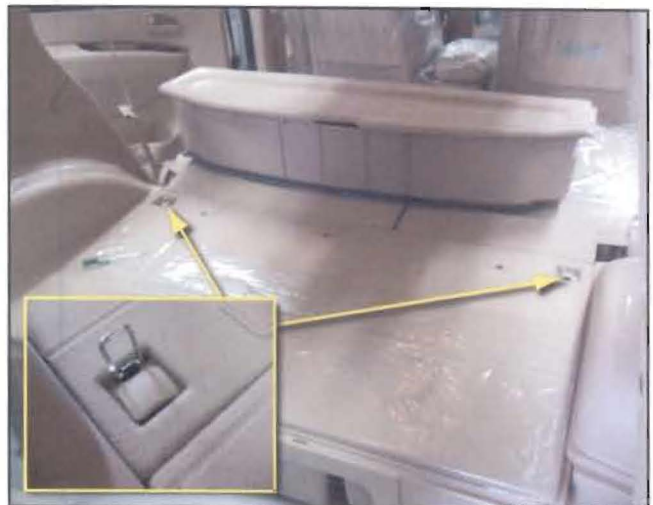
3. Remove the front storage cover trim. Remove the forward storage cover from the vehicle.

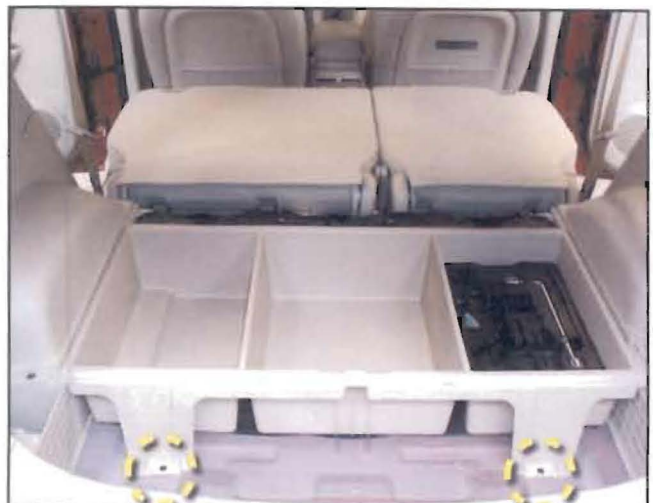
4. Remove the two (2) rear fasteners from the forward storage assembly legs. Remove the spare tire kit.

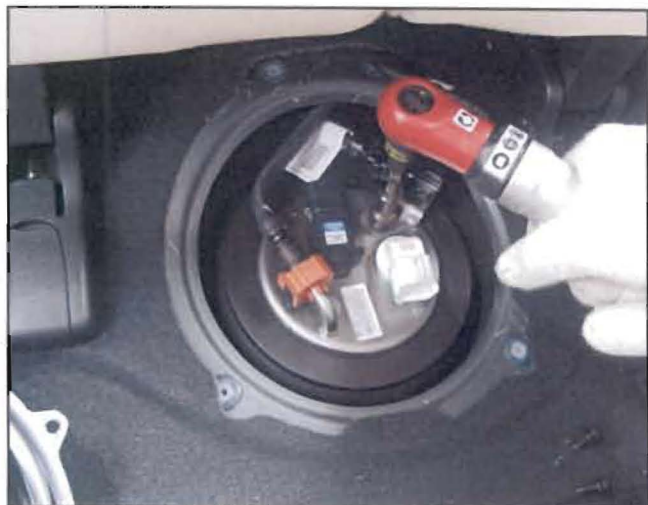
1. Disconnect the electrical connector(s) for the FTPS and Fuel Pump. Remove the nut for the Canister Close Valve bracket.

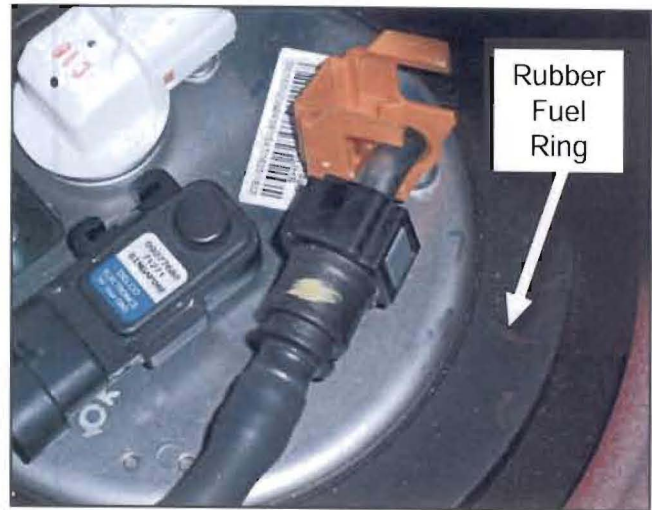
2. Release the fuel line quick-connect retaining clip and slide it forward. Depress both grey tabs on the fuel line and disconnect the fuel line. Remove the rubber fuel ring from the base of the fuel pump.

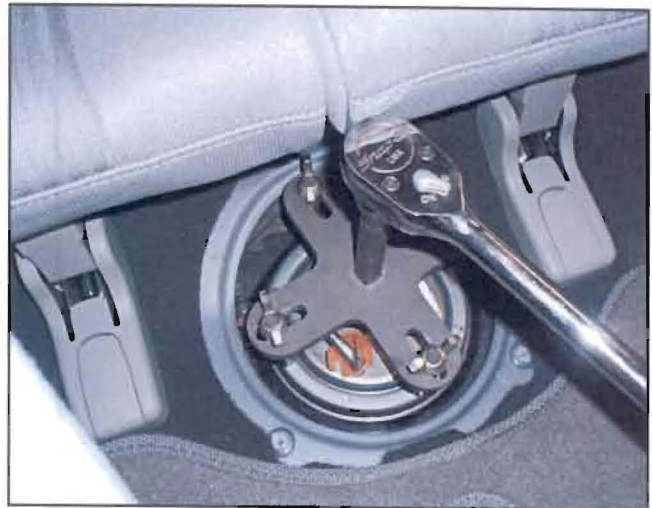
3. Using SST# TKET125A, remove the fuel pump retaining ring.

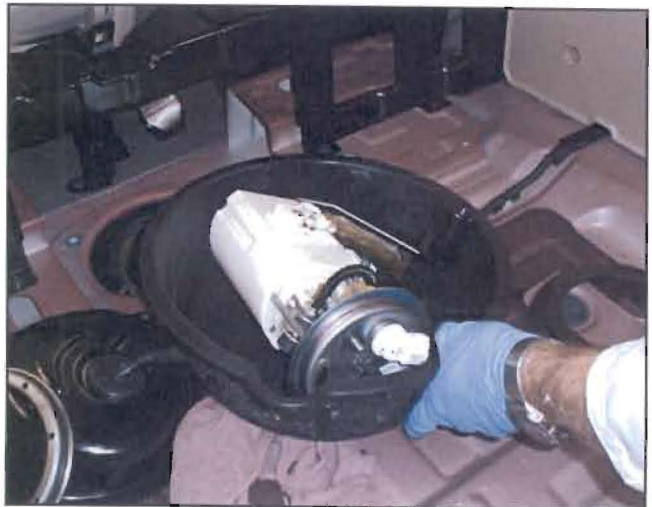
4. Place two~three shop towels or plastic covering(s) around the base of the body opening. Remove the fuel pump from the tank and immediately place the fuel pump into a small catch pan. Move the fuel pump to a clean area for the disassembly procedure.

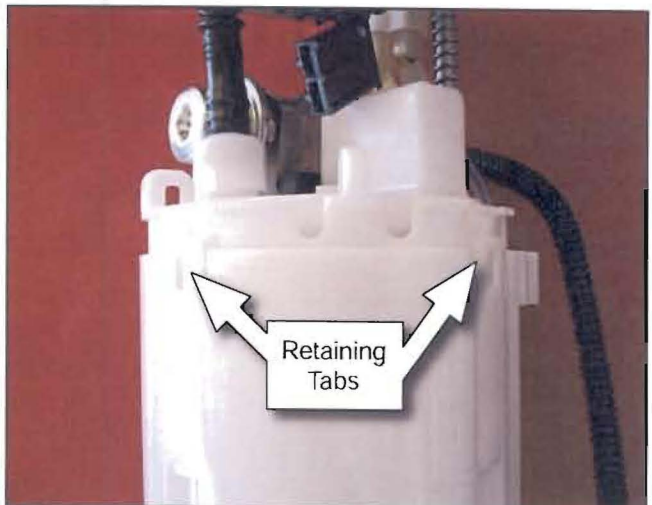
- 7. Release the three (3) pump reservoir retaining tabs. Separate the fuel pump assembly from the reservoir.

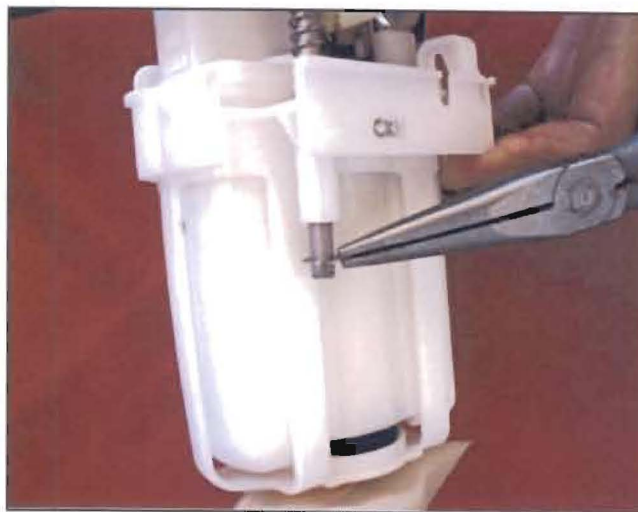
8. Compress the top of the fuel pump and remove the c-clip from the upper pump support. Separate the fuel pump upper assembly from the fuel pump assembly.

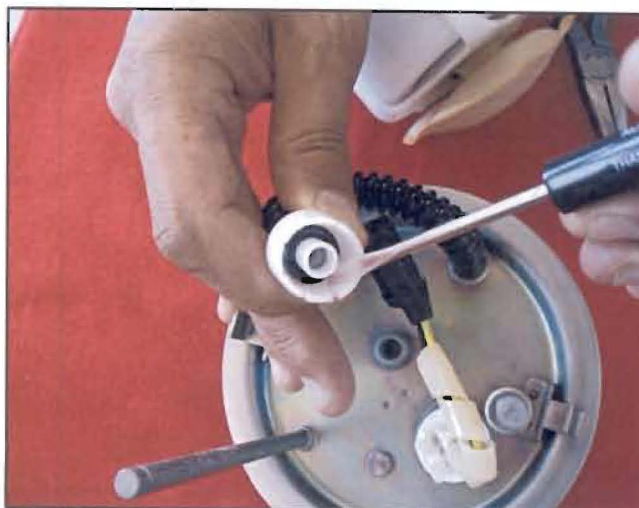
10. Remove the old discharge hose o-ring. Install the new o-ring to the discharge hose. Install the three (3) retaining tabs from the discharge hose to the new fuel pump assembly. Ensure proper retention of all three (3) retaining tabs of the discharge hose.

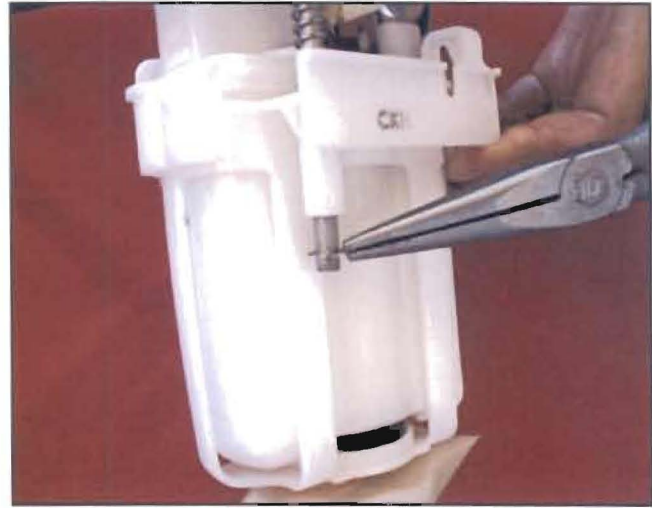
11. Install the fuel pump upper assembly to the new fuel pump assembly. Compress the upper spring assembly and install the supplied c-clip to the upper pump support.

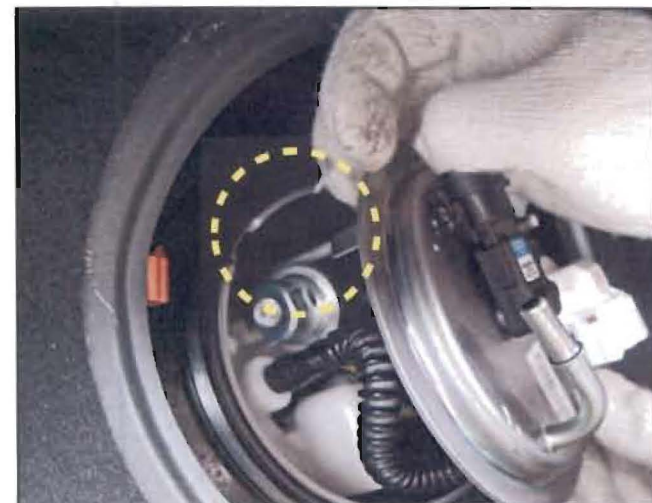
13. Align the tank and pump locating tab and install the fuel pump into the tank assembly.

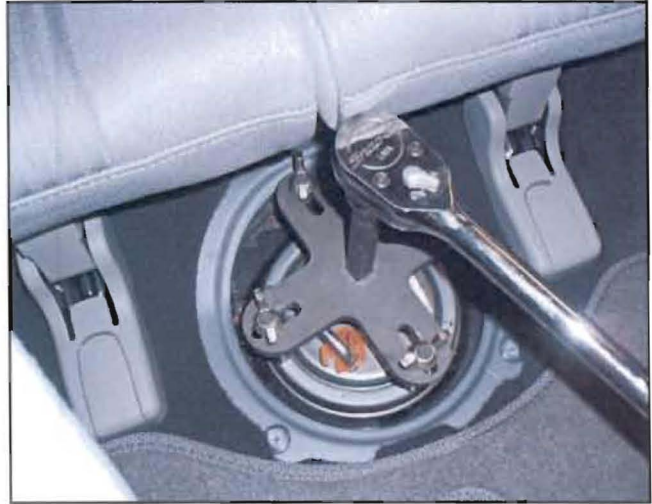
14. Using SST# TKET125A, install the fuel pump retaining ring and torque to (57.9 ~ 72.4 lbs-ft / 78.5 ~ 98.1 Nm). Install fuel tank rubber ring.

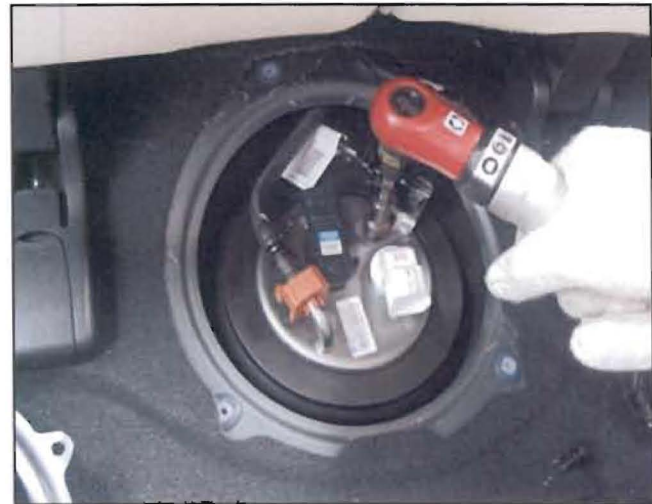
15. Reinstall the Canister Close Valve bracket & nut. Install fuel line and retaining clip. Reconnect the FTPS and Fuel Pump electrical connector(s).

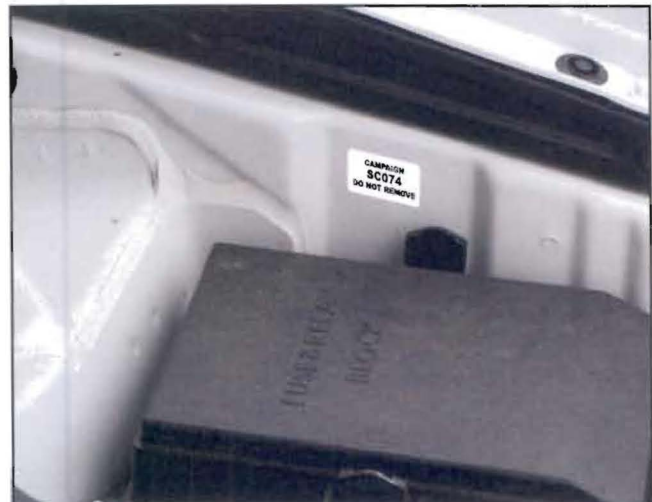
18. Install an SC074 campaign completion sticker on the inner panel above the under hood fuse box.
