IMPORTANT RECALL INFORMATION #80912

**SUBJECT: RECALL CAMPAIGN #80912
2008/2009 Class C - Front Clearance Lights Wiring**

RECALL BULLETIN:
80912

SUBJECT:
Installing
protection for
front clearance
light wire harness

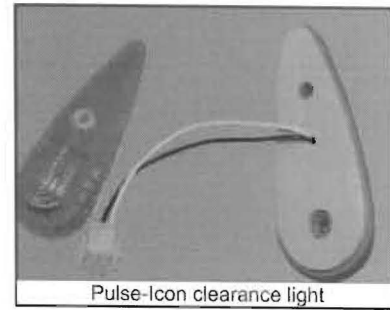
Figure 1

8. A. **Pulse or Icon products:** The light base is connected to the wiring. Allow the base to hang from attached wires while repairs are performed. See Figure 1.

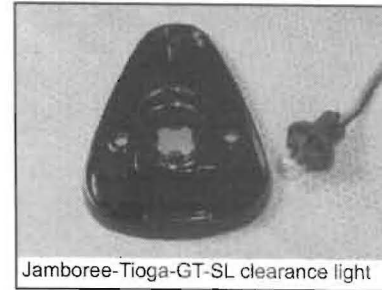
Figure 2

B. **Jamboree, Tioga, Jamboree GT or Tioga SL products:** The light base (shown in Figure 2) will need to be removed to access the clearance light wires. Remove this piece, using care to avoid disconnecting the bulb socket assembly attached to the clearance light wire harness. Retain the light base and original gaskets for reassembly.

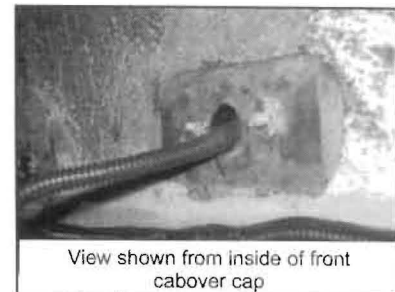
Figure 3

9. Inspect all clearance light wires and clearance light wire harness for evidence of being chafed or cut by the edges of the steel plate (bonded to the inside of the cap), through which they pass:

10. Cover all exposed clearance light wires with 3/8" diameter auto loom in the area where they pass through the front cap. See Figure 3. Apply sealant to the inside of the auto loom to keep wires in place after light reinstallation. Allow sealant to fully cure before reinstalling the lights.

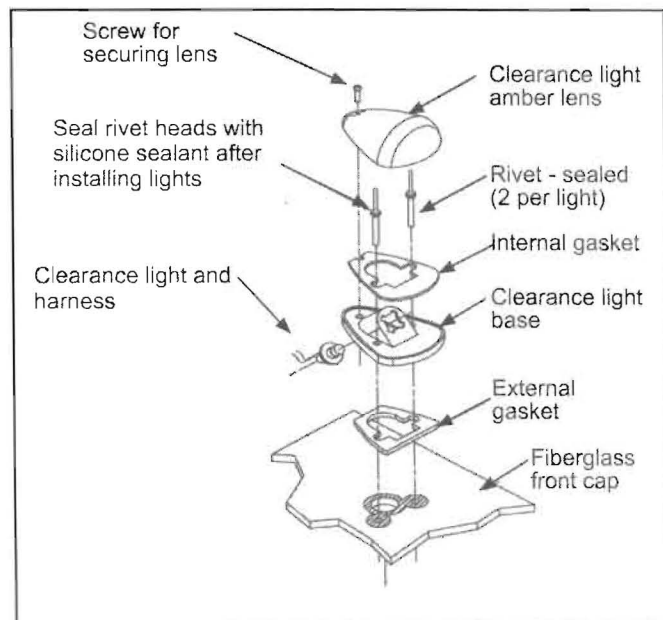
Refer to Figure 4 for clearance light part installation. Clearance light parts may be different in appearance than those shown.

BASIC REPAIR - PERFORM STEPS 10-17 IF CLEARANCE LIGHT WIRES AND WIRE HARNESS ARE UNDAMAGED. REFER TO FIGURE 4 ON PAGE 3 FOR CLEARANCE LIGHT PART INSTALLATION ORDER.

3. Cover all exposed clearance light wires with 3/8" diameter auto loom in the area where they pass through the front cabover cap. Apply sealant to the inside of the auto loom to keep wires in place after light reinstallation. Allow sealant to fully cure according to manufacturer's instructions.
4. Apply the external gasket included with the new light.
5. Insert the bulb socket, attached to the light wires, into the opening in the clearance light base before reattaching the light base.

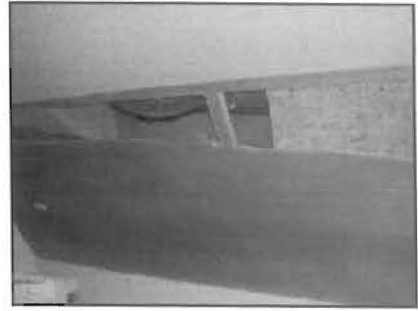
Figure 5

5. Pull back the insulation inside the cap to expose damaged wires. Remove and discard any damaged insulation. See Figure 5.
6. Cut and discard the damaged section of wire harness. Use care to keep remaining wires from dropping down inside the cap.
7. Install replacement wires of the same wire gauge and specifications, using insulated butt connectors.
8. Cover all exposed wires with 3/8" diameter auto loom.
