# SAFETY RECALL

Sr08-21

DATE : NOVEMBER 2008	SECTION : 18-BODY
SUBJECT : REPLACING PASSENGER SEATS PEDESTAL ASSEMBLY FIXING SCREWS

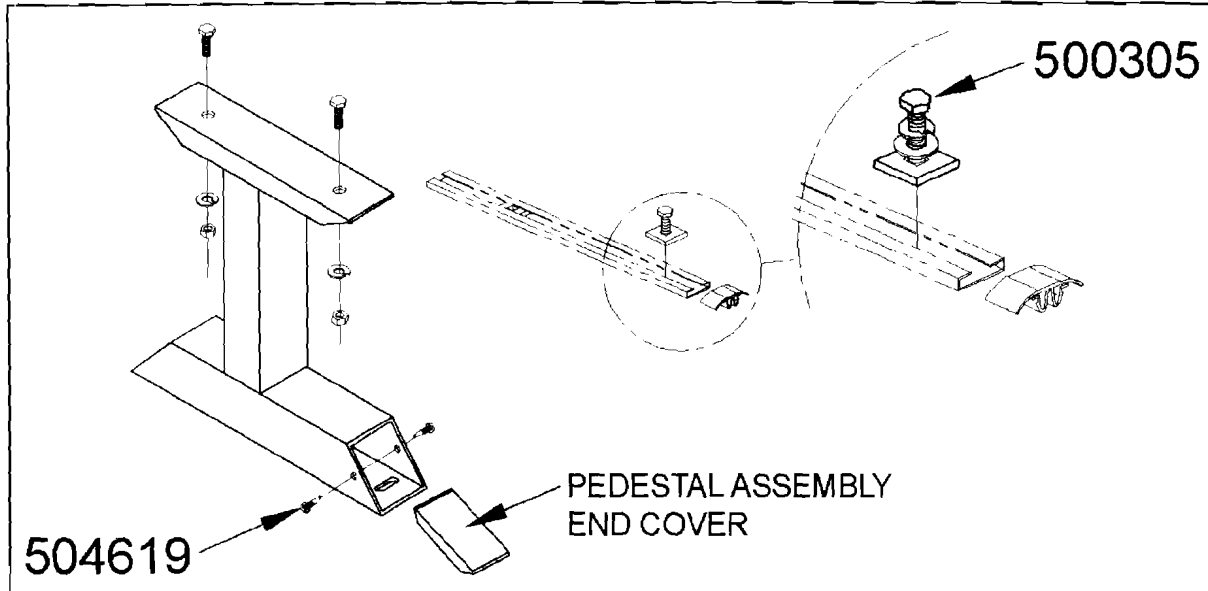
On vehicles affected by this recall, it is **absolutely necessary** to verify the screws fixing the passenger seats pedestal assembly to the floor rail system. There is a possibility that the manufactured screws were not of the proper quality and may break upon tightening or in use. If a "P" is present on the screw head, these must be replaced.

1. Remove pedestal assembly end covers.

Try re-using "Christmas Tree" type fasteners

2. Verify if "P" sign is present on cap screw head fixing pedestal assembly to the floor rail system.
3. If this is the case, these screws must be replaced with (500305) and torque tighten screw to 27 lb-ft.

4. Reinstall end covers and fix using "Christmas Tree" type fasteners (504619).
