SUBJECT: Campaign #110 – Adventurer® Limited Windshield Wiper Linkage

INSTRUCTIONS TO PERFORM CAMPAIGN 110

Selected 2008 model year Winnebago Adventurer Limited motor homes manufactured before May 3, 2008.

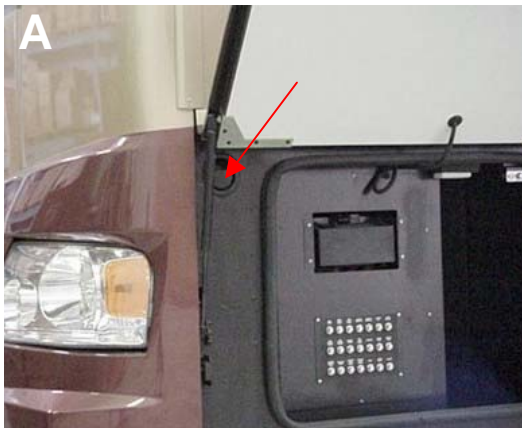
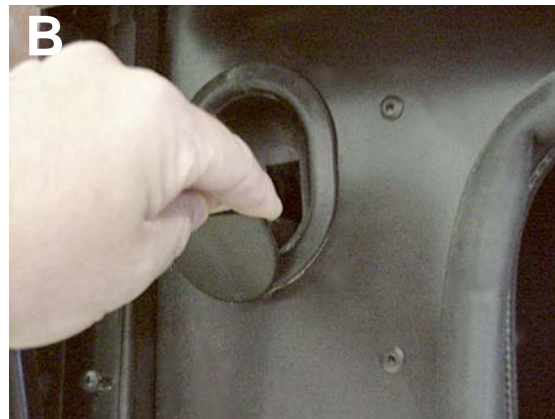
1. Open front hood by pulling top of hood latch outward (located in front driver's side compartment) to release hood panel. Gas props will allow the top of the hood panel to swing outward and lower slowly until fully open. See Photos A and B.

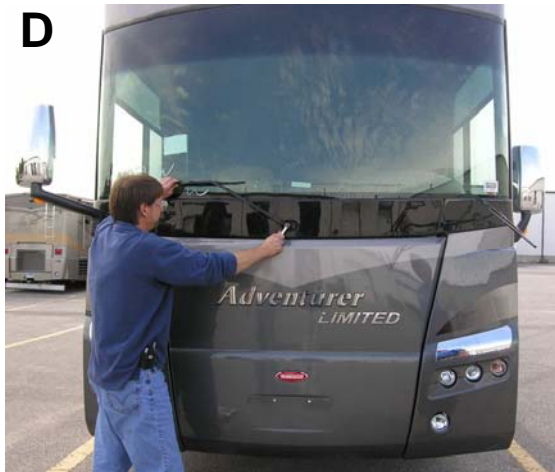
3. Remove driver and passenger side wiper arms. See Photo D.

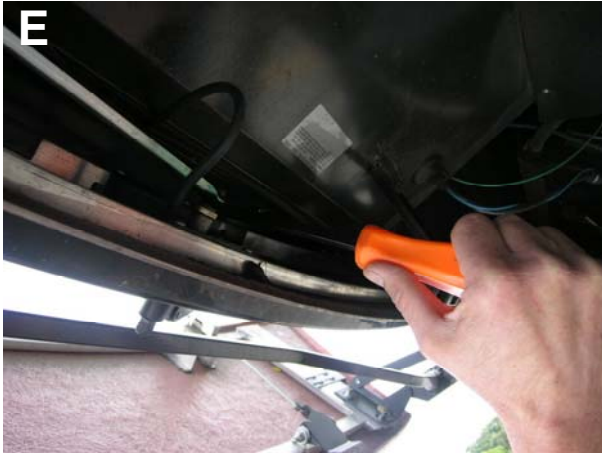
4. Remove wiper link arm from ball stud on the pivot assemblies at the driver and passenger side wipers by using a pry bar. See Photo E.

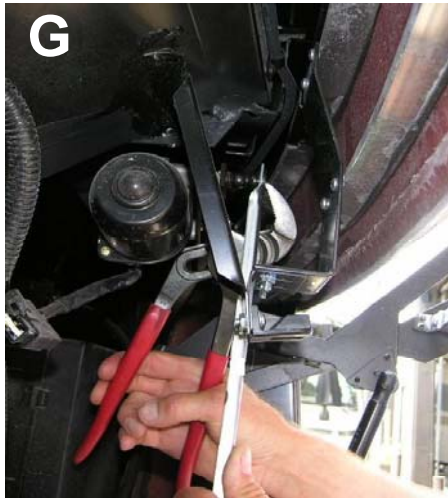
- Using a channel lock pliers, install the driver side wiper link arm (the shorter link) first on the driver side pivot assembly and then to the inside ball of the wiper motor drive arm. See Photo G.

NOTE: If the ball stud is dry, apply a small amount of multipurpose grease to ease installation.

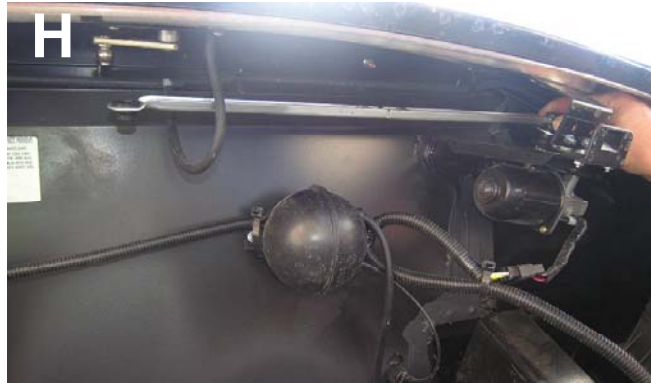
Install the passenger side wiper link arm (the longer link) first to the outside ball of the wiper motor drive arm and then to the passenger side pivot assembly. See Photo H.

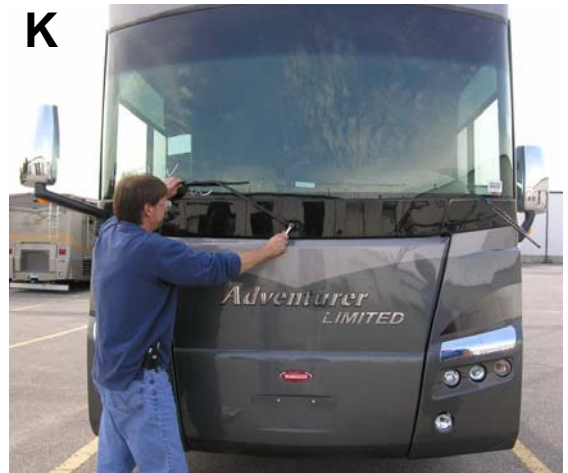
10. Close hood gently and push top of hood inward firmly with both palms outstretched to latch.
11. Reinstall driver and passenger side wiper arms on the pivot assemblies. Shown in Photo K.

12. Torque wiper arms to 13 ft.-lbs.

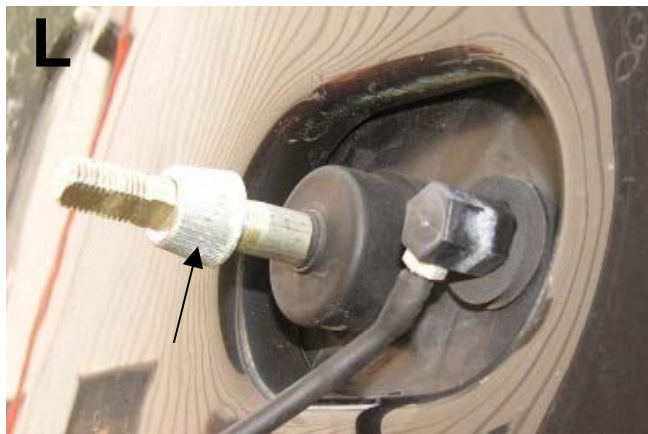
NOTE: Each notch on the spline shaft is 6 degrees. See Photo L.

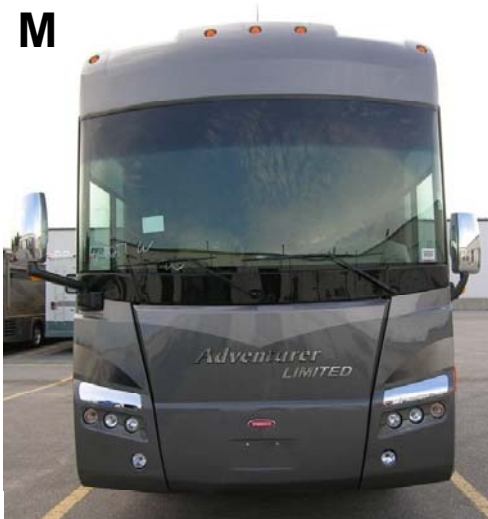
M

13. Spray the windshield with water, start the engine, and cycle the wiper system several times while engaging the windshield wipers. Turn the wipers off allowing them to stop at the “park” position. Stop the engine and assure that the wipers “park” in a level position. See Photo M.

14. If the wipers do not park in a level position, remove the wiper arms from the pivot assemblies and reposition on the splined shafts. Repeat Step 11 until the windshield wipers “park” in a level position. Retorque wiper arms to 13 ft.-lbs.
