Winnebago Industries, Inc. has started a recall campaign.

**SUBJECT: Campaign #110 – Adventurer® Limited Windshield Wiper Linkage**

## INSTRUCTIONS TO PERFORM CAMPAIGN 110

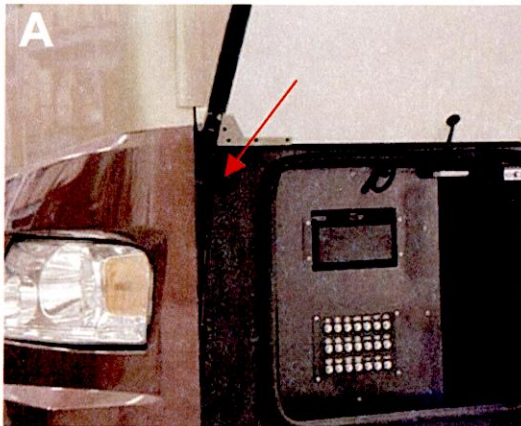
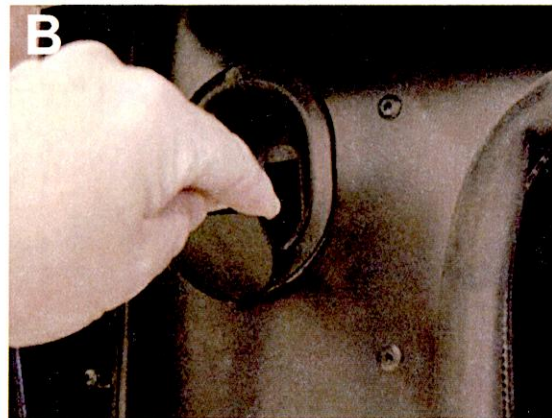
1. Open front hood by pulling top of hood latch outward (located in front driver's side compartment) to release hood panel. Gas props will allow the top of the hood panel to swing outward and lower slowly until fully open. See Photos A and B.

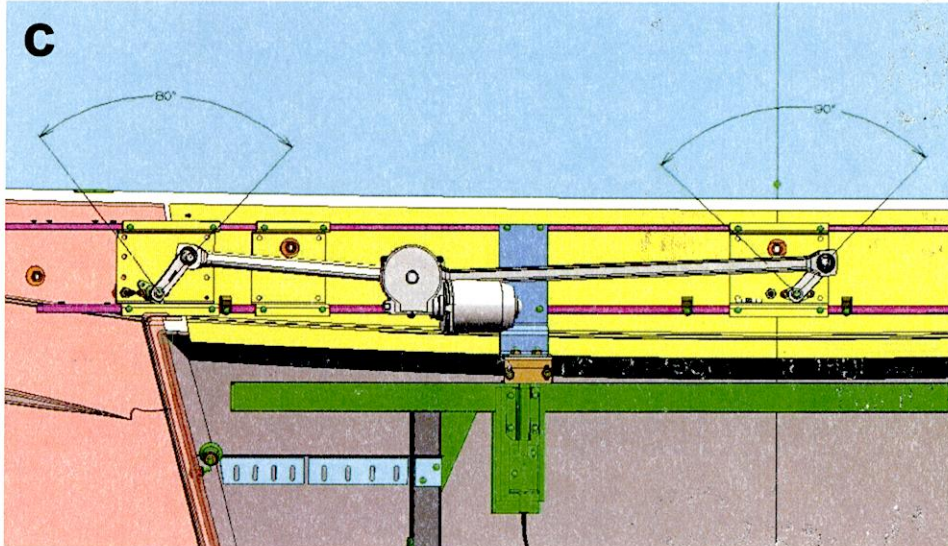
2. With another person operating the wipers from inside the coach, confirm that the driver and passenger side pivot assemblies operate within the suggested range as shown below. See Photo C.

NOTE: If the driver and passenger side pivot assemblies are operating out of the suggested range, proceed with the following instructions.

The windshield wiper motor and bracket assembly have been installed in a position that could allow the wiper arm to bind and not work properly. This recall process involves inspecting, and if necessary, replacing the existing wiper link arms with updated wiper link arms.

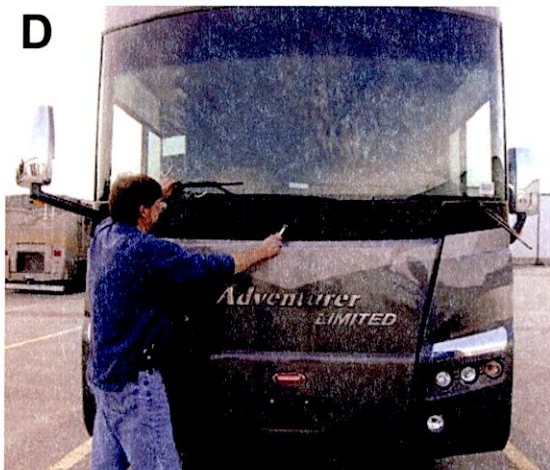
3. Remove driver and passenger side wiper arms. See Photo D.

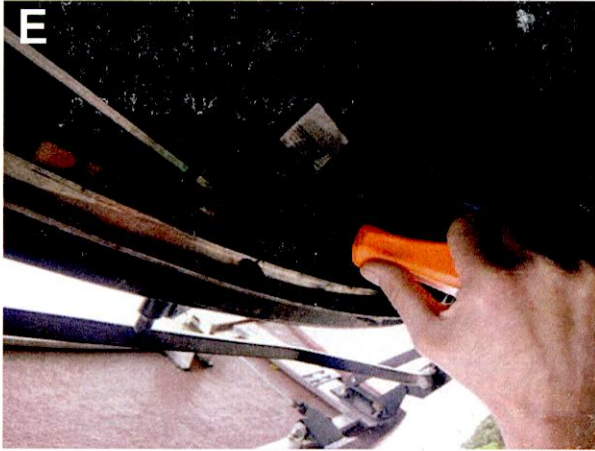
4. Remove wiper link arm from ball stud on the pivot assemblies at the driver and passenger side wipers by using a pry bar. See Photo E.

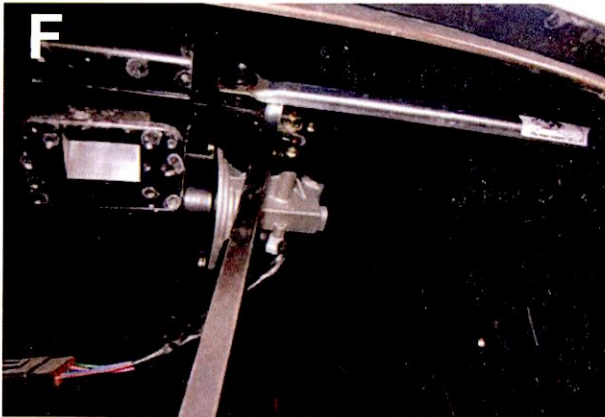
5. Remove driver and passenger side wiper link arm from the ball stud at the motor drive arm by using a pry bar. See Photo F.

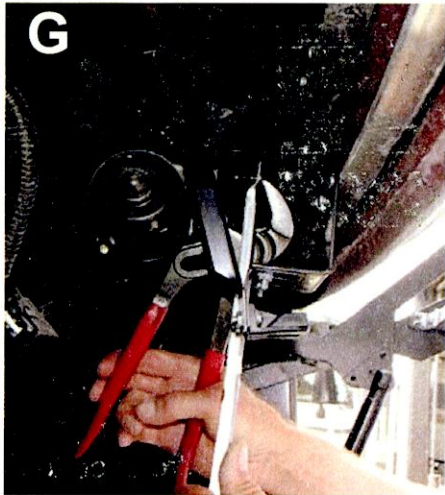
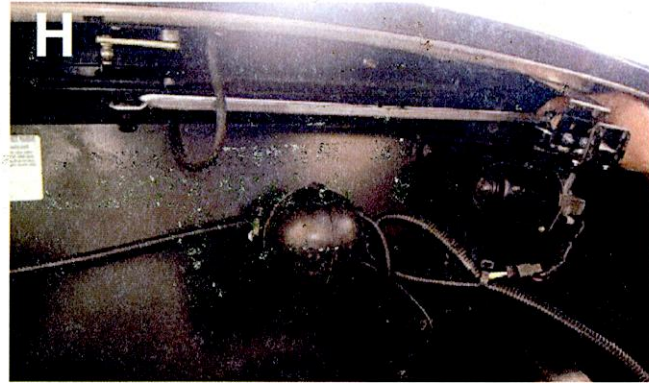
- Using a channel lock pliers, install the driver side wiper link arm (the shorter link) first on the driver side pivot assembly and then to the inside ball of the wiper motor drive arm. See Photo G.

Install the passenger side wiper link arm (the longer link) first to the outside ball of the wiper motor drive arm and then to the passenger side pivot assembly. See Photo H.

NOTE: If the ball stud is dry, apply a small amount of multipurpose grease to ease installation.

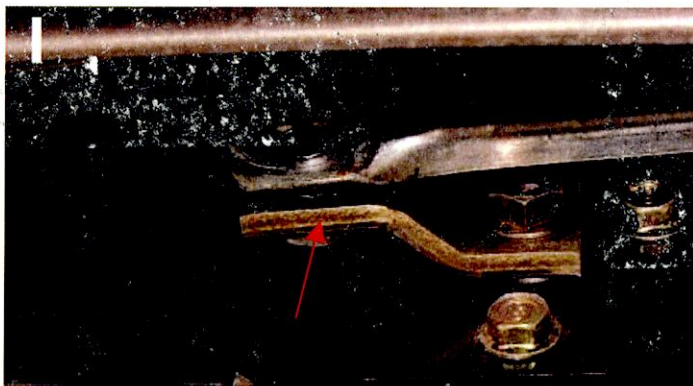
- Start the engine and cycle the wiper motor making sure to allow the wiper motor to come to a stop in the "park" position prior to turning off the engine.
- Check to assure the wiper motor drive arm is at a 9 o'clock position. Shown in Photo I.

NOTE: If the wiper motor drive arm is not at a 9 o'clock position, repeat Steps 7 and 8.

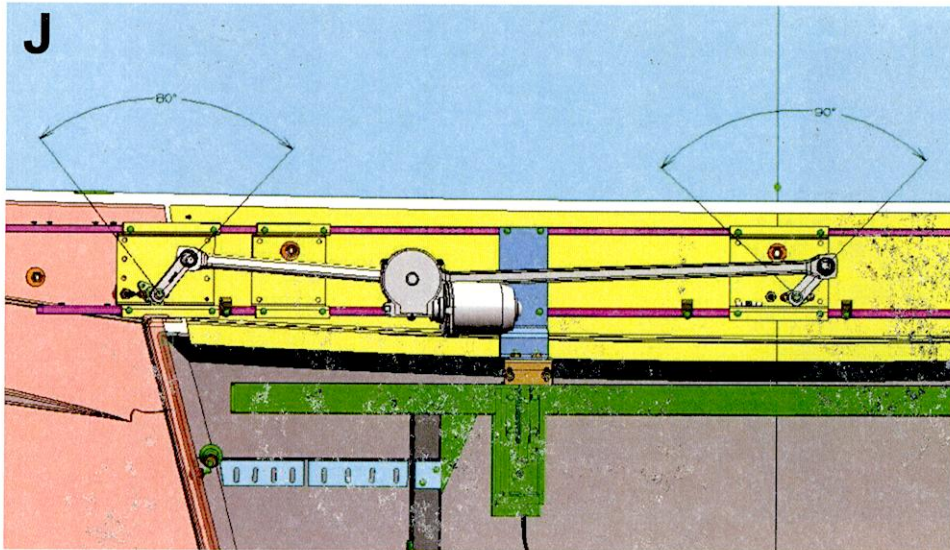
9. With another person operating the wipers from inside the coach, confirm that the driver and passenger side pivot assemblies operate within the suggested range as shown below. See Photo J.

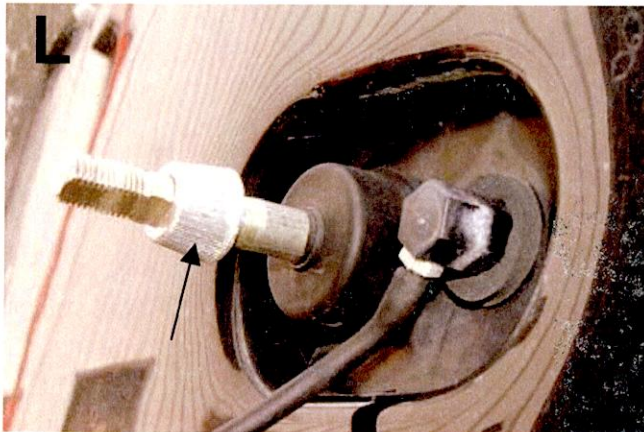
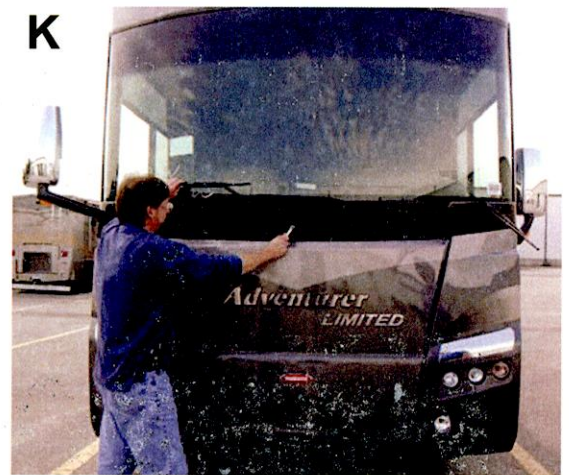
10. Close hood gently and push top of hood inward firmly with both palms outstretched to latch.
11. Reinstall driver and passenger side wiper arms on the pivot assemblies. Shown in Photo K.

NOTE: Each notch on the spline shaft is 6 degrees. See Photo L.

12. Torque wiper arms to 13 ft.-lbs.

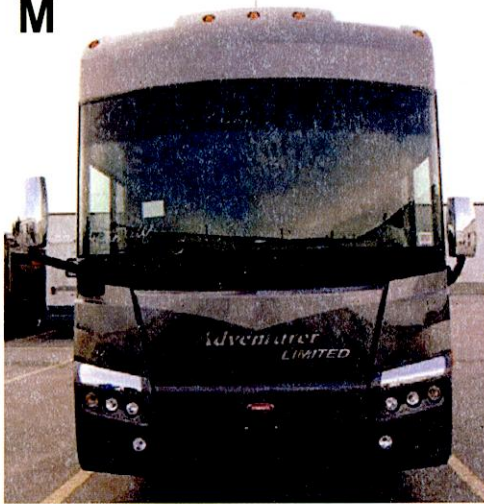
**M**

13. Spray the windshield with water, start the engine, and cycle the wiper system several times while engaging the windshield wipers. Turn the wipers off allowing them to stop at the “park” position. Stop the engine and assure that the wipers “park” in a level position. See Photo M.

14. If the wipers do not park in a level position, remove the wiper arms from the pivot assemblies and reposition on the splined shafts. Repeat Step 11 until the windshield wipers “park” in a level position. Retorque wiper arms to 13 ft.-lbs.
