**PREVOST**ENREGISTRÉ - REGISTERED  
**ISO 9001 & ISO 14001****SAFETY  
RECALL**

Sr08-22A

| <b>DATE : APRIL 2009</b> | <b>SECTION : 14-STEERING</b> |
| <b>SUBJECT : POWER STEERING HOSE INSPECTION AND REPLACEMENT</b> | |

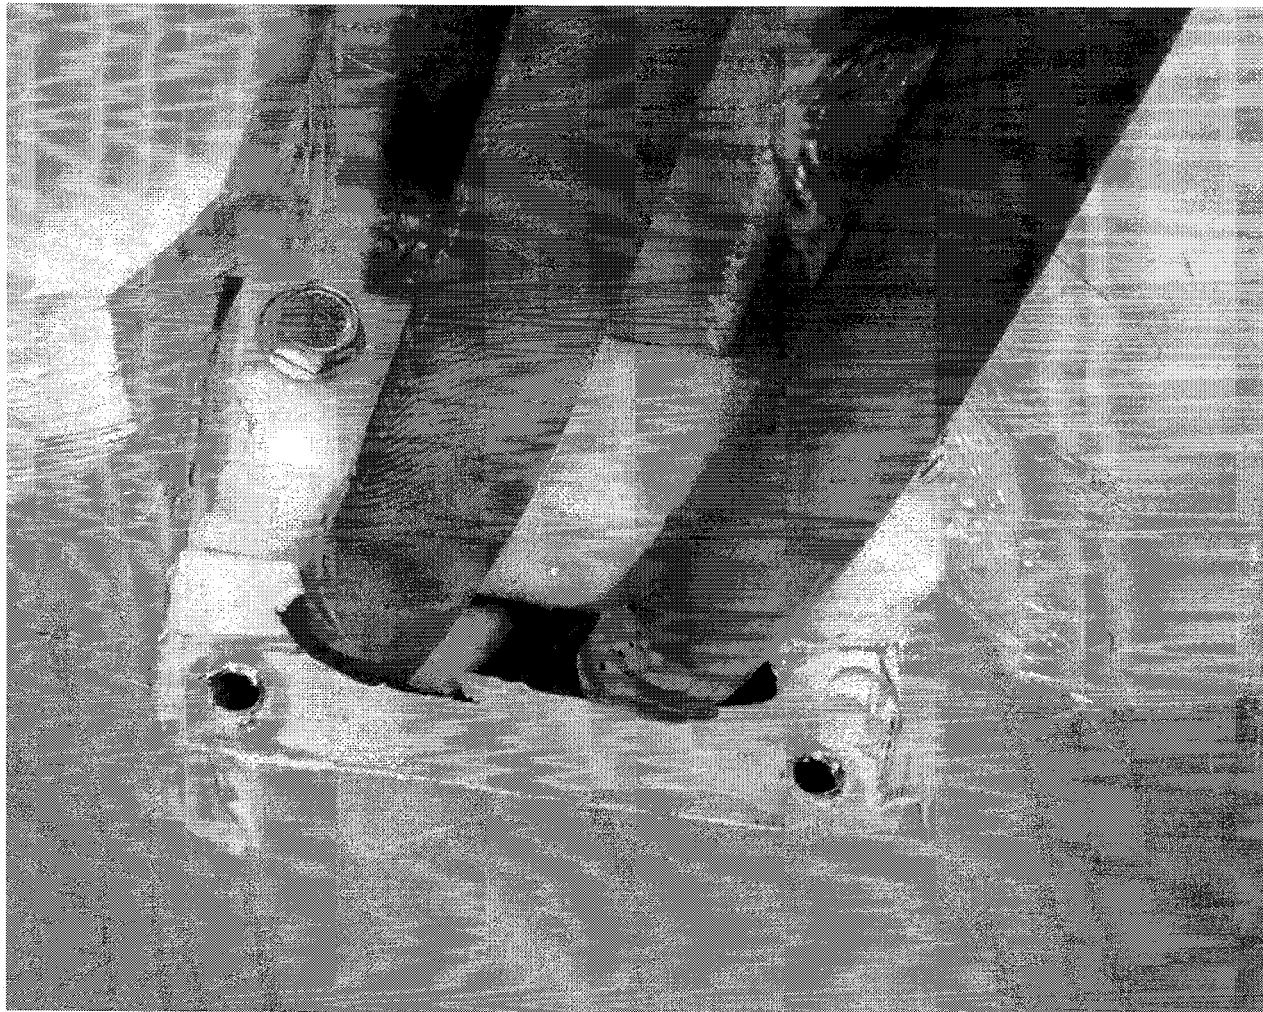
1. Open rear baggage compartment door.
2. Remove the 2 nylon blocks fixing the power steering hoses on the wall separating the rear baggage compartment from the rear wheelhousing.
3. Inspect power steering pressure hoses especially where the hoses come in contact against the nylon blocks. Check for signs of wear or abrasion.

4. If the hose metal sheathing is not visible, proceed with PART A. If pressure hose metal sheathing is visible, proceed with PART B.

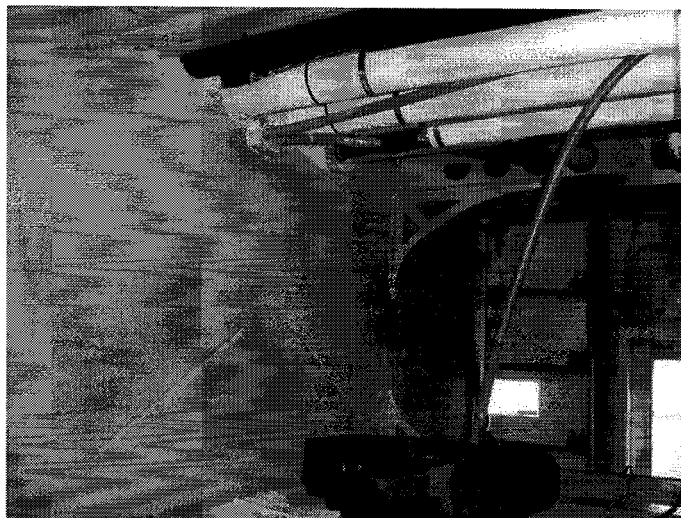
3. Inside rear baggage compartment, cut worn hose close to the rear wall (near the white nylon fixing blocks).

4. Remove worn hose located between tag axle and rear baggage compartment.
5. Install new hose on vehicle starting with fitting above tag axle.

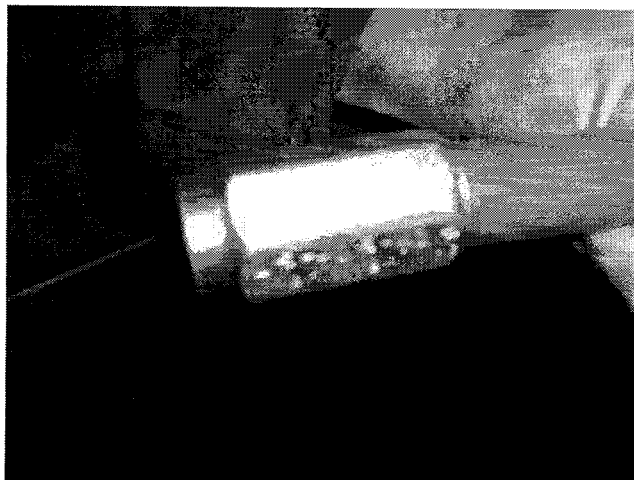
6. Secure hose to vehicle inside rear wheelhousing.
7. Replace former nylon plastic blocks inside rear baggage compartment with new ones with flared openings (160033).
8. Secure 2 nylon fixing blocks to hoses.
9. Apply some Sika 221 (680532) between the structure (wall) and the fixing blocks for watertightness.
10. Fasten the blocks to the rear baggage compartment wall.
11. Cut worn hose again so as to leave a 1 3/8 inch (35 mm) gap between front hose and the rear hose fitting end.
12. Clean and remove all residues from cut out area.
13. Fasten female part of fitting (501005) onto front hose (left-end thread).

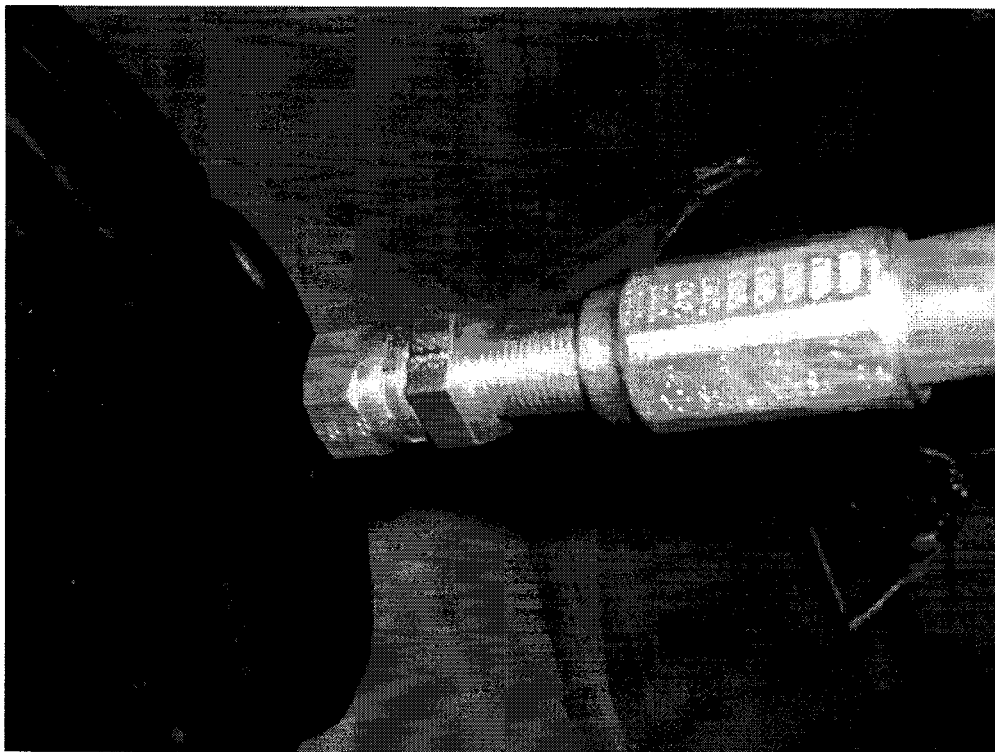
14. Fasten male part of fitting onto hose.
15. Connect front hose to rear hose.

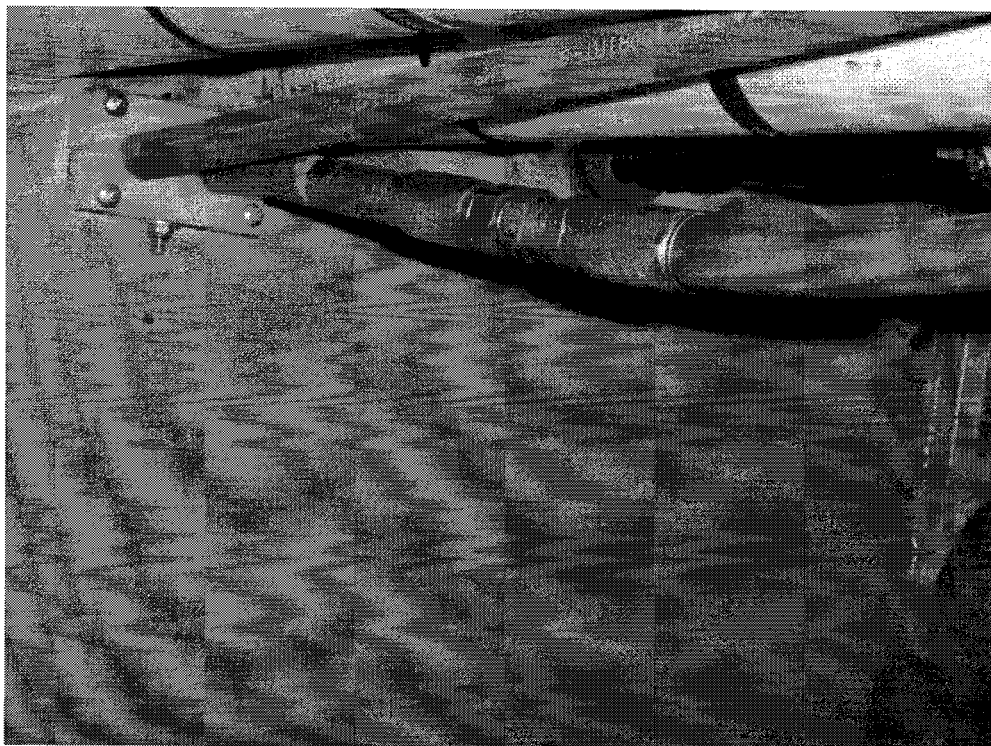
16. Secure hoses to the structural tubing using the green plastic supports.

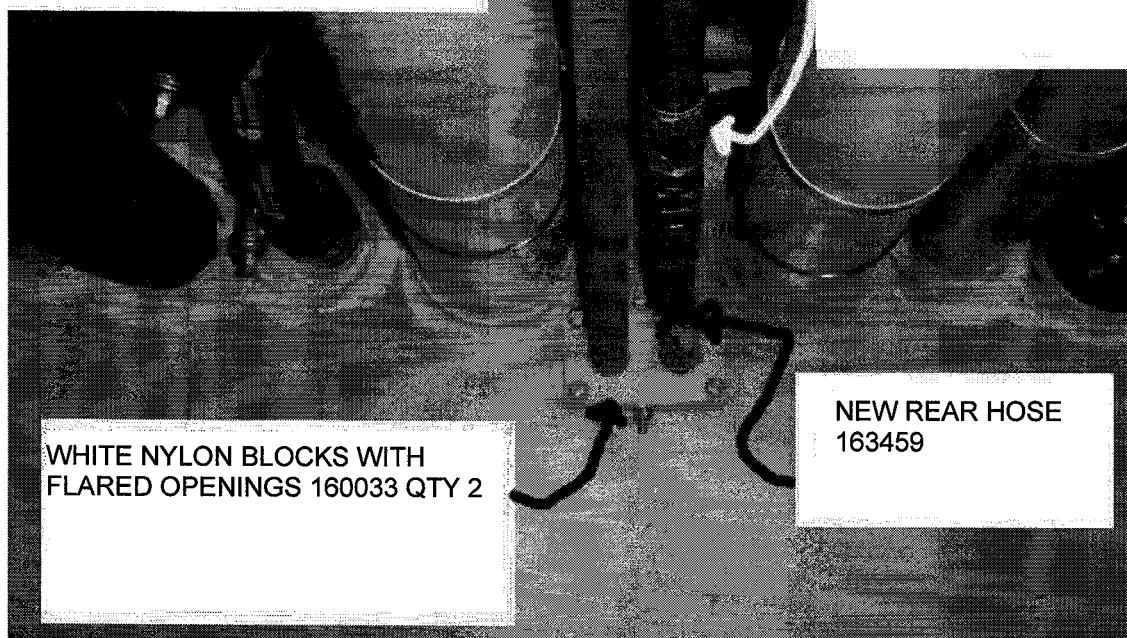
17. Add if necessary, a support inside the rear baggage compartment to prevent any contact between hoses or with surroundings.

NYLON BLOCK 504727 QTY 1  
FIXING PLATE 504728 QTY 1  
SCREW TC 1/4 X 20 500107 QTY 1

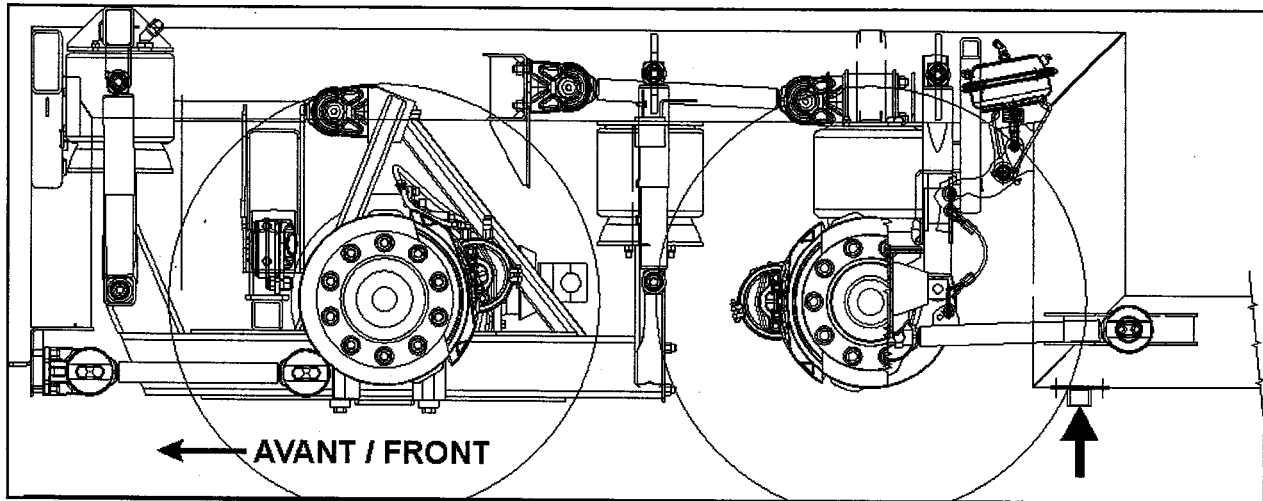
1. Raise the vehicle using the axle jacking points.
2. Place a jack on each side of vehicle to support the rear end.

3. From the rear wheelhousing, visually inspect the wall separating the rear baggage compartment from the rear wheelhousing, where the blue power steering pressure hoses go through. Check for signs of oil or rust especially where the hoses come in contact against the nylon blocks. If this is the case, contact your nearest Prevost Service Center or your Regional Service Manager to have the hose replaced. If not, go on with procedure.
4. Clean the wall area near the power steering pressure hoses. Use a cleaner such as "Brake Cleaner" (685248).
5. Amply apply some Sika 221 (680532) onto the cleaned area and the pressure hoses.
6. Split open black protective sheathing (144923) and install (split facing down) over pressure hoses near the wall.
7. Fix protective sheathing using nylon tie wraps (507664).
