**PREVOST**ENREGISTRÉ - REGISTERED  
**ISO 9001 & ISO 14001****SAFETY  
RECALL**

Sr08-22

| <b>DATE : DECEMBER 2008</b> | <b>SECTION : 14-STEERING</b> |
| <b>SUBJECT : POWER STEERING HOSE INSPECTION AND REPLACEMENT</b> | |

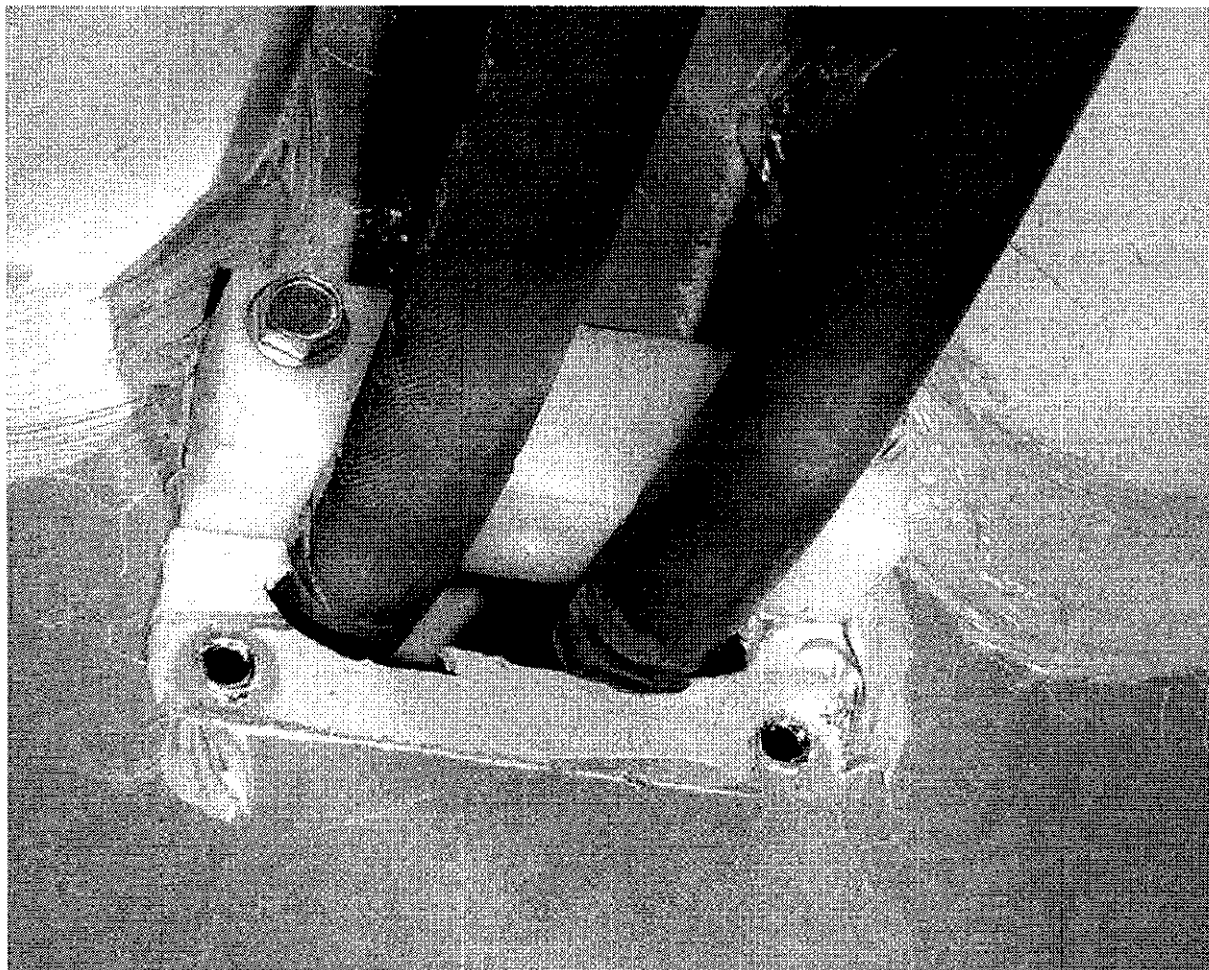
3. Inspect power steering pressure hoses especially where the hoses come in contact against the nylon blocks. Check for signs of wear or abrasion.

4. If the hose metal sheathing is not visible, proceed with PART A. If pressure hose metal sheathing is visible, proceed with PART B.

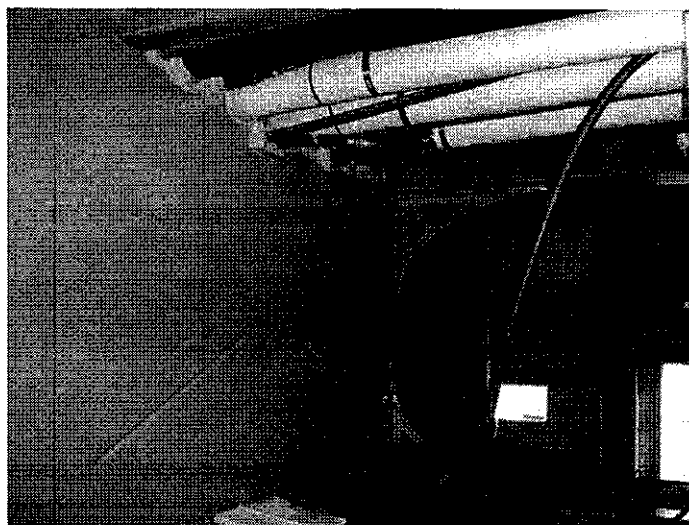
1. Disconnect hose fitting located above tag axle.
2. Remove hose brackets between fitting and rear baggage compartment partition wall.
3. Inside rear baggage compartment, cut worn hose close to the rear wall (near the white nylon fixing blocks).

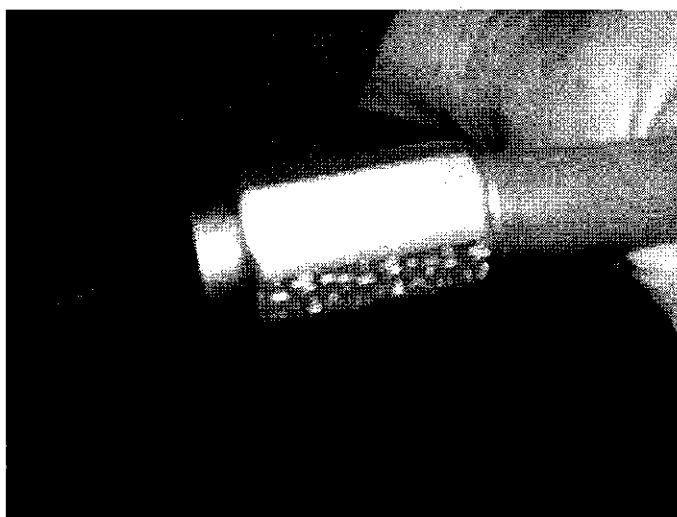
6. Secure hose to vehicle inside rear wheelhousing.
7. Replace former nylon plastic blocks inside rear baggage compartment with new ones with flared openings (160033).
8. Secure 2 nylon fixing blocks to hoses.
9. Apply some Sika 221 (680532) between the structure (wall) and the fixing blocks for watertightness.
10. Fasten the blocks to the rear baggage compartment wall.
11. Cut worn hose again so as to leave a 1 3/8 inch (35 mm) gap between front hose and the rear hose fitting end.
12. Clean and remove all residues from cut out area.
13. Fasten female part of fitting (501005) onto front hose (left-end thread).

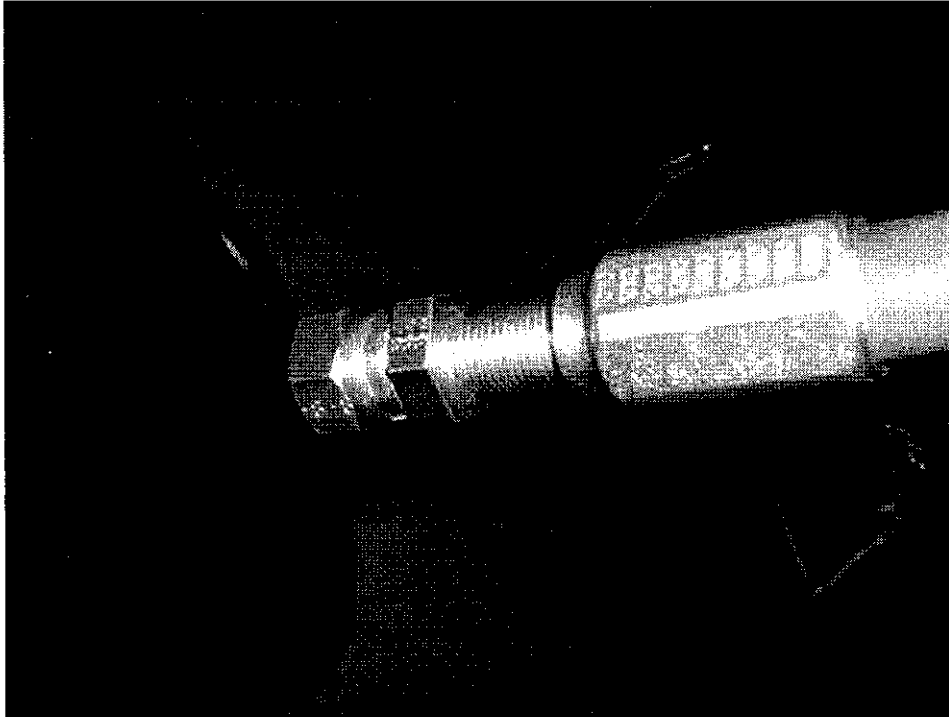
14. Fasten male part of fitting onto hose.

15. Connect front hose to rear hose.

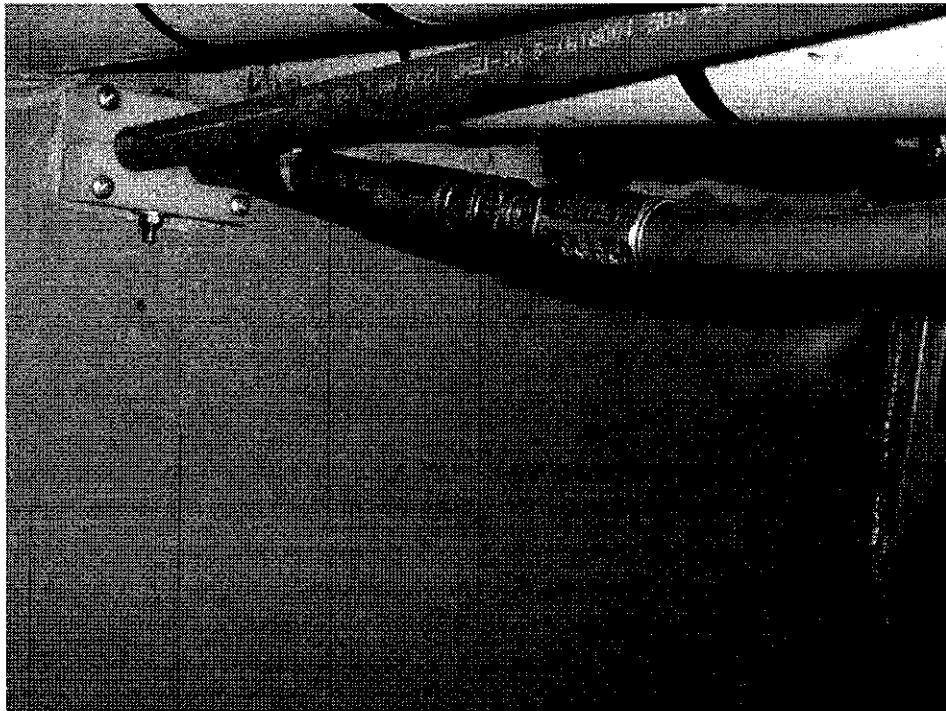
16. Secure hoses to the structural tubing using the green plastic supports.

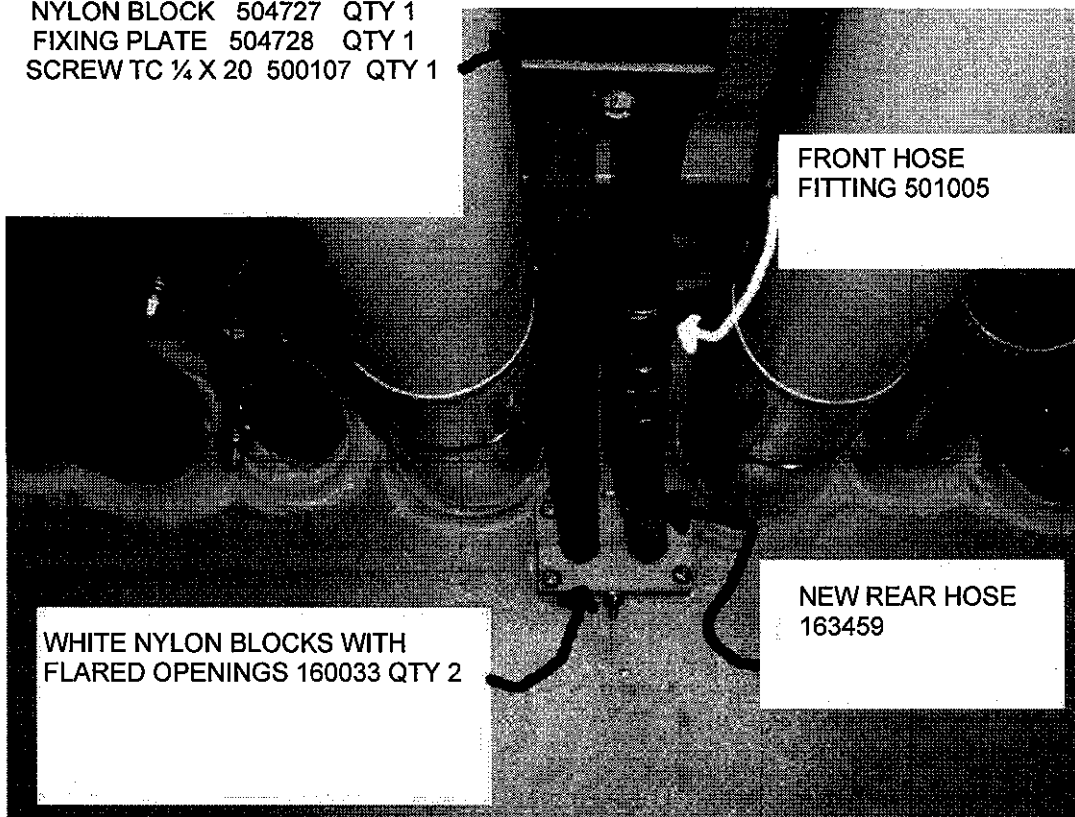
17. Add if necessary, a support inside the rear baggage compartment to prevent any contact between hoses or with surroundings.

NYLON BLOCK 504727 QTY 1  
FIXING PLATE 504728 QTY 1  
SCREW TC 1/4 X 20 500107 QTY 1
