SERVICE PROCEDURE INFORMATION

APPLICABILITY: 2008 Tribeca Late Model Production,
 2009 Tribeca Early Model Production

SUBJECT: Incorrect VDC G Sensor Position

VDC G SENSOR POSITION INSPECTION

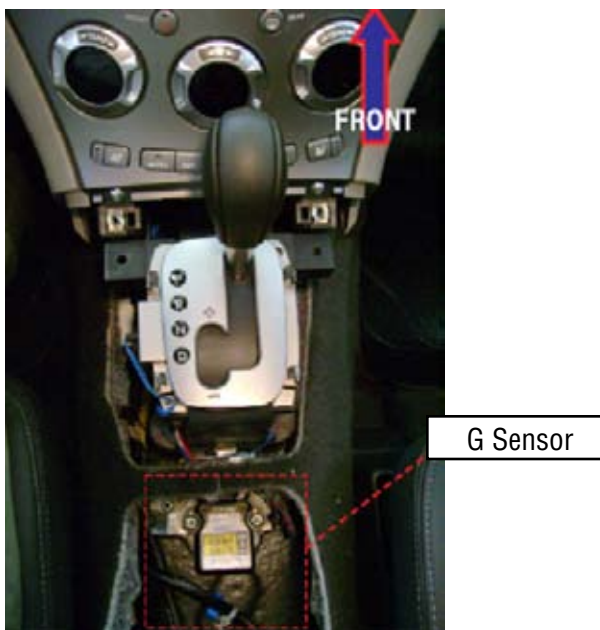
The VDC G Sensor is located in the center console just below the transmission shifter.

Note: the center console was removed for illustration purposes.

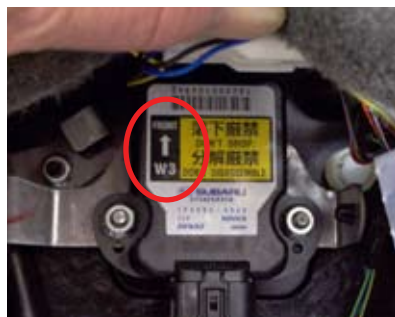
Correct Position (arrow is pointing towards the front of the vehicle.)

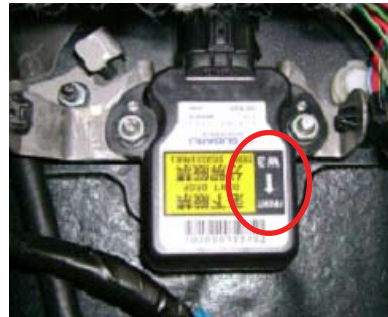
Incorrect Position (arrow is pointing towards the rear of the vehicle.)

If the G Sensor arrow is pointing towards the rear of the vehicle, continue with the following procedure.

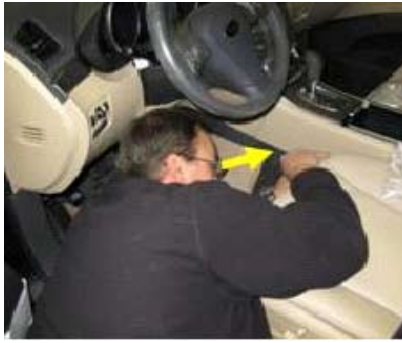
Move the driver's seat to the most reward position. Position yourself as illustrated.

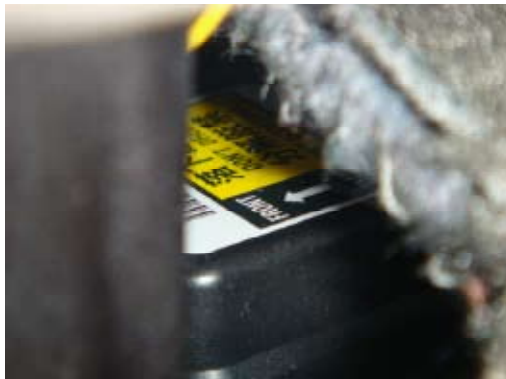
Push in, slightly pull down, and move the carpet slightly forward to gain a view of the G Sensor. Use a flashlight to verify the direction of the arrow on the G Sensor.

If the arrow is pointing towards the front of the vehicle, no further action is required.

Note: Make sure the carpet is in the original position before returning vehicle to customer.

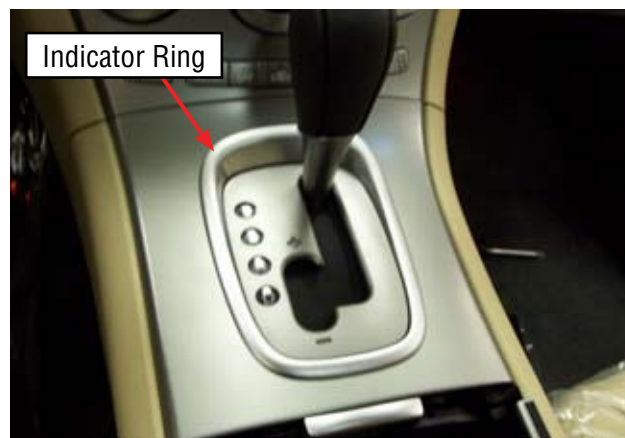
Remove the indicator ring by gently prying up on each corner using a plastic trim tool.

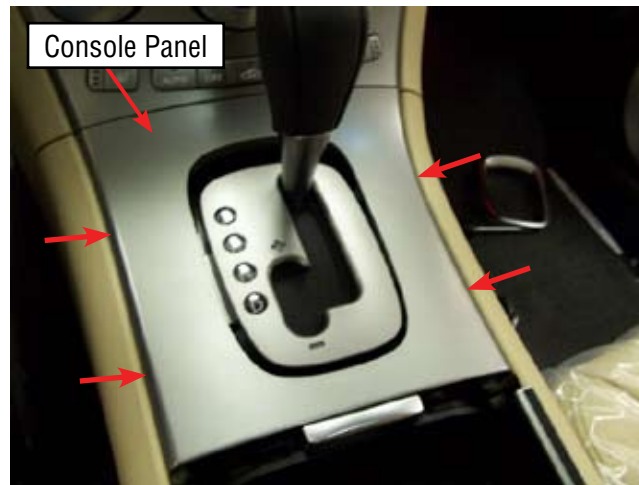
Remove the front console panel by gently pushing in on each tab (4) using a plastic trim tool.

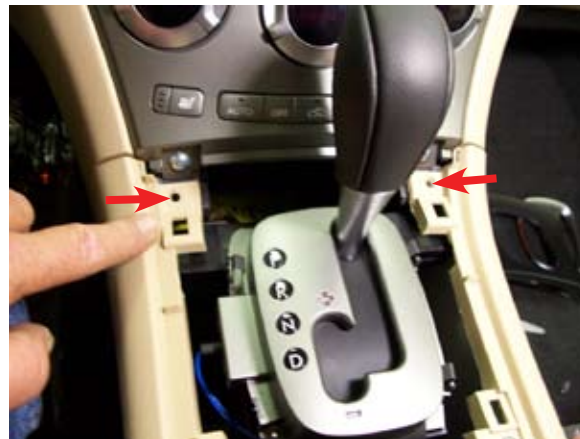
Remove the 2 screws that secure the front of the console.

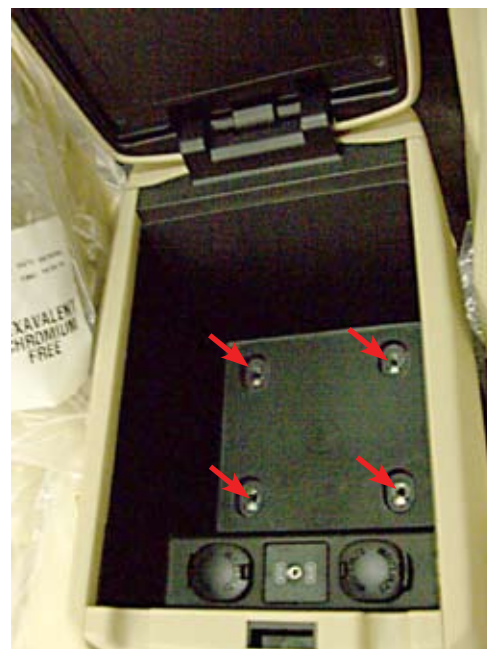
Remove the 4 bolts that secure the upper console pocket.

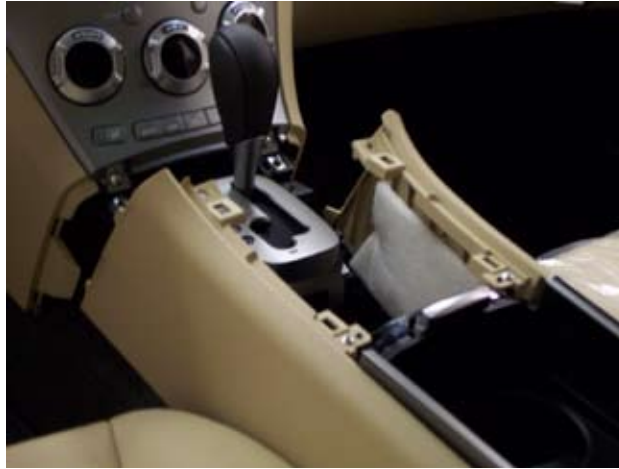
Gently pull the center console assembly rearward to disengage from the lower instrument panel. Carefully position center console assembly upward to gain access to G sensor.

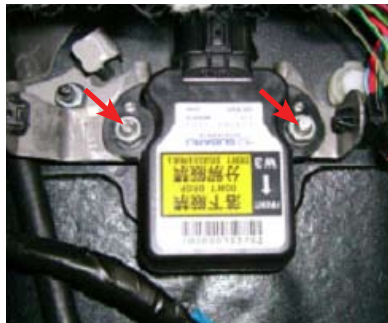
Remove 2 nuts which secure the G sensor to the bracket.

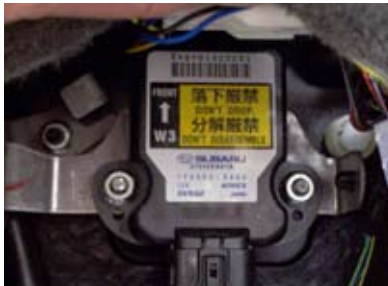
Reposition the G Sensor with the arrow pointing towards the front of the vehicle, install nuts and torque to 7.5 N-m (0.76 kgf-m, 5.53 ft-lb).

Reinstall console and trim pieces in reverse order of removal.

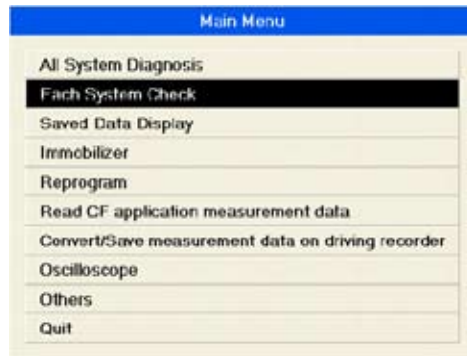
1) Select Each System Check

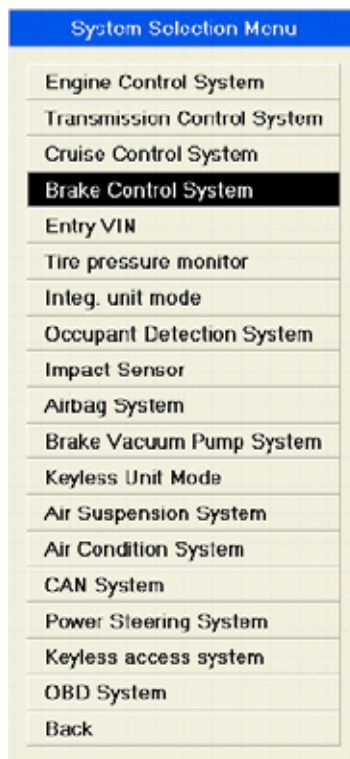
2) Select Brake Control System

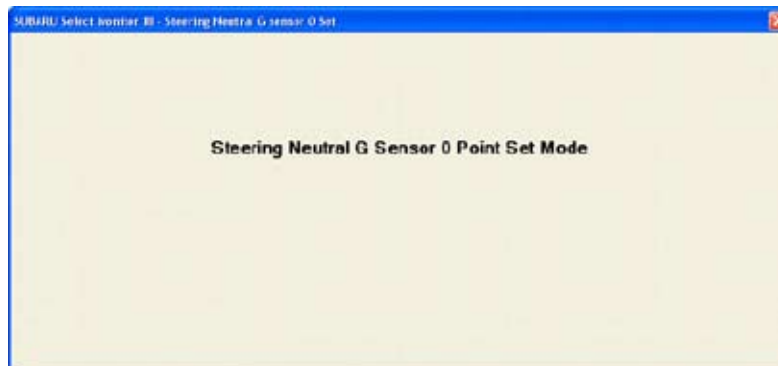
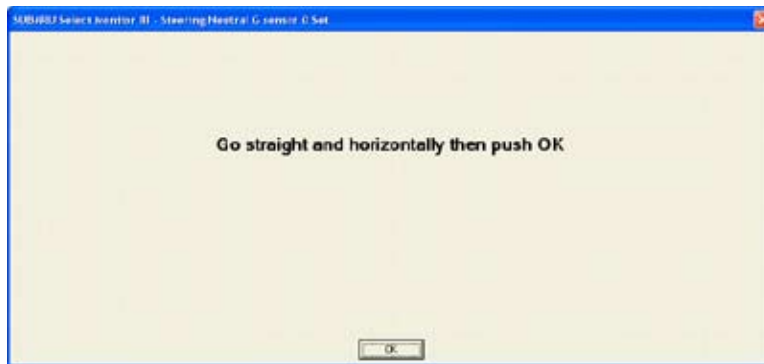
6) Wait and read the following screens.

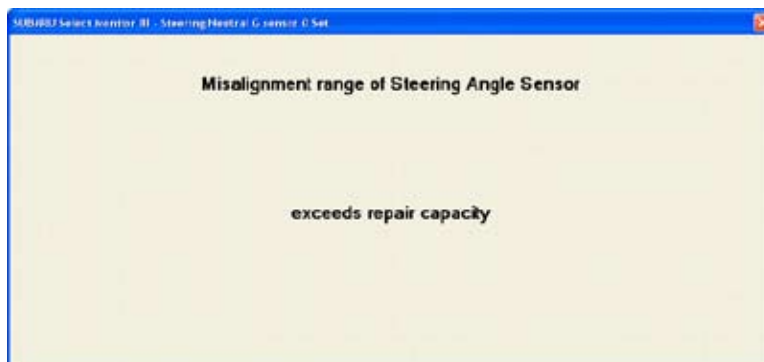
This is the display when the steering wheel is off center a large degree.

In either case, the display will go back to the function check sequence after a few seconds. Center the steering wheel and repeat the procedure.

NOTE: Centering is best performed by moving the steering wheel to the left and right of the center point and then back to center.

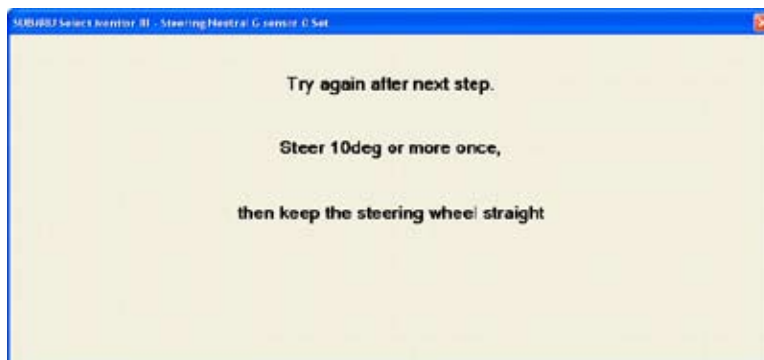
This is the display when the steering wheel is off center a small degree.

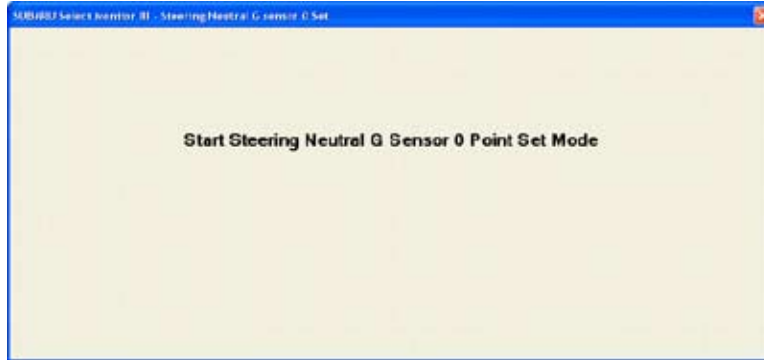
8) When the steering wheel is centered the following screen will be displayed indicating the alignment procedure is beginning.
