090004 INFORMATION REPORT
(NHTSA RECALL NOTICE XXXXX)

**SAFETY RECALL NOTICE NUMBER 090004
(NHTSA RECALL NOTICE XXXXX)**

Haldex Quick Release Valve Date Code Identification

Quick Release Valve Replacement Instructions

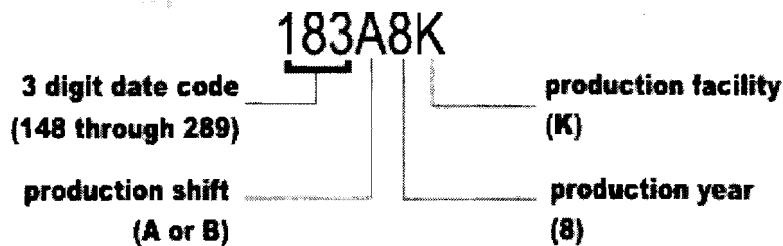
Manufacturing date code stamp scheme:

3. Inspect for the manufacturing date code stamped on the QRV.
 Note: The subject population of QRVs was manufactured from May 27, 2008 through October 15, 2008 with production date codes of **148 through 289** during the first (A) and second (B) shift of production at the Haldex Iola, Kansas facility (K). Refer to the attached Haldex Quick Release Valve Date Code Identification procedure.

- If the manufacturing date code falls within the affected manufacturing date codes, continue on to step 4.
- If the QRV installed on your trailer is outside of the manufacturing date code affected, no further action is necessary.

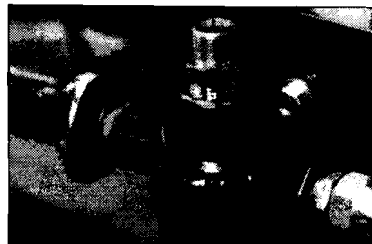
Remove all of the hoses from the Supply and Delivery Ports of the valve. Mark/identify hoses as they are removed to assure proper reassembly.

Fig. 2 shows removal of the hoses.

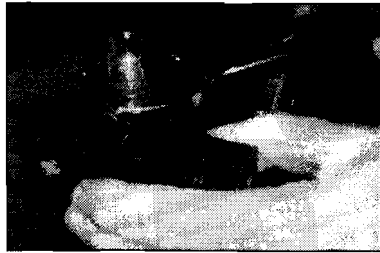
If required, assemble the appropriate size D.O.T.-approved fittings into the new QRV. Haldex recommends lightly coating the threads of the new fittings with a PTFE (Teflon) thread sealant. Do NOT use Teflon tape. Torque the fittings to a range of 75 to 200 in-lbs.

Fig. 4 shows installation of the fittings.

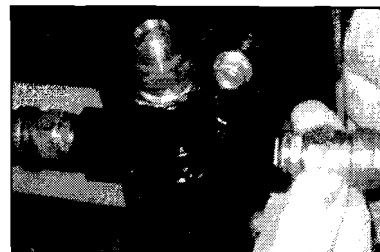
Install the vehicle air hoses onto the valve. Use wrenches on both the fitting and the hose to make certain that fitting torques into the QRV remain in the range of 75 to 200 in-lbs.

Fig. 6 shows a hose being connected.
