SAFETY RECALL NOTICE

**SAFETY RECALL RVXX0902
DECEMBER 2010 – 2nd Notice**

Wiper Motor Recall

RVXX0902, Wiper Motor Recall

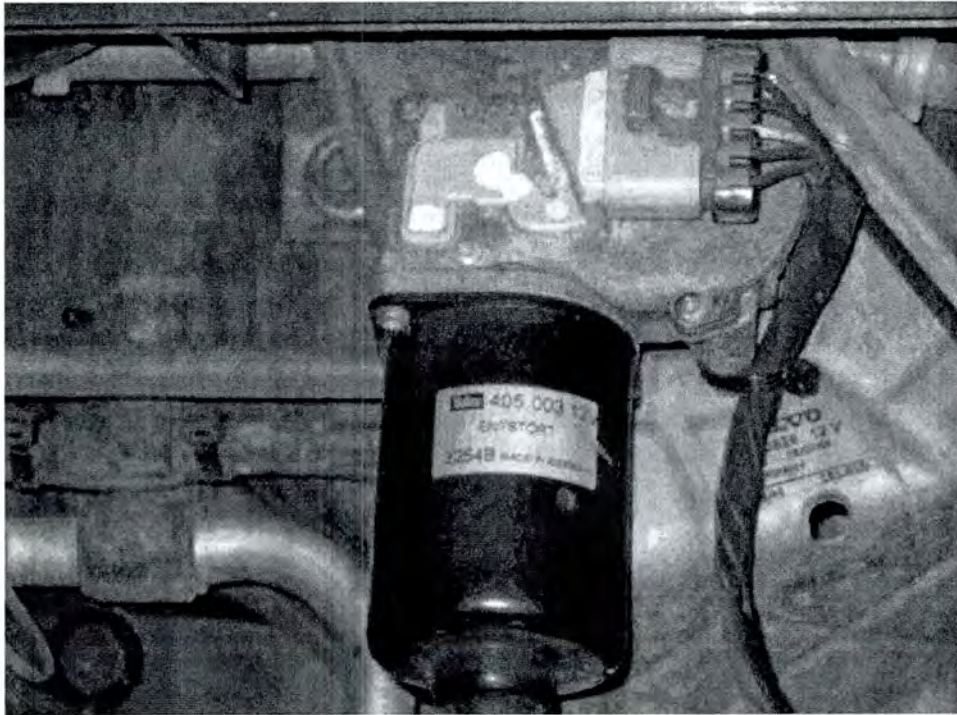
Figure 1 — Valeo wiper motor

2. Verify that the vehicle has a Valeo wiper motor (figure 1). If the truck already has a Sprague wiper motor (figure 2) installed, file a claim for inspection time using the recall authorization making an appropriate note in the warranty claim.

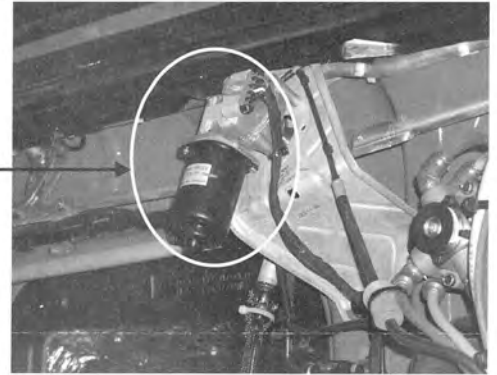
Wiper motor

The windshield wiper motor is located under the hood on the upper bulkhead on the driver's side of the vehicle. The following image shows the location of the wiper motor:

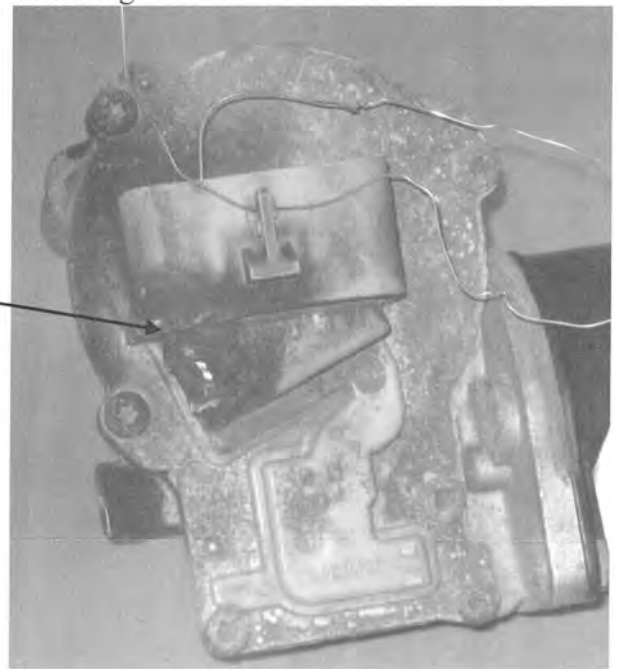
The two images below show connectors that exhibit signs of overheating:

Example of melted connector:
(Plastic melted and charred)

Volvo **strongly recommends** that you inspect the wiper motor for evidence of overheating (melting or charring) (see photos on the last page of this document in the section titled "Inspection") during your daily pre and post trip vehicle inspections.

If your motor shows signs of overheating, do not drive the vehicle; also remove the ignition key. You should contact Volvo's wiper motor recall support line (1-877-800-4945) for further help and instruction.

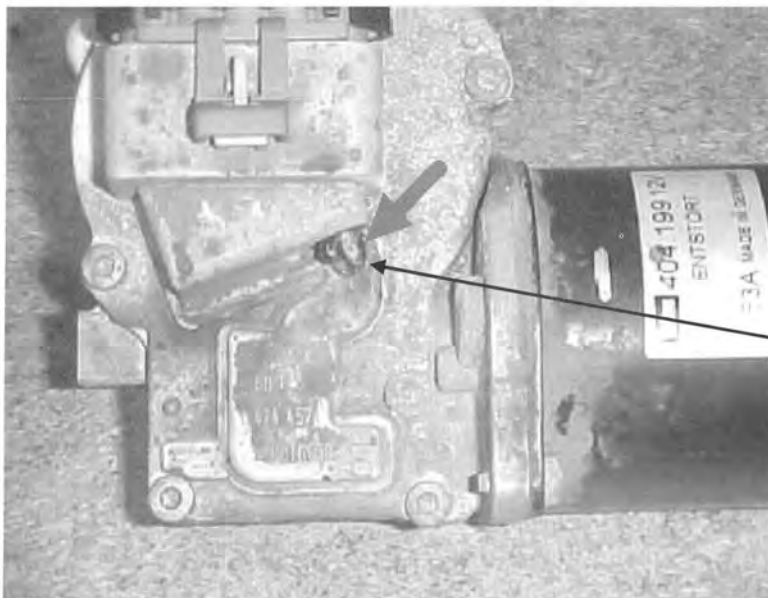
Example of melted connector (plastic deformed)
