**Subject:** NHTSA Recall #09V-188 Piaggio X9 & BV500-Fuel pump-Flange-Filter pipe

**Service Communication:** 2009-001 USA

**Affected Models:** Select 2005-2007 Piaggio X9 & 2006-2008 BV500 models

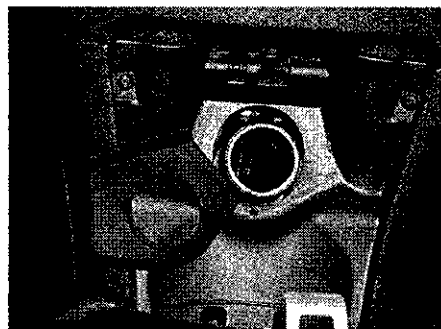
- 2) Remove gas cap, splash gasket and center panel (Two- Phillips screws)

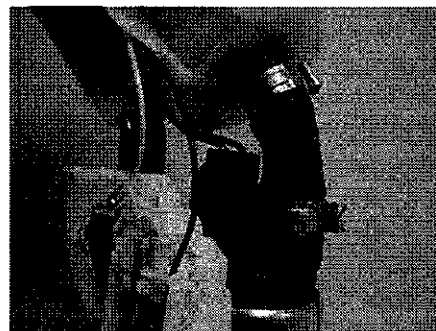
- 4) Unscrew the fuel pump assembly from the fuel tank by turning the round collar counterclockwise. Raise the fuel pump assembly above the top of the fuel tank. Allow residual fuel to drain into the tank, before moving it away.
- 5) Locate the fuel hose between the fuel pump and filter. Remove the old hose and install the new hose with new hose clamps. Note: If installation of new hose and clamps is difficult due to clearance issues, disassemble pump assembly in a similar fashion as BV500 procedure on pages 6-8. (Be careful with black and white fuel level sensor wires if screws are removed for hose installation. Tuck wires back in place when finished)
