### **Safety Recall Campaign Replacement of Bosch Service Brake Calipers**

**BULLETIN NO: 51101-C**

**SUBJECT: Replacement of Bosch Service Brake Calipers**

**MODELS: All 2001 through 2011 Model Year W20, W21, W22, and W22D Motor Home Chassis Equipped with Bosch Brake Calipers**

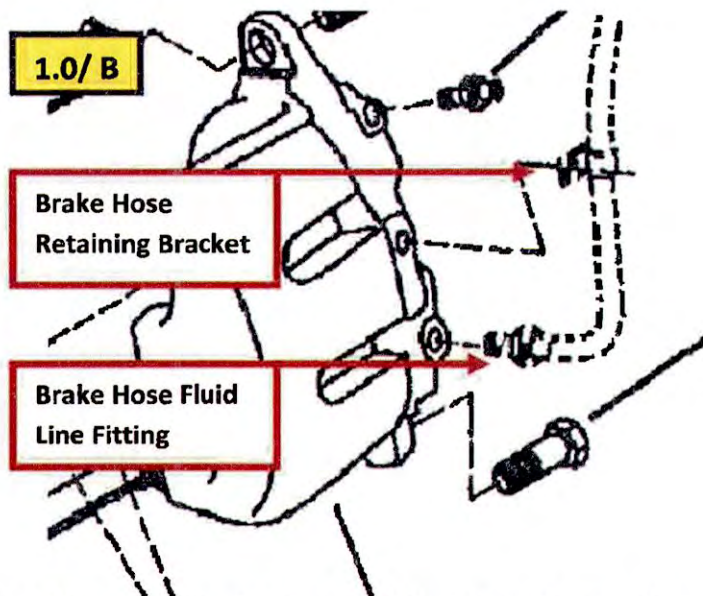
7. Remove the tool used to compress the caliper pistons.
8. Remove the brake hose retaining bracket fastener from the caliper. (View Illustration 1.0/ B)

9. Disconnect brake hose fluid line fitting from caliper and cap off to prevent brake fluid leakage or contamination in the line. Do not allow the brake line hose to become pinched or kinked during the remedy procedure. (View Illustration 1.0/ B)
10. Remove the upper (top) caliper mounting bolt securing the caliper to the upper guide pin. (Shown in Photo 1.0/ C)
11. Remove the lower (bottom) caliper mounting bolt securing the caliper to the lower guide pin.

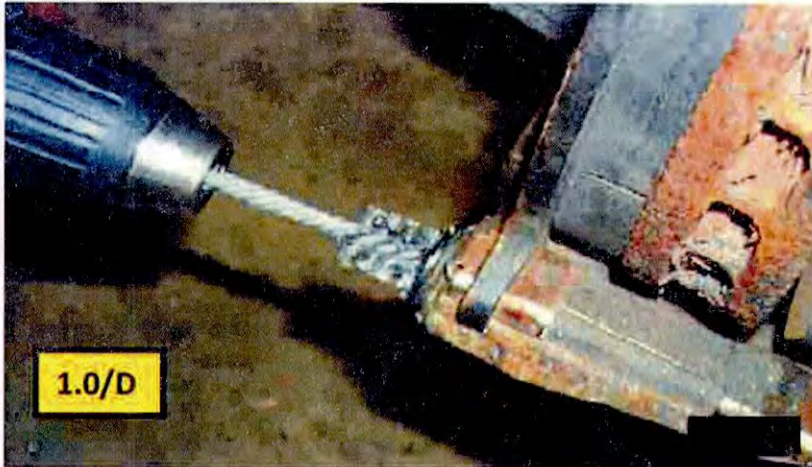
14. Clean the machined surface of the anchor plate with wire brush. (See photo 1.0/D)
15. Clean and lubricate the anchor plate bores with silicone brake grease.

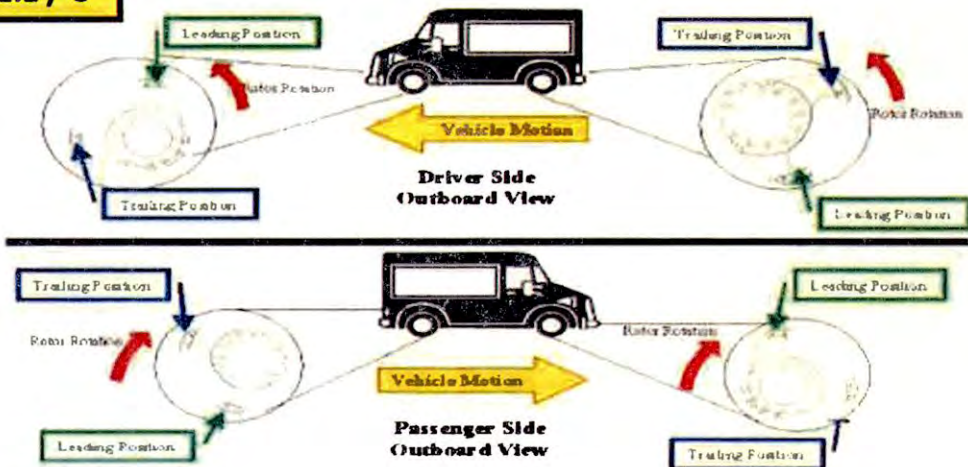
**1.1/C**

**Identifying Slide Pin Leading and Trailing Positions**

6. Torque the ZOH-T mounting bolts as follows:
  - a. Torque leading bolt to 93-107 lb-ft (126-145 N-m)
  - b. Torque trailing bolt to 93-107 lb-ft (126-145 N-m)
  - c. See Leading and Trailing bolt position illustration (1.1 / C)
7. Connect the brake hose fitting to the fluid inlet port on the caliper and torque to 14-17 lb-ft (20-24 N-m). (See illustration 1.0 / B)
8. Reconnect the brake hose retaining bracket to the caliper using the original bolt removed. (See illustration 1.0 / B)
9. Bleed brake system torque bleeder screw to 8-15 lb-ft. (10-20 N-m)
10. Install the tire and wheel assembly and torque the wheel lug nuts to 450-500 lb-ft.
11. Lower the vehicle.

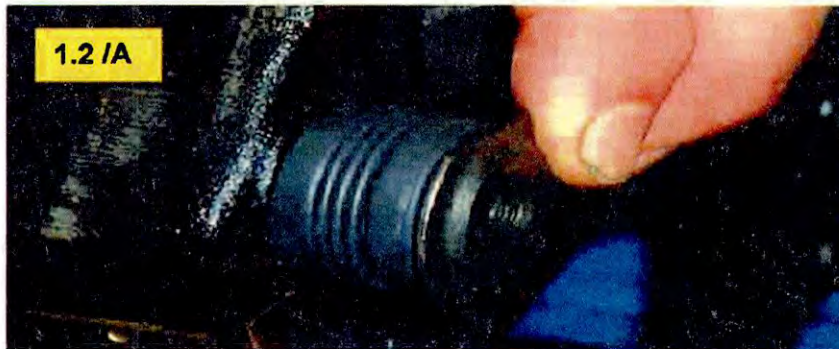
1. Inspect and lubricate the caliper slide pins with silicone brake grease.
2. When reusing the ZOH-T slide pin mounting bolt clean the threads and apply Loctite 2440 adhesive on bolt threads.
3. Align flat on upper (top) slide pin boss with the flat on the caliper housing upper (top) guide pin boss. Be careful when positioning caliper over disk brake pads, rotor and upper (top) guide pin to avoid tearing or dislodging piston boots or guide pin boots. (View Photo 1.2 /A)

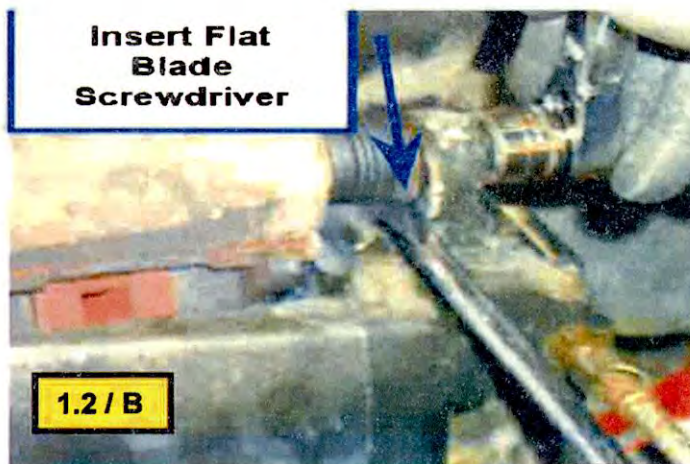
4. Install upper (top) mounting bolt "finger" tight.
5. Align the flat on the lower pin flange, and then carefully rotate the caliper closed and install lower mounting bolt "finger" tight. Utilize a flat blade screwdriver to retain the slide pin during the torque procedure. (Shown in photo 1.2 / B)

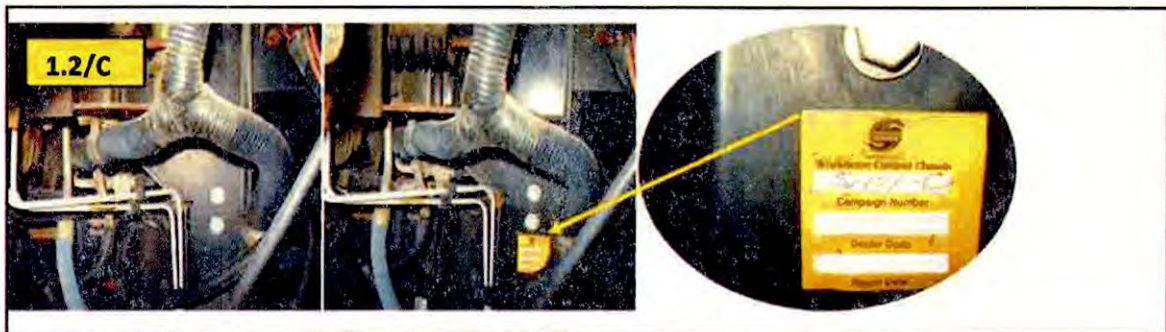
12. Complete the Recall Campaign Completion label and attach to the vehicle bulk head in a visible area near the chassis fuse box / Maxi Booster mounting bracket (Shown in photo 1.2/ C). One completion label (PN W8001493) will be shipped with every two caliper kits ordered.
