SAFETY RECALL BULLETIN

SUBJECT:		No:	SR-09-004
FUEL RETURN PIPE REPLACEMENT — SAFETY RECALL CAMPAIGN		DATE:	September, 2009
		MODEL:	See below
CIRCULATE TO:	<input type="checkbox"/> GENERAL MANAGER	<input checked="" type="checkbox"/> PARTS MANAGER	<input checked="" type="checkbox"/> TECHNICIAN
<input checked="" type="checkbox"/> SERVICE ADVISOR	<input checked="" type="checkbox"/> SERVICE MANAGER	<input checked="" type="checkbox"/> WARRANTY PROCESSOR	<input type="checkbox"/> SALES MANAGER

The manner in which the fuel return pipe is attached to the engine, in combination with frequent driving at certain engine revolutions, may cause vibration that if continued over time, may cause a stress crack, which could result in fuel leakage. This bulletin describes how to install a new fuel return pipe and additional securing hardware to prevent this condition.

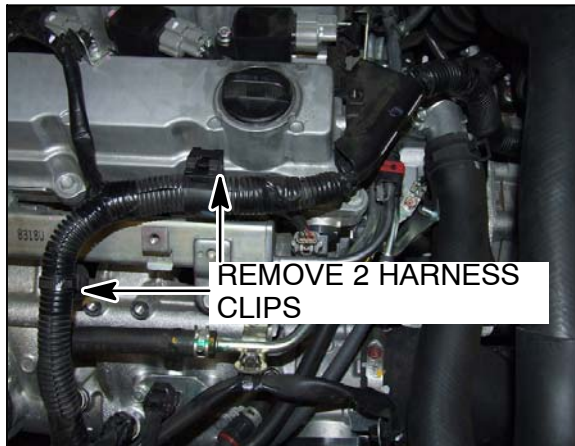
2. Remove the air intake hose by loosening the hose clamps.

After removing the hose, apply tape to cover the intercooler pipe and hose, to prevent entry of foreign material during this repair.

3. Remove the engine cover.

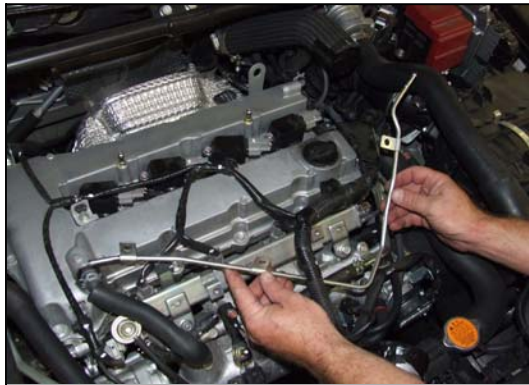
6. Loosen the hose clamps at both ends of the fuel return pipe and pull off the hoses. Then remove the three bolts securing the pipe and remove the pipe from the engine compartment.

Some fuel leakage may occur. Cover the pipe ends and hoses with a cloth.

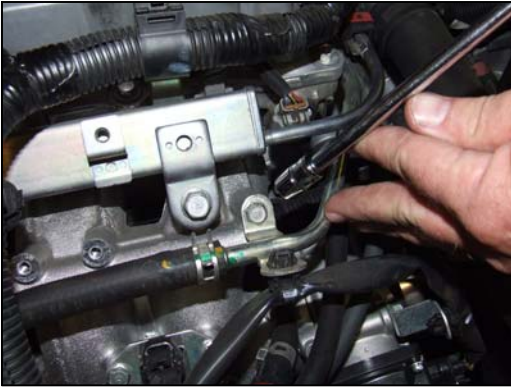
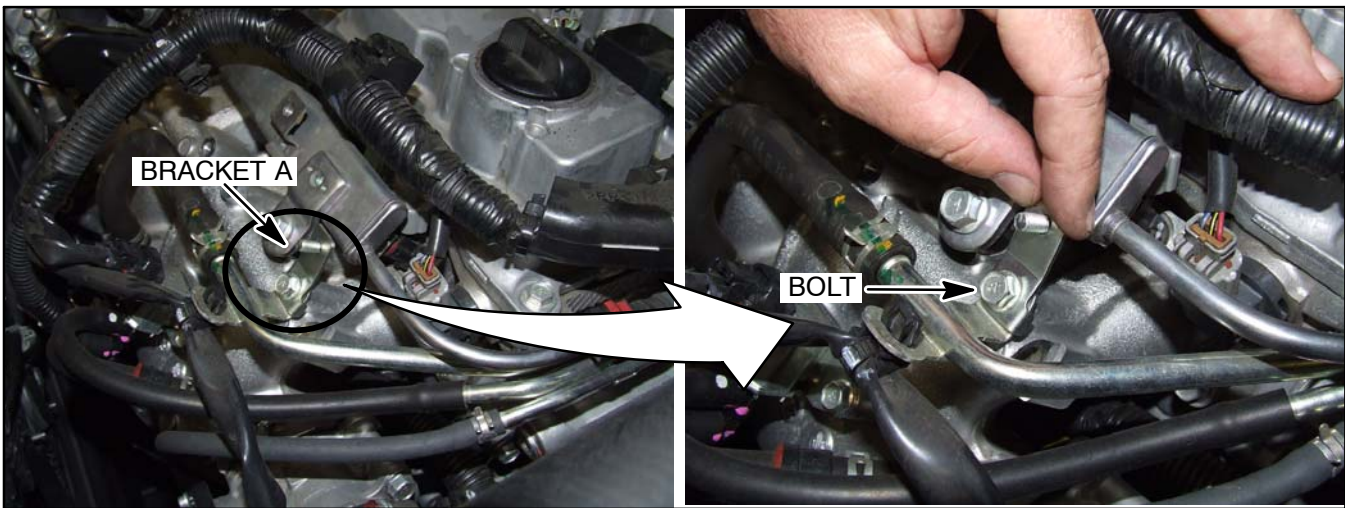
7. Remove the bolt for the vacuum pipe located in front of the engine. Retain this bolt.

Use this bolt to secure Bracket A (small bracket provided in the repair kit) in the same location. Do not torque the bolt yet (finger-tight only).

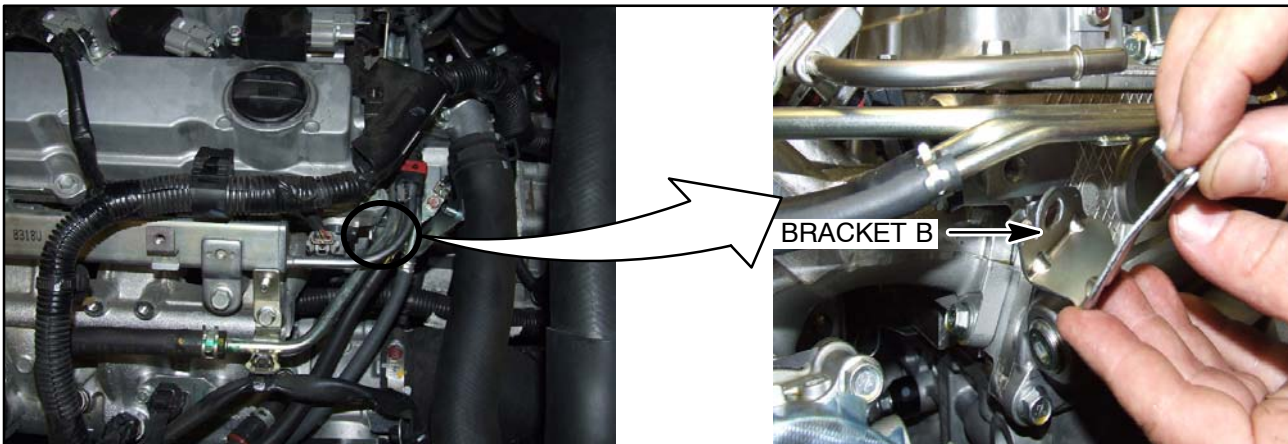
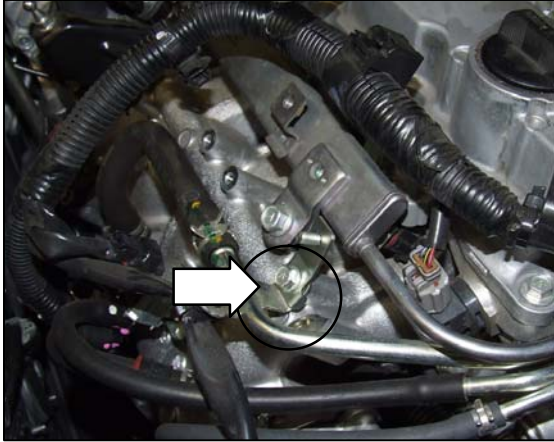
8. Remove the bolt for the vacuum pipe located at the LH side of the engine. Install Bracket B (large bracket provided in the repair kit) using the new 8X16 bolt provided in the repair kit. Tighten the bolt to $23.5 \text{ Nm} \pm 3.5 \text{ Nm}$ ($16.5 \pm 2.6 \text{ ft/lb.}$).

Be sure to use the new, longer bolt (size 8X16) provided in the kit for Bracket B (large bracket). Discard the old 8X14 bolt.

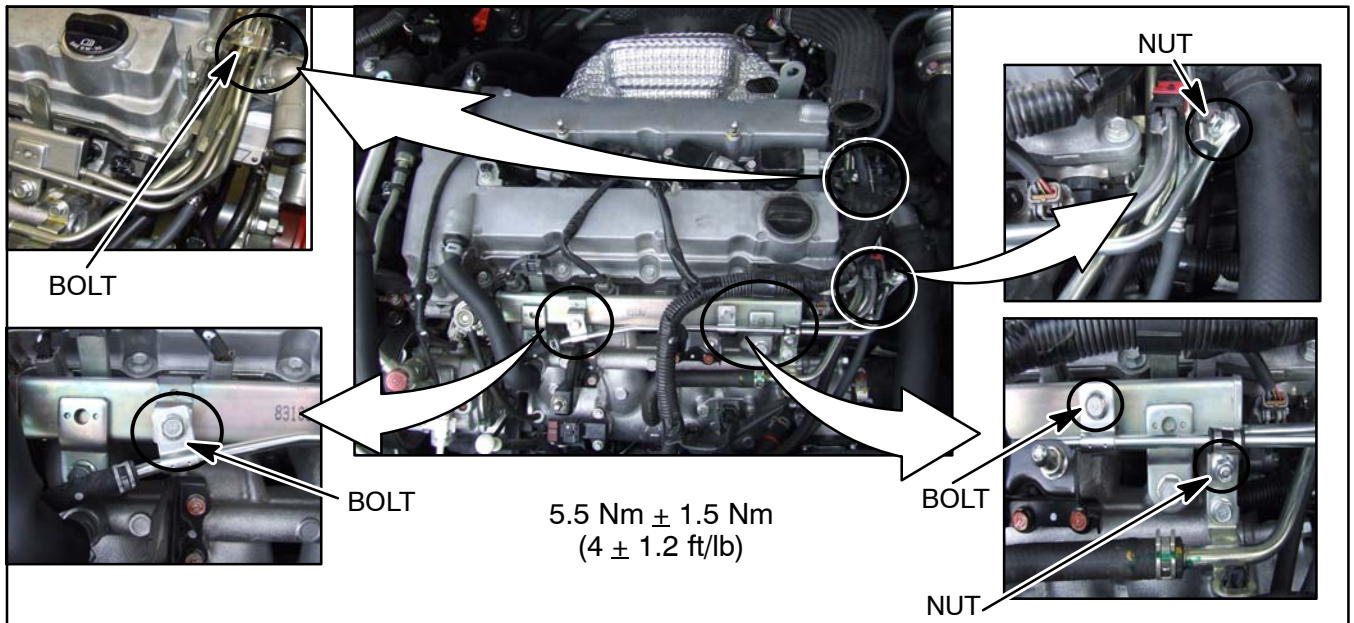
9. Torque the bolt securing Bracket A (small bracket) to $10 \text{ Nm} \pm 2 \text{ Nm}$ ($7.5 \pm 1.5 \text{ ft/lb}$ or $90 \pm 18 \text{ in/lb}$).

10. Install the new fuel return pipe provided in the kit. Secure it with 3 bolts and two nuts tightened to $5.5 \text{ Nm} \pm 1.5 \text{ Nm}$ ($4 \pm 1.2 \text{ ft/lb}$ or $48 \pm 14 \text{ in/lb}$).

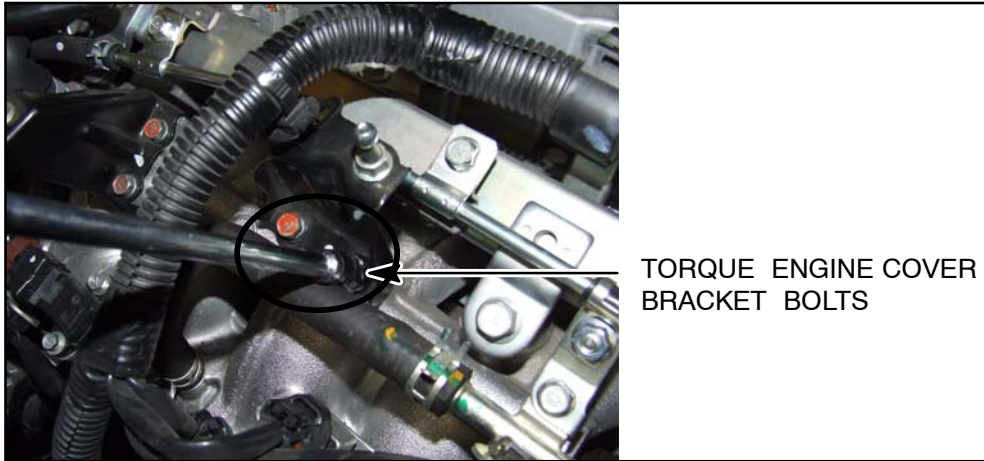
11. Connect the hoses to both ends of the new fuel return pipe. **DO NOT APPLY ANY LUBRICANT TO THE HOSES.** Reinstall the hose clamps.

Be sure the hoses are fully inserted onto the new fuel return pipe and the hose clamps are securely installed in the correct locations.

12. Torque the two bolts for the engine cover bracket to $8 \text{ Nm} \pm 2 \text{ Nm}$ ($6 \pm 1.5 \text{ ft/lb}$ or $72 \pm 18 \text{ in/lb}$).

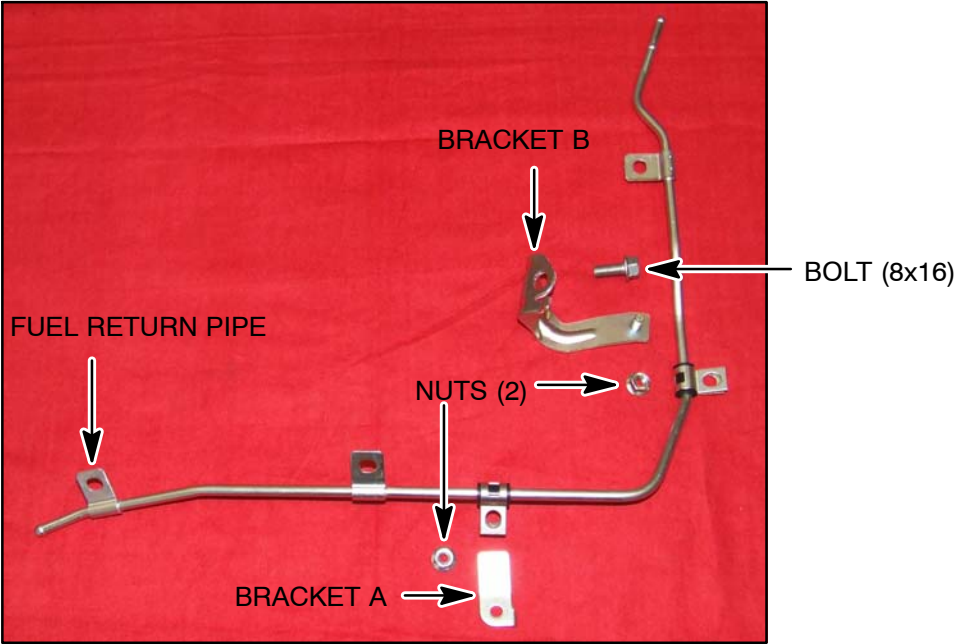
Description	Part Number
Fuel Return Pipe & Bracket Kit Kit contains 1 fuel return pipe, 2 brackets, 1 bolt, 2 flange nuts	MW400021
