RECALL CAMPAIGN BULLETIN

NTB09-086

VOLUNTARY SAFETY RECALL CAMPAIGN 2009 – 2010 ALTIMA AND MAXIMA FRONT STRUT MOUNTING INSULATOR

CAMPAIGN ID #: PC012

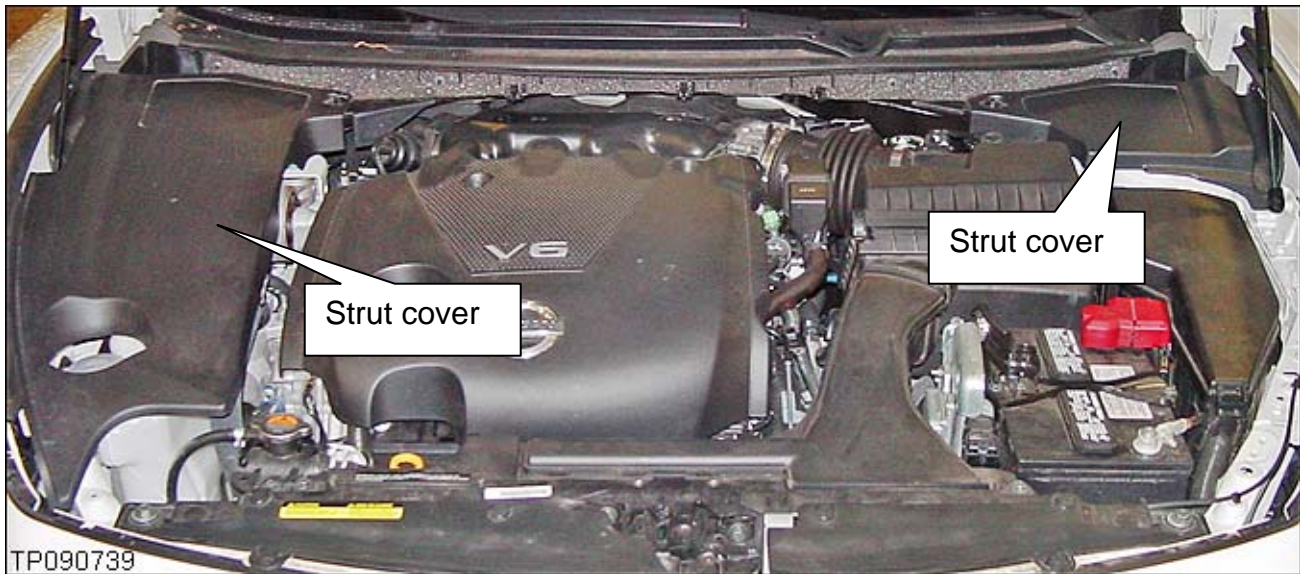
Figure 1

1. If equipped; remove the strut covers (see Figure 1).

- Driver side has 2 clips.
- Passenger side has one clip.

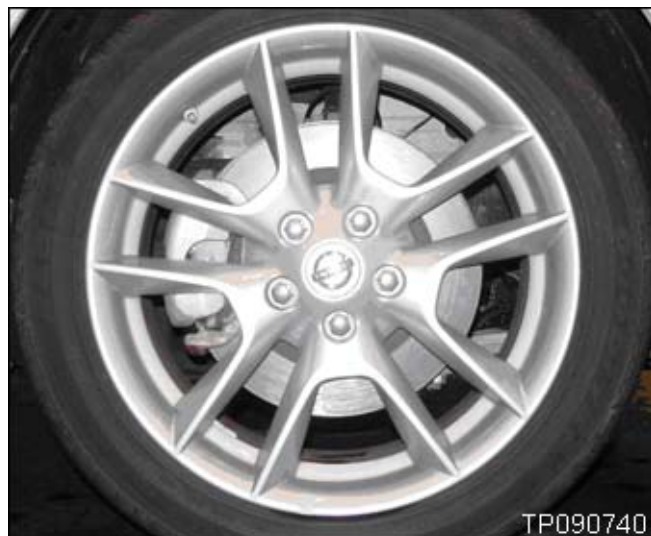
Figure 2

2. Remove the front wheels.

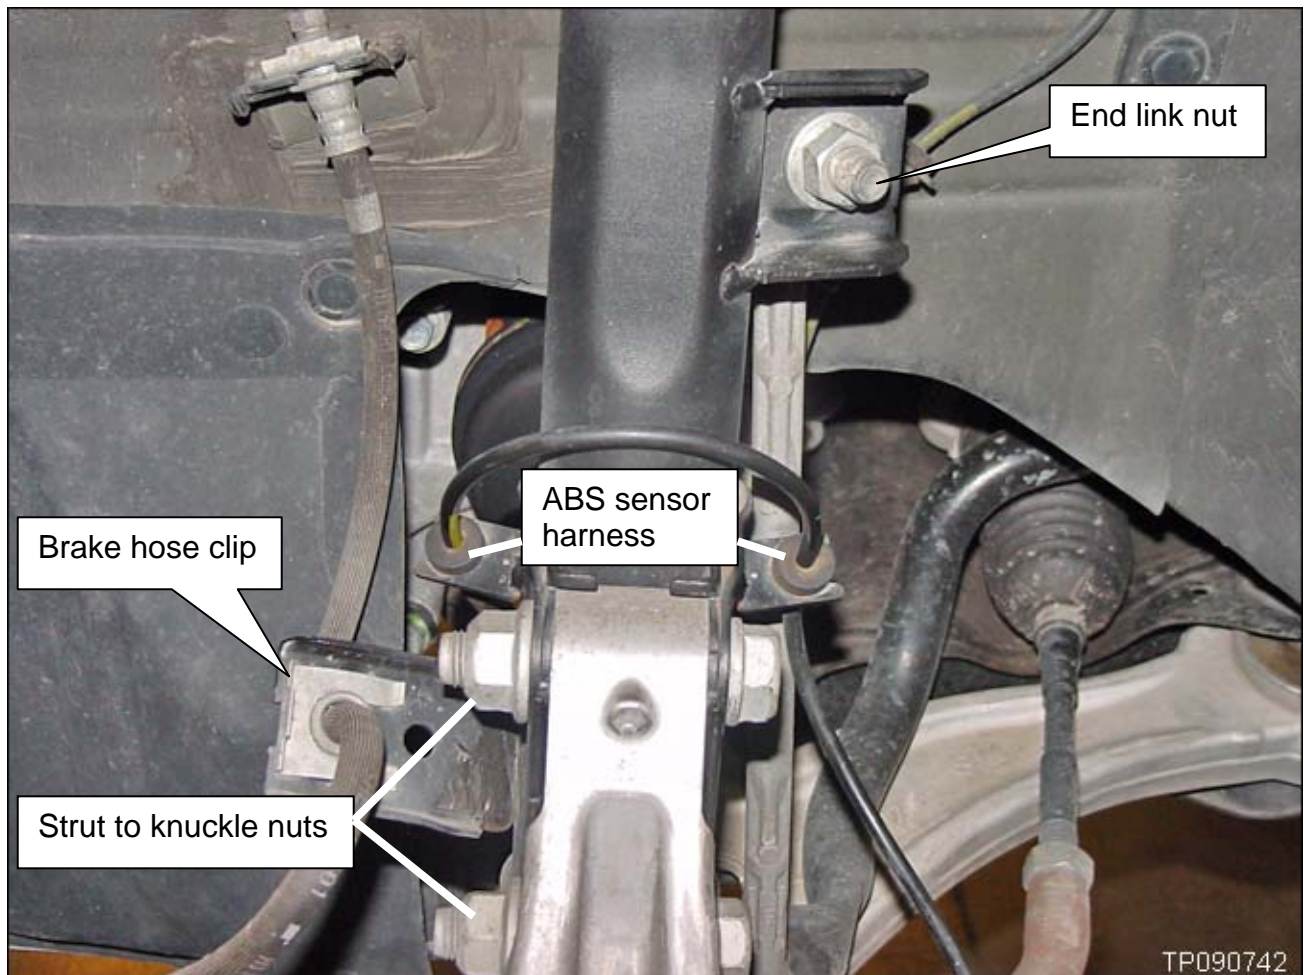
Figure 3

3. Remove the brake hose clip and brake hose from the strut bracket (see Figure 3).
4. Remove the ABS sensor harness from the strut brackets – 2 spots (see Figure 3).
5. Remove the sway bar end link nut (see Figure 3).
 - IMPORTANT: Hold the link with a wrench on the opposite side to prevent damage to the end link joint.
 - Keep the nut; it will be reused during reassembly.
6. Loosen—do not remove—both strut to knuckle nuts (see Figure 3).
 - IMPORTANT: Do not fully remove nuts at this time.

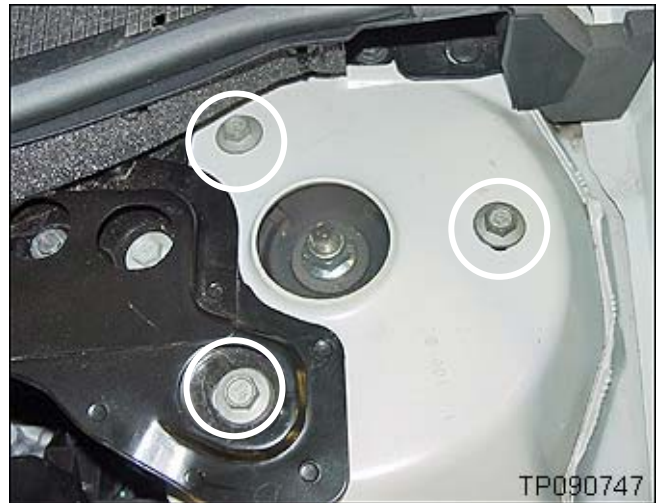
Figure 4

7. Remove the 3 upper strut mounting bolts.
 - Keep the bolts; they will be reused during reassembly.

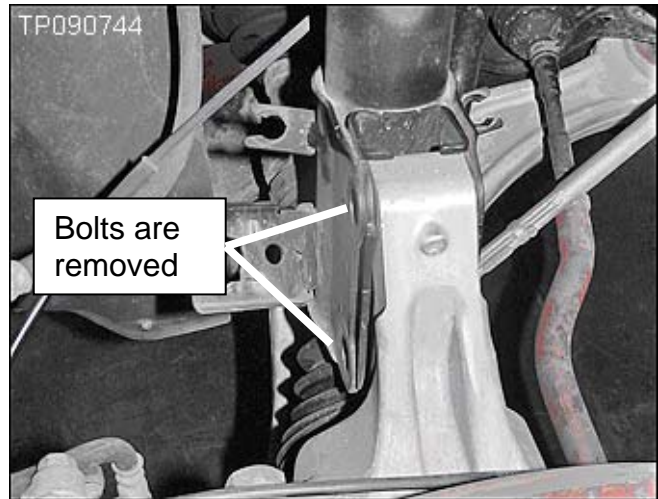
Figure 5

8. Remove the strut to knuckle nuts & bolts.
 - Discard the nuts; new nuts will be used during reassembly.

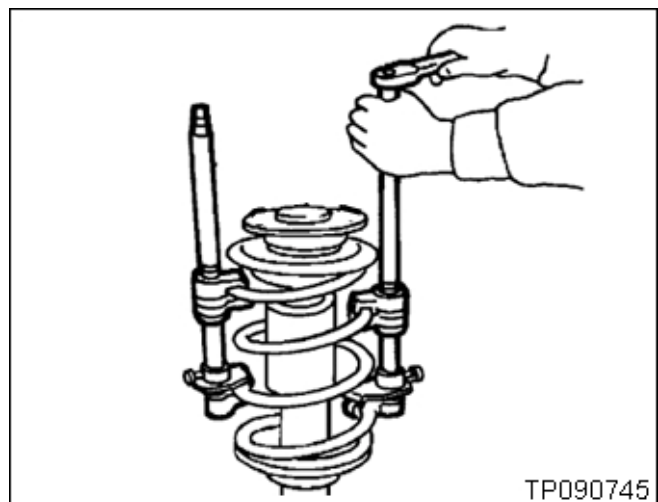
Figure 6

11. Use a suitable spring compressor to compress the strut spring.

WARNING: Make sure the spring compressor is securely connected / hooked to the spring.

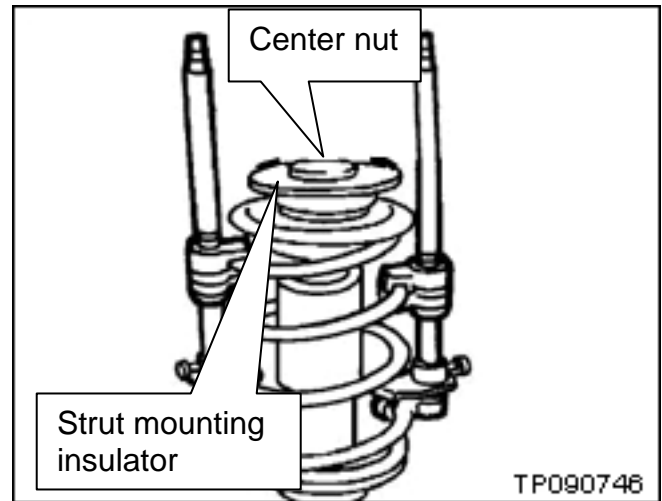
Figure 7

12. Remove the center nut at the top of the strut.

- Discard the nut, a new nut will be used for reassembly.

13. Remove the strut mounting insulator.

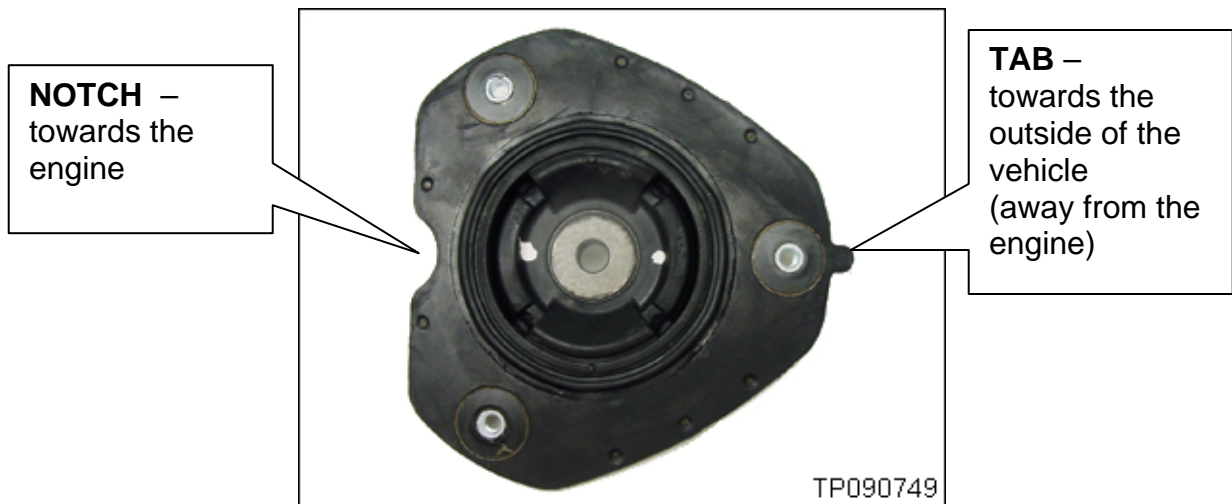
Figure 8

14. Install the new strut mounting insulator.

- The new insulator has 2 white dots in the center (see Figure 8).
- Make sure the insulator is positioned correctly, as shown in Figure 8.

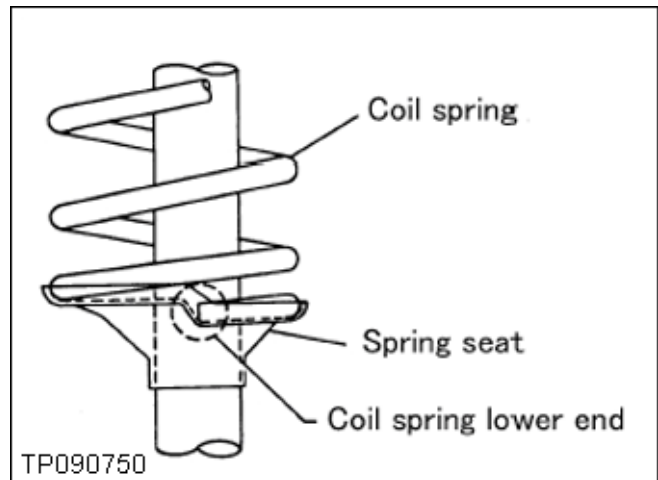
Figure 9

17. Make sure the lower end of the spring coil is correctly and firmly seated in the spring seat as shown in Figure 9.

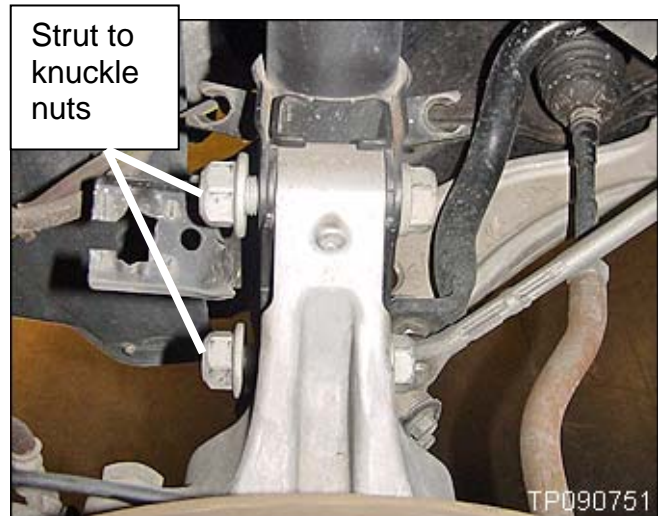
Figure 10

18. Install the strut assembly into the vehicle.

- Use **new** nuts on the strut to knuckle bolts.
- Install loosely—do not tighten—at this time.

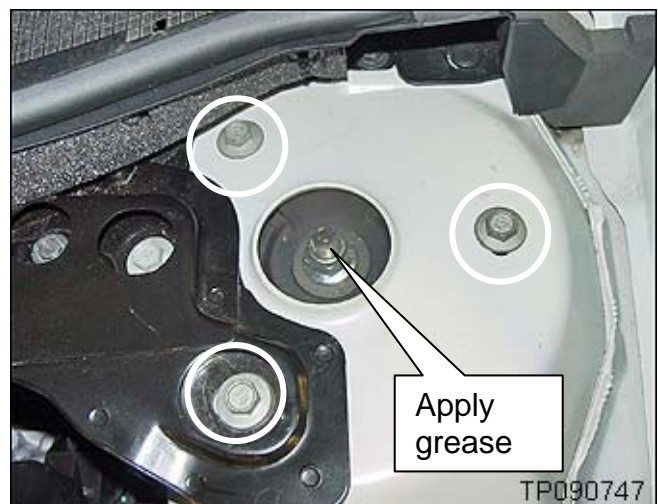
Figure 11

19. Install the 3 top strut mounting bolts.

- Torque bolts to $35.3 \text{ N}\cdot\text{m}$ (3.6 kg-m, **26 ft-lb**).
- Apply a small amount of multi-purpose grease to the threads on the strut center shaft.

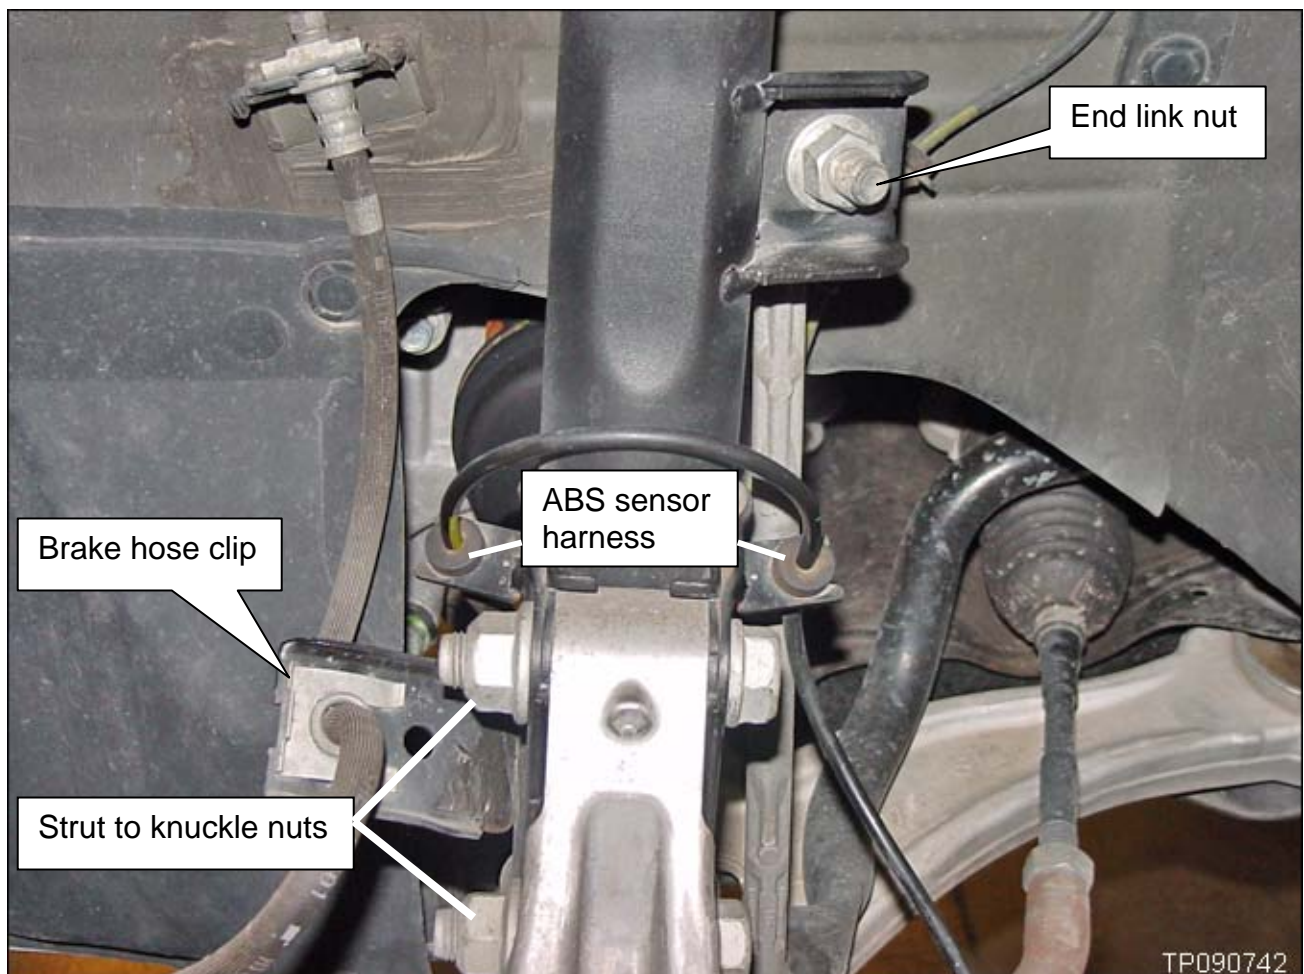
Figure 12

20. Torque the strut to knuckle nuts (see Figure 12).

- Torque bolts to 139.6 N·m (14.2 kg-m, **103 ft-lb**).

21. Install the sway bar end link nut (see Figure 12).

- Torque nut to 78.6 N·m (8.0 kg-m, **58 ft-lb**).
- **IMPORTANT:** Hold the link with a wrench on the opposite side to prevent damage to the end link joint.

22. Install the ABS sensor harness into the strut brackets – 2 spots (see Figure 12).

23. Install the brake hose and clip into strut bracket (see Figure 12).
