TOYOTA

Subject: Safety Recall – 90L
Certain 2007 – 2010 Model Year Camry & 22, 2009 Model Year Camry Hybrid Vehicles
Potential Floor Mat Interference with Accelerator Pedal
Phase 2 – Vehicles Equipped with Accelerator Pedals manufactured by CTS Corporation

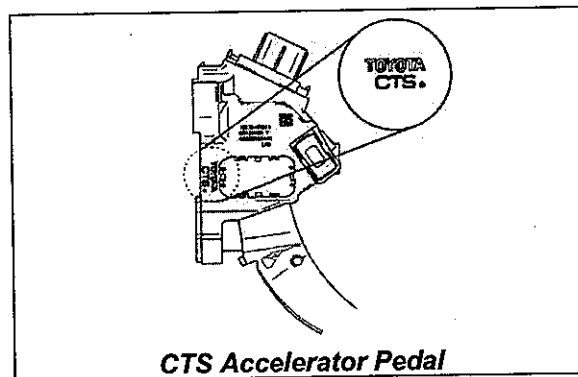
- **The name of the pedal manufacturer is embossed (CTS) on the upper sensor housing on the brake pedal side.**
- **The majority of 2007 – 2010 model year Camry vehicles equipped with CTS accelerator pedals are also involved in Safety Recall A0A (Accelerator Pedal Reinforcement Bar Installation). Please verify TIS for vehicle applicability of both campaigns.**
