# TOYOTA CUSTOMER SERVICES

Volume: XVI  
Number: TC10-007  
Date: 02/11/2010  
X Action  
X Retain  
\_\_\_ Information

Subject: Safety Recall – 90L  
Certain 2007 – 2010 Model Year Camry Vehicles  
Potential Floor Mat Interference with Accelerator Pedal  
**Phase 2** – Vehicles Equipped with Accelerator Pedals Manufactured by CTS Corporation

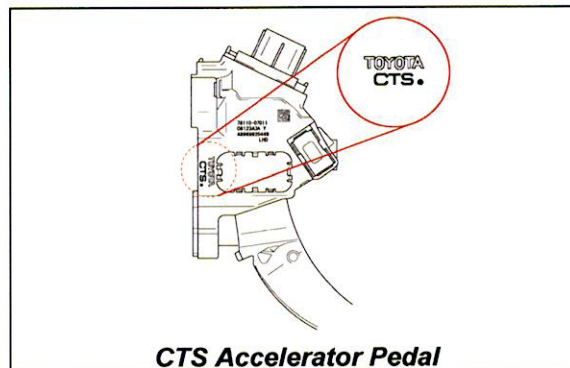
- **The name of the pedal manufacturer is embossed (CTS) on the upper sensor housing on the brake pedal side.**
- **The majority of 2007 – 2010 model year Camry vehicles equipped with CTS accelerator pedals are also involved in Safety Recall A0A (Accelerator Pedal Reinforcement Bar Installation). Please verify TIS for vehicle applicability of both campaigns.**

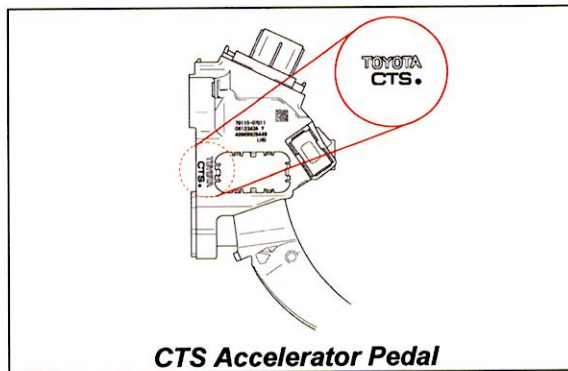
- ***The name of the pedal manufacturer is embossed (CTS) on the upper sensor housing on the brake pedal side.***
- ***The majority of 2007 – 2010 model year Camry vehicles equipped with CTS accelerator pedals are also involved in Safety Recall A0A (Accelerator Pedal Reinforcement Bar Installation). Please verify TIS for vehicle applicability of both campaigns.***
