Recall Campaign 09V-474: Inspect Tire Information Placard

Cooper and Cooper S (R56)

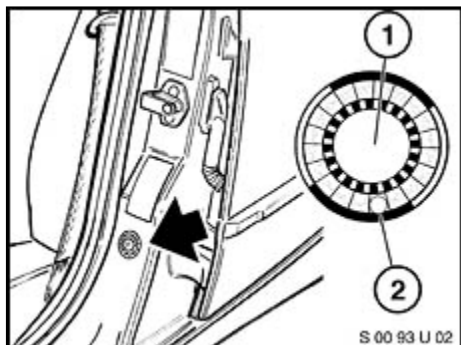
LABEL INSTRUCTIONS

This Recall Campaign has been assigned code number **45**. After the vehicle has been checked and/or corrected, obtain a label (MD 20-040) and:

- A. Emboss your MINI dealer warranty number in the middle of the label (1);
- B. Punch out code number **45** (2), printed on the label; and
- C. Affix the label to the **B**-pillar as shown.

If the vehicle already has a label from a previous Service Action/Recall Campaign, affix the new label next to the old one. Do not affix one label on top of another one, because a number from an underlying label could appear in the punched-out hole of the new label.
