TO: ALL U.S. RETAILERS
RE: FUEL PUMP RECALL 220

<h1 style="margin: 0;">VOLVO</h1> <h2 style="margin: 0;">Service Manager Bulletin</h2>				TITLE:		GROUP: 23	NO: 220A
				Recall 220: Fuel Pump Inspect & Replace if Necessary 2001-2005 S80, 2001-2004 S60, V70, V70XC/XC70, 2003-2005 XC90		ISSUING DEPARTMENT: Warranty	
REFERENCE BULLETINS: RTJ 22721 PB 23-220A		CARMARKET: United States					
		SERVICE PERSONNEL: read and initial.		DATE:		YEAR	MONTH
SERVICE MANAGER	SERVICE WRITER			WARRANTY ADMINISTRATOR	2010	07	28
Page 1 of 4

Title Recall 220 Fuel pump inspection/replacement**Ref No** US22721.1.4 en-US**Issuer** -**Partner** 3 US 7510 Volvo Cars North America**Func Group** 2331 **Func Desc** fuel pump; feed pump**Status** Released**Status Date** 2010-12-06**Issue Date** 2010-12-02**Reference** VIDA**Attachment**

Volvo Car Customer Service		
		Instruction
		TJ No.22721
		Reference VIDA Special Tool Bulletin 178
Title	Fuel pump, check/replacement	Page 1 of 21
Model	S60 / S80 (-06) / V70 (00-08) / V70 XC (01-)/XC70 (-07), engine B5254T2/T4, B5234T3, B5244T3, B5244S, B6284T, B6294T, B6294S/S2	
Model Year	2001-2005

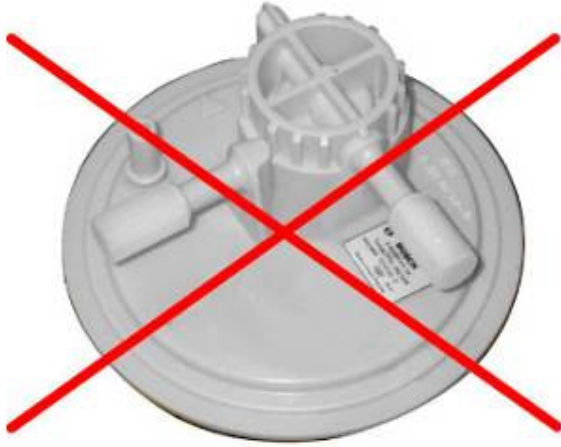
5.

The pump flange is **white** with a smooth surface (except for the connections).

Note! This pump is defective and must be replaced.

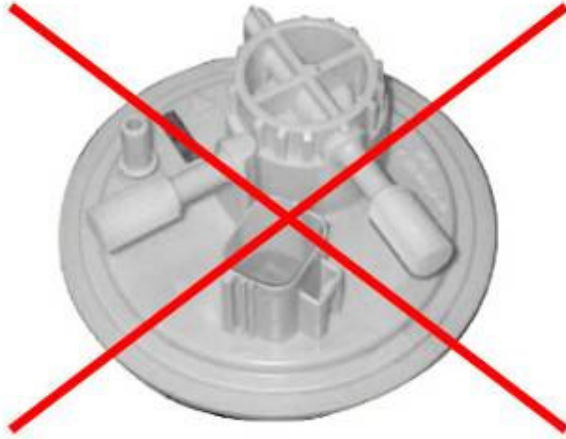
6.

The pump flange is **white**

Note! This pump is defective and must be replaced.

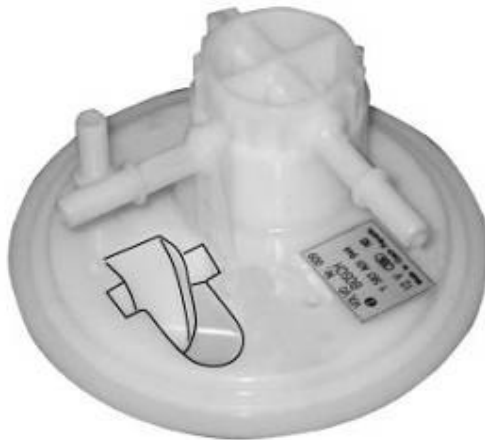
7.

The pump flange is **white** with a cavity cast in the flange.

Note! This pump is correct.

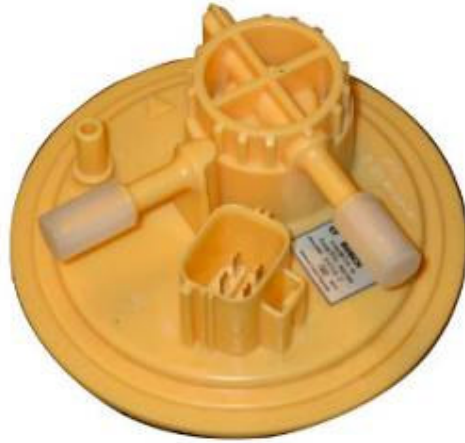
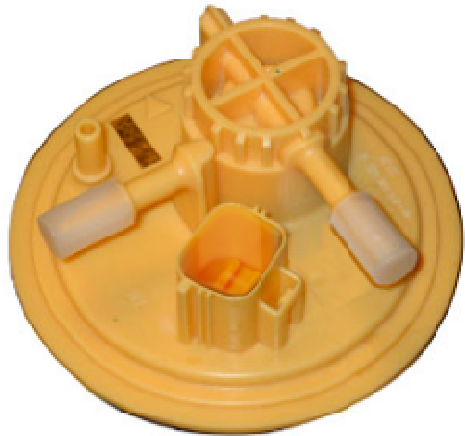
8.

The pump flange is **yellow**.

Note! This pump is correct.

Note!
All fuel pumps with yellow flange are correct. The yellow flanged pump may come with or without electrical connector pins.
