BLUE BIRD

R09PB

# Battery Cable Routing **RECALL**

**MODELS AFFECTED:** 2007-2008 BBCV with Caterpillar C7 Engines

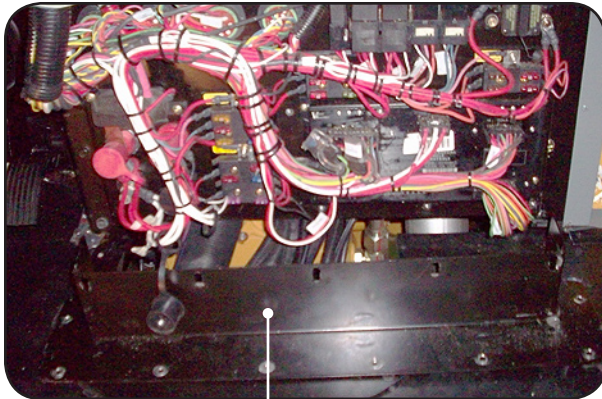
Lower cover panel

6.2 Remove the fasteners securing the lower cover panel to the PDU.

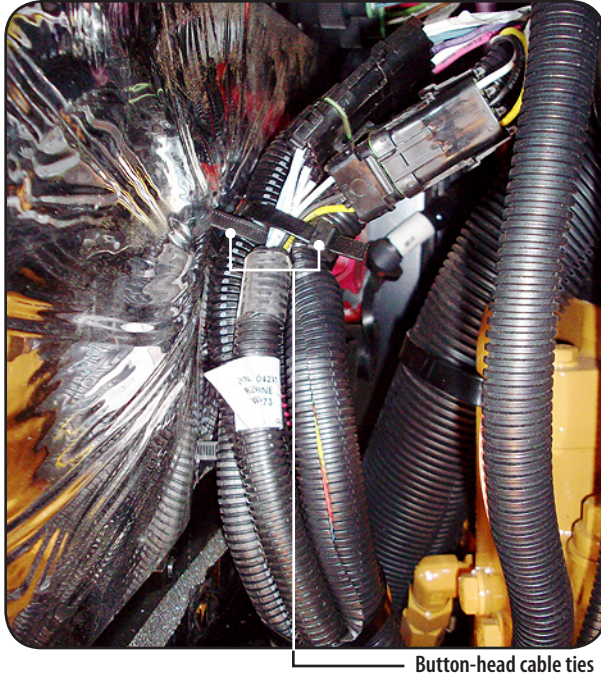
7.2 Locate the two button-head cable ties which secure battery cables to the PDU. If either of the button-head cable ties are broken, missing, or damaged during the removal of the PDU, install new button-head cable ties (0024706) before reinstalling the PDU.

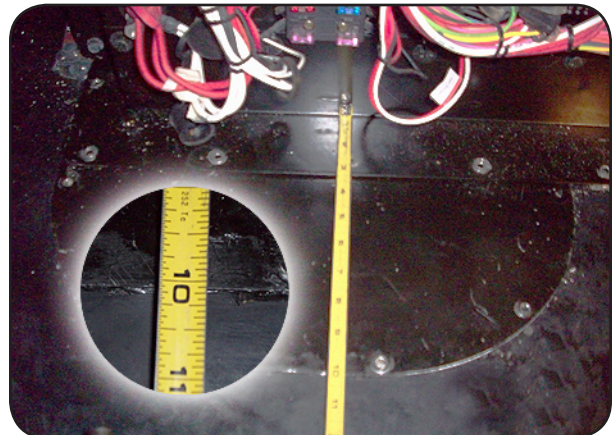
- 8.1 Remove the fasteners for the transmission cover plate.
- 8.2 Slide the transmission cover plate rearward approximately ½".
- 8.3 Install the lower cover panel between the Power Distribution Unit and the transmission plate with the existing fasteners.
- 8.4 Slide the transmission cover plate rearward until the rear of the transmission cover plate is 10" from the vertical surface of the lower panel.

- 8.5 Using a .218" drill bit with a drill stop set at 1 ¼", using the transmission plate as a guide, drill new attaching holes for the transmission cover plate. Reinstall the transmission cover plate in the new location, using the original fasteners.
