## ***Great Dane Trailers***

09V-199

RE: Haldex Quick Release Valve N50009A

### Quick Release Valve Replacement Instructions

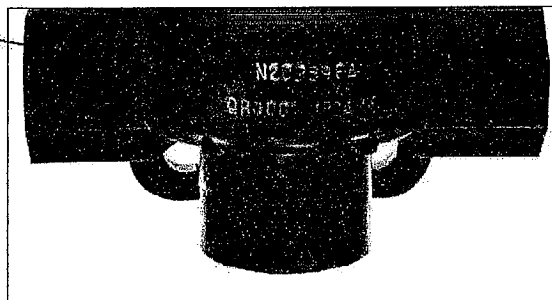
The Date Code on the  
Haldex QRV Valve shown  
here indicates:

Gregorian Date -183 (July 1st)

Shift - A (First Shift)

Year - 8 (2008)

Location - K (Iola, Kansas)

The specification used by Haldex to identify Quick Release Valves defines a six (6) character alpha numeric date code. The first three (3) digits indicate the Gregorian Calendar day of the year. The fourth alpha character indicates the production shift. The fifth digit indicates the last number of the year of manufacture. The last alpha character indicates the manufacturing location.

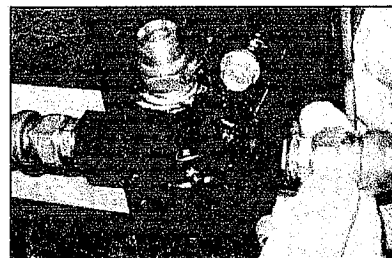
Fig. 6 shows a hose being connected.

Install the vehicle air hoses onto the valve. Use wrenches on both the fitting and the hose to make certain that fitting torques into the QRV remain in the range of 75 to 200 in-lbs.
