**Regarding: 09V-002**

# Technical BULLETIN

## RECALL

### 2006~2008 and Certain 2009 FJR1300A/AE FACTORY MODIFICATION CAMPAIGN – Main Switch

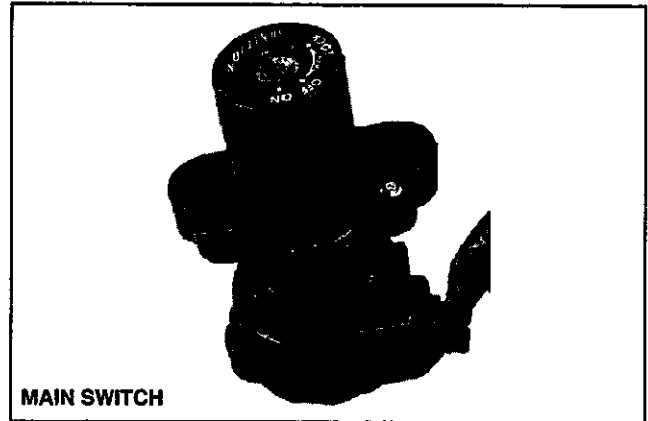
MAIN SWITCH

Yamaha Motor Corporation, U.S.A. has decided that a defect which relates to motor vehicle safety exists in all 2006 through 2008 and certain 2009 FJR1300A and AE model motorcycles. The main ignition switch's wire connection could overheat due to electrical resistance, becoming hot enough to melt the solder connecting the wire to the main switch. The wire could come off the switch if the solder melts, preventing the electrical system from functioning. If this occurs while the motorcycle is being ridden, the engine would stall and be impossible to restart which could result in an accident with injury or death.

To correct this defect, Yamaha is initiating a Factory Modification Campaign. Affected motorcycles must have the main switch replaced with a new one designed to prevent overheating.

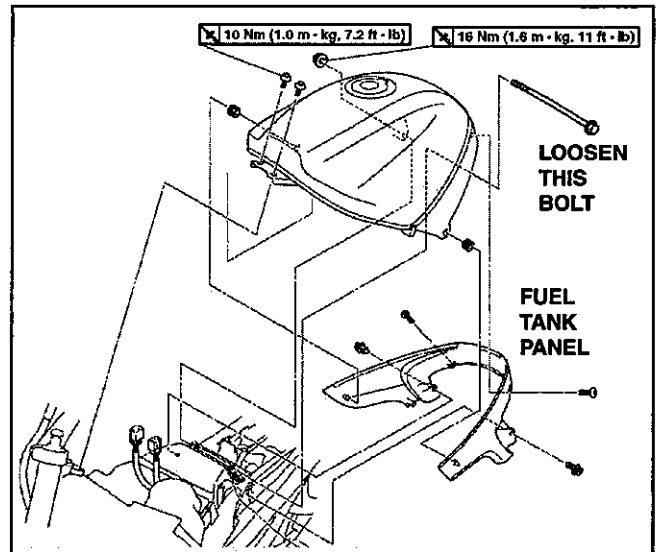
2. Remove the fuel tank panel. Remove the two bolts holding the front of the tank. Loosen (do not remove) the long bolt holding the rear of the tank. Lift and support the front of the tank as it pivots on the rear mount.

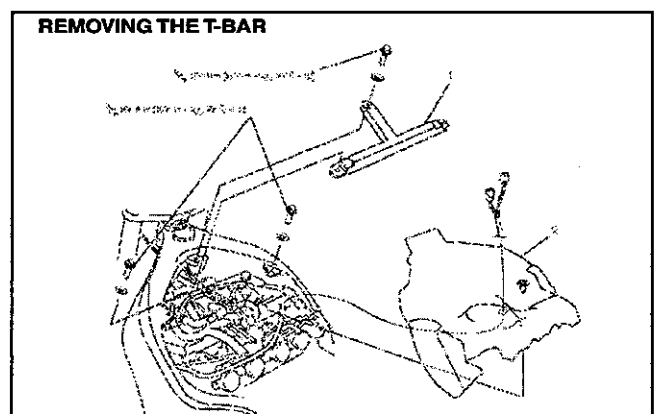
3. Remove the center support (T-bar) and pull back the heat protector to access the connectors. Disconnect the red and white connectors.

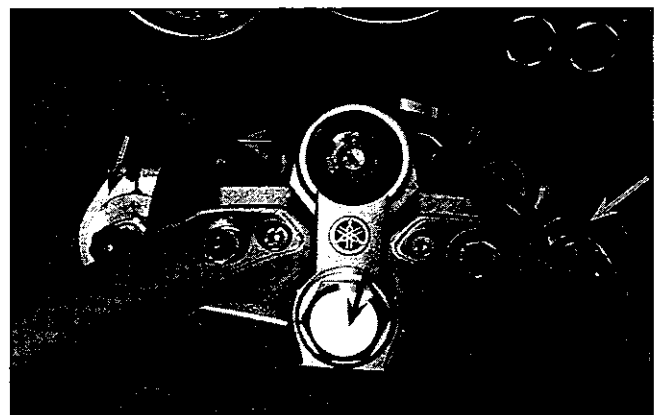
5. Remove the upper triple clamp nut and loosen the two fork clamp bolts (see adjacent photo).
6. The handlebar has three adjustment positions. Mark handlebar position on the upper triple clamp with erasable marker so the handlebars can be returned to their same position for the customer. Remove the handlebars and hang them carefully along side the cowling, supported by the cables and hoses, with padding to avoid damage.

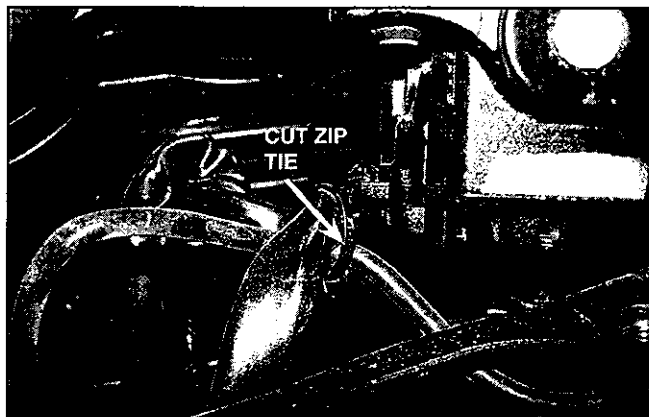
7. Cut the zip tie holding the main-switch harness, then remove the upper triple clamp and main switch assembly from the motorcycle.

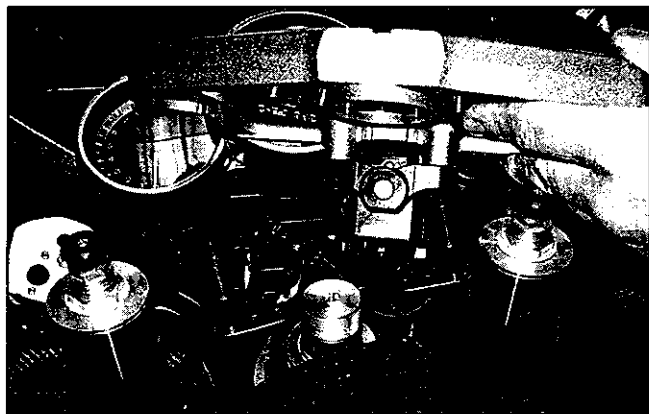
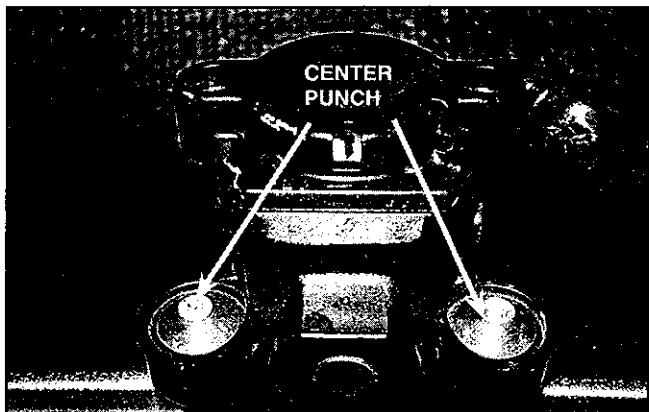
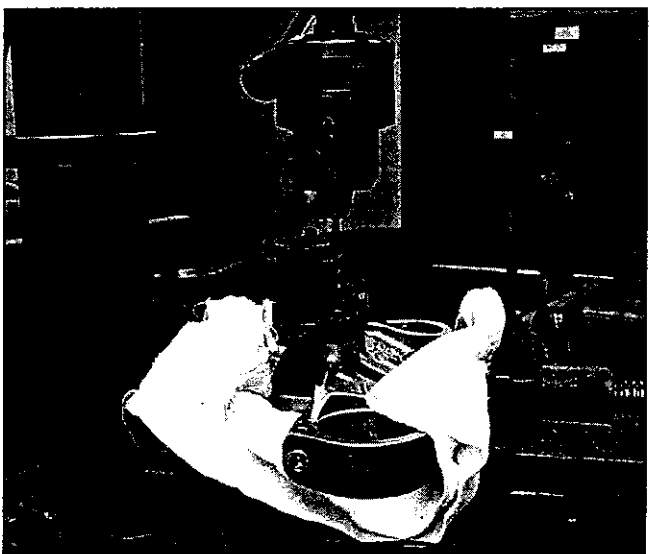
8. Place a punch mark as accurately as possible in the center of each bolt. An automatic-type punch works best.
9. Place the upper triple clamp upside down in a proper drill press vice, using extreme caution not to damage it. Use sturdy padding to avoid scratching.
10. Starting with an 1/8" drill bit, drill each bolt, dead center, slightly deeper than the switch base (approx. 1/2" to 3/4" deep).
11. Repeat step 10 using a 1/4" drill bit.
12. Repeat step 10 again using a 3/8" drill bit. Only drill deep enough to pop the head off the bolt.

If the bolt head does not come off, the hole may not have been centered properly. Repeat the drilling again with a one-size-larger drill bit which should remove the head.

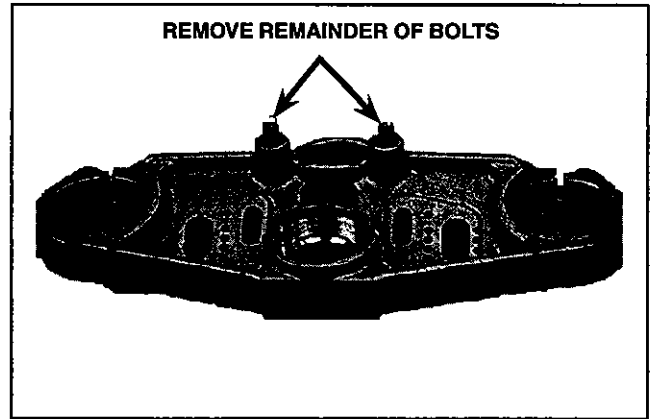
13. Remove the upper triple clamp from the drill press vise. Using locking pliers (such as Vise-Grips®), remove the remainder of the bolts from the holes. Set the upper triple clamp aside.

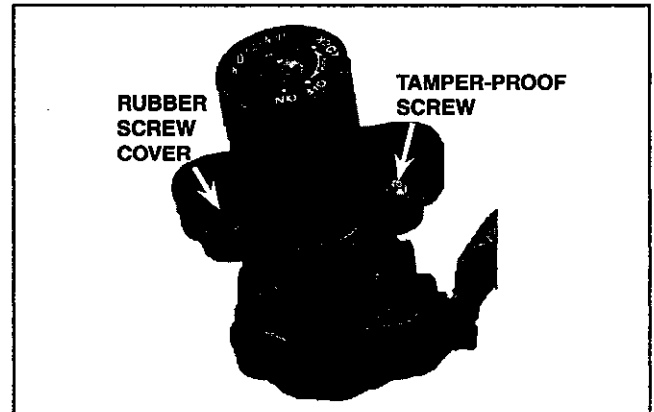
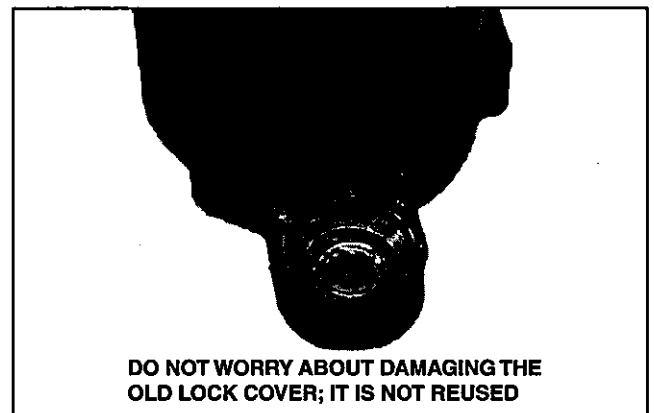
14. Remove the rubber screw covers from the lock cover on the old main switch. Use a 3/8" drill bit to drill out the two tamper-proof screw heads holding the lock cover to the main switch. The lock cover, which will not be reused, acts as a guide for drilling the screws.
15. Remove the lock cover from the new main switch by unscrewing the two tamper-proof screws. Remove the key cylinder assembly and spring from the new main switch. Only the cover will be reused.

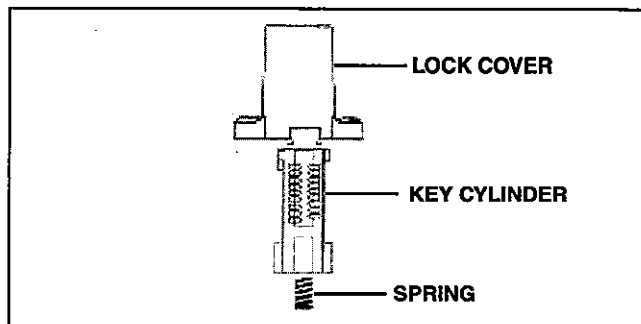
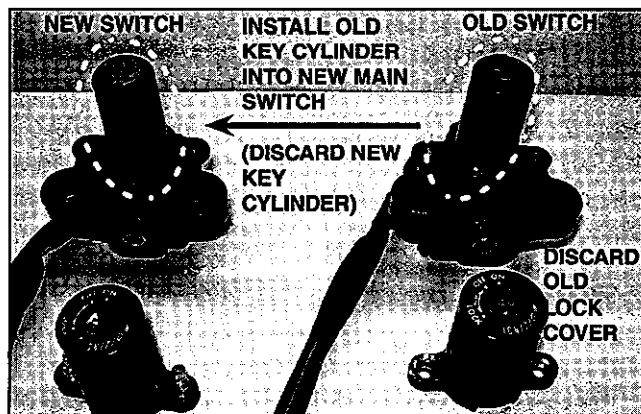
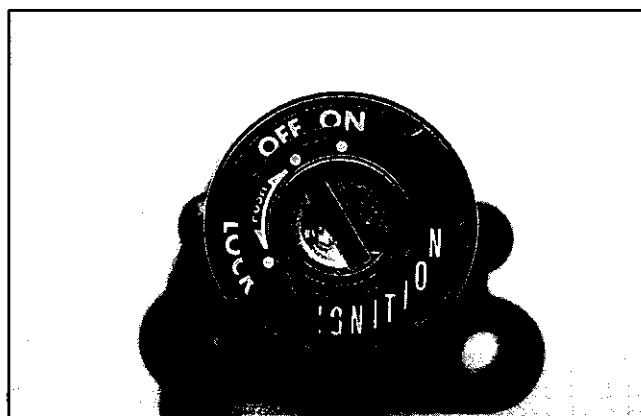
16. Carefully remove the key cylinder assembly and spring from the old lock cover and install them in the new main switch cover in the same position as it was in the old switch.

17. Install the new lock assembly cover over the old key cylinder and spring on the new main switch. Temporarily finger-tighten the new tamper-proof screws.

18. Check the new main switch for proper mechanical operation, using the original key from the old main switch. Make sure the key operates smoothly in all positions. If not, remove the spring and cylinder and reinstall correctly.

19. Tighten the tamper-proof screws until they break off just above the screw heads. The screws are designed to break when the proper tightening torque is reached.

20. Install the new rubber covers over the tamper-proof screws.

21. Remove the "red circled" protective cover from the top of the main switch. The new main switch is now ready to be installed on the upper triple clamp.

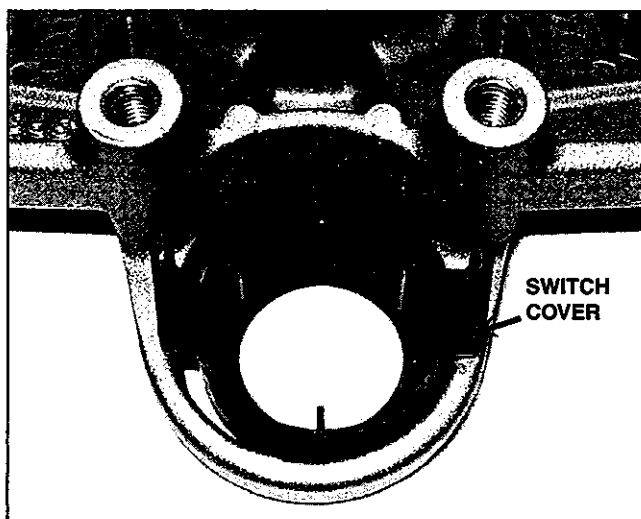
22. Be sure the plastic main switch cover is still installed properly in the upper triple clamp.

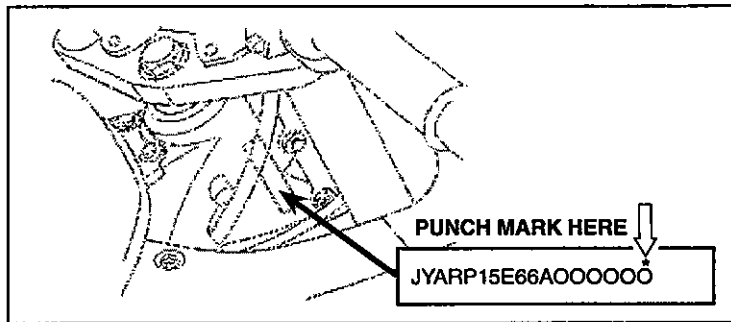
When the modification is complete, put a punch mark next to the Primary ID as shown. Check for this punch mark if you encounter an unfamiliar unit. You can also check unit status on YDS or by contacting your Regional Technical Advisor.
