**TRANSICOLD**

## **K410 Identification Method**

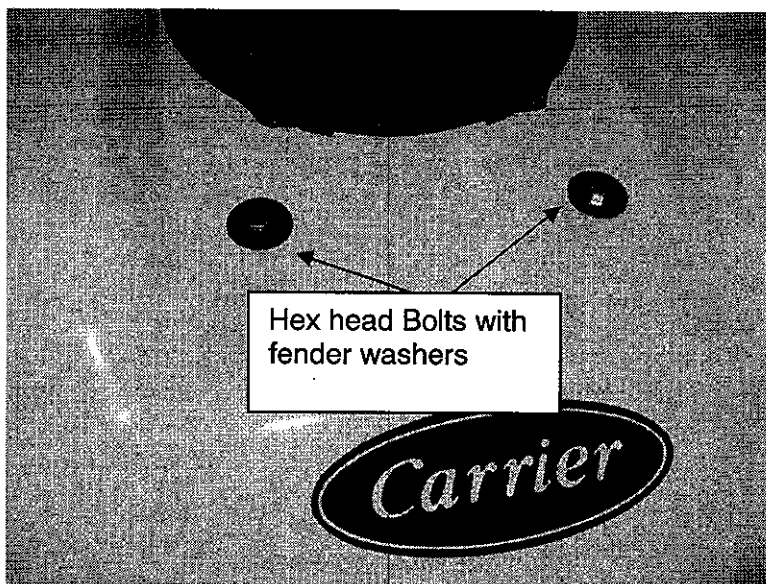
In order to check if your K410 rooftop condenser needs to be updated please look at the unit, if the cover is secured by Hex head bolts with fender washers (2 in the front and 4 in the back). Reference the Fig 1 below. If this is the case, then your unit was already retrofitted and **no further action is needed**.

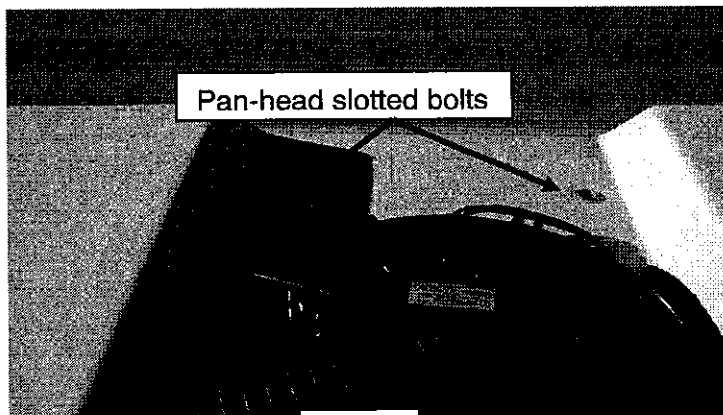
Fig 2

If the cover of your K410 is secured by Pan-head slotted bolts (fig 2), then it will need to have a, PN# 74-62047-00, retrofit kit installed by a Carrier authorized dealer or at your shop. Please call 1-800-450-2211 to have the retrofit kit(s) send. Carrier will pay all costs to have this kit installed on your unit(s). Please have the serial number(s) of the units(s) ready for our records.

Carrier recommends that until the K410 is modified, that the cover be removed and the high pressure switch is disconnected. (**Warning ! Do not operate the air conditioning on the bus without the K410 cover secured on the unit**). The cover should be stored in a safe place until retrofit kit can be properly installed and the cover replaced.

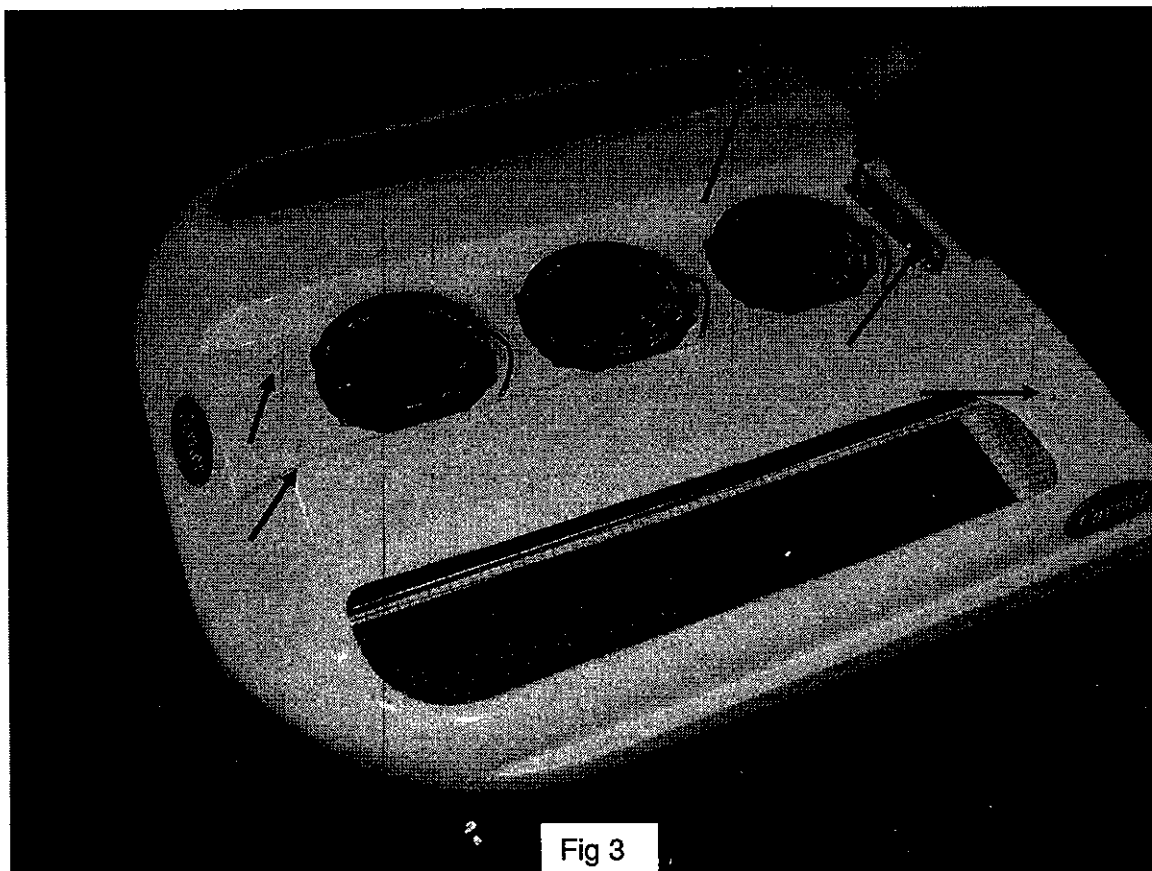
Fig 3

Remove 6 bolts, locations as seen in fig 3, lift cover and unplug 3 fan connectors, remove cover and store in a safe place until retrofit kit can be installed.
