WORKHORSE CUSTOM CHASSIS SERVICE BULLETIN

BULLETIN NO: 51101-C

SUBJECT: Replacement of Bosch Service Brake Calipers

MODELS: All 2001 through 2011 Model Year W20, W21, W22, and W22D Motor Home Chassis Equipped with Bosch Brake Calipers

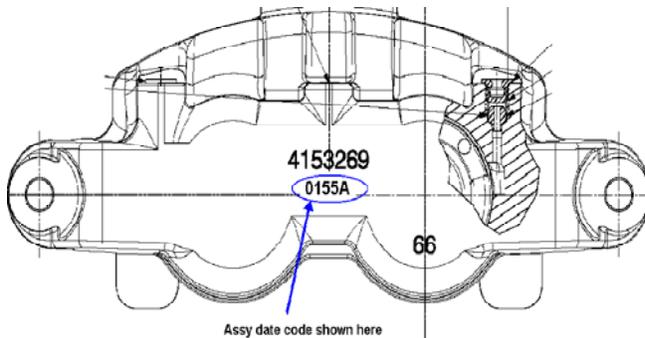
Part Number W8006753 (Caliper Kit)

Remedy Bosch Brake Caliper Identification

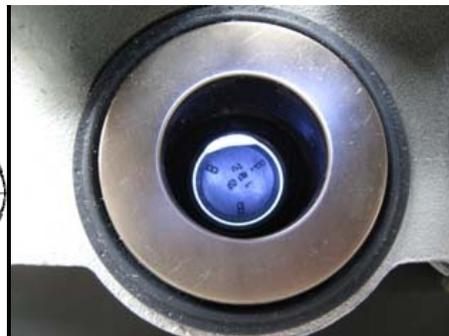
The first date code was 0155A.

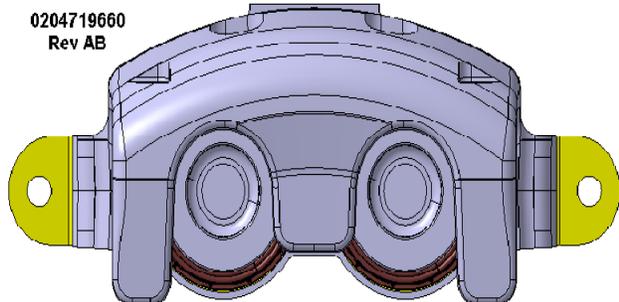
0204719660
Rev AB

Caliper machined areas shown in yellow are not plated.

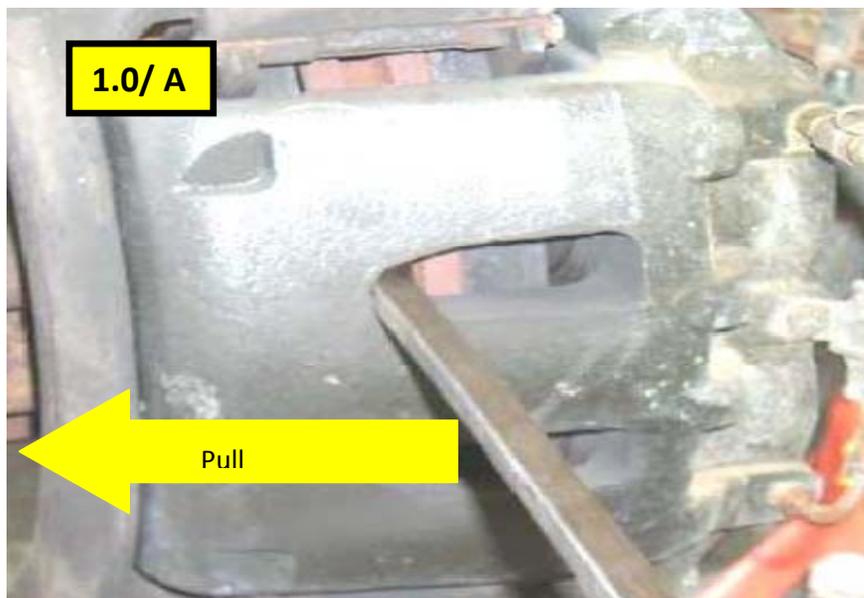
1. Remove two thirds of brake fluid from master cylinder.
2. Raise the vehicle, Refer to *Lifting and Jacking the Vehicle* in General Information in the service manual.
3. Support the vehicle with safety stands.
4. Mark relationship of the wheel to hub.
5. Remove the tire and wheel assembly, Refer to *Tire and Wheel Removal and Installation* in the service manual.
6. Compress caliper pistons using a disc brake caliper pad spreader, caliper dual piston compressor tool, c-clamp, pry bar, or other similar equipment. Compress until the pistons bottoms in the bore. (Shown in photo 1.0 / A)

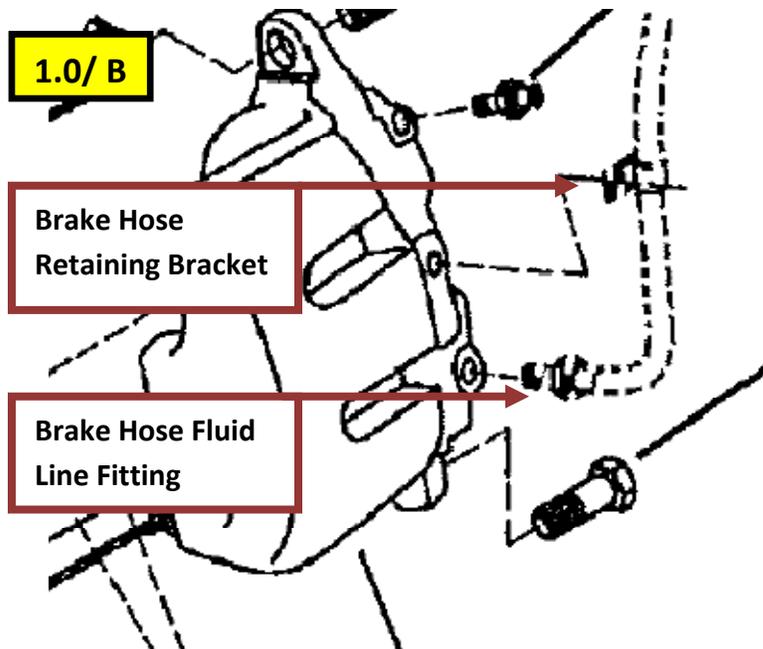
7. Remove the tool used to compress the caliper pistons.
8. Remove the brake hose retaining bracket fastener from the caliper. (View Illustration 1.0/ B)

9. Disconnect brake hose fluid line fitting from caliper and cap off to prevent brake fluid leakage or contamination in the line. Do not allow the brake line hose to become pinched or kinked during the remedy procedure. (View Illustration 1.0/ B)
10. Remove the upper (top) caliper mounting bolt securing the caliper to the upper guide pin. (Shown in Photo 1.0/ C)
11. Remove the lower (bottom) caliper mounting bolt securing the caliper to the lower guide pin.

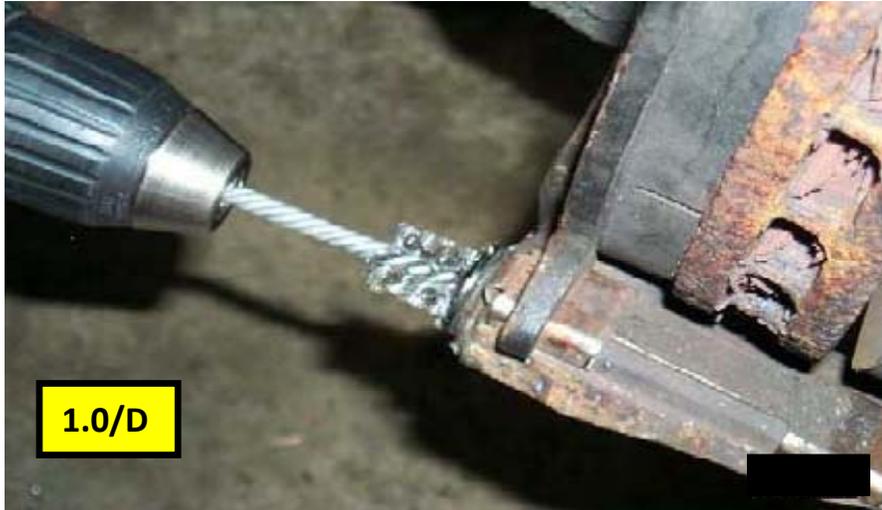
14. Clean the machined surface of the anchor plate with wire brush. (See photo 1.0/D)
15. Clean and lubricate the anchor plate bores with silicone brake grease.

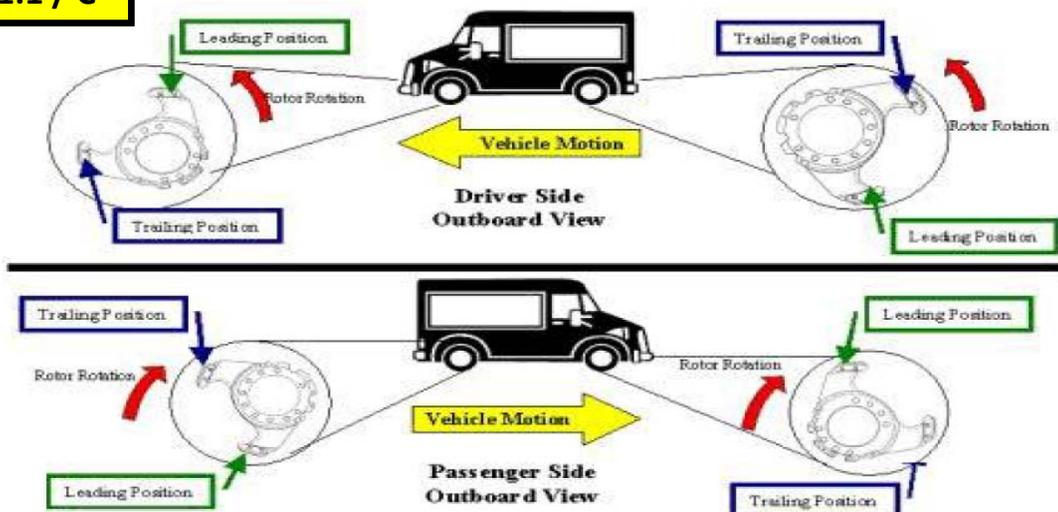
1.1 / C

IMPORTANT: The ZOH-T leading bolt must be tightened first during the assembly process after both leading and trailing bolts are installed finger tight.

Identifying Slide Pin Leading and Trailing Positions

6. Torque the ZOH-T mounting bolts as follows:
 - a. Torque leading bolt to 93-107 lb-ft (126-145 N-m)
 - b. Torque trailing bolt to 93-107 lb-ft (126-145 N-m)
 - c. See Leading and Trailing bolt position illustration (1.1 / C)
7. Connect the brake hose fitting to the fluid inlet port on the caliper and torque to 14-17 lb-ft (20-24 N-m). (See illustration 1.0 / B)
8. Reconnect the brake hose retaining bracket to the caliper using the original bolt removed. (See illustration 1.0 / B)
9. Bleed brake system torque bleeder screw to 8-15 lb-ft. (10-20 N-m)
10. Install the tire and wheel assembly and torque the wheel lug nuts to 450-500 lb-ft.
11. Lower the vehicle.

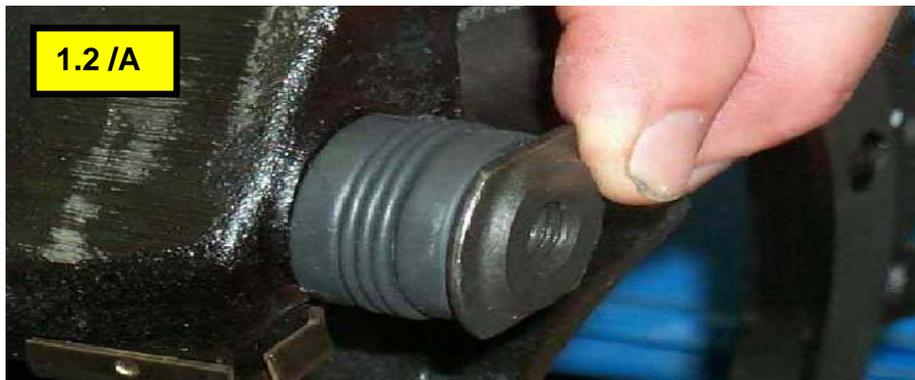
1. Inspect and lubricate the caliper slide pins with silicone brake grease.
2. When reusing the ZOH-T slide pin mounting bolt clean the threads and apply Loctite 2440 adhesive on bolt threads.
3. Align flat on upper (top) slide pin boss with the flat on the caliper housing upper (top) guide pin boss. Be careful when positioning caliper over disk brake pads, rotor and upper (top) guide pin to avoid tearing or dislodging piston boots or guide pin boots. (View Photo 1.2 / A)

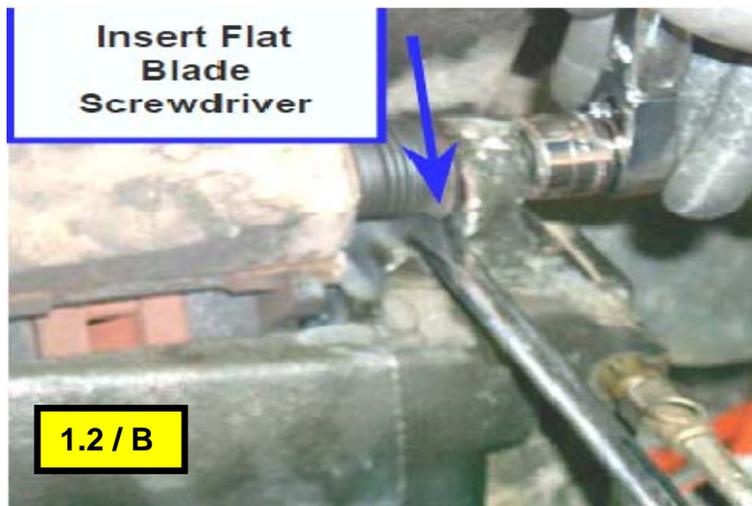
4. Install upper (top) mounting bolt "finger" tight.
5. Align the flat on the lower pin flange, and then carefully rotate the caliper closed and install lower mounting bolt "finger" tight. Utilize a flat blade screwdriver to retain the slide pin during the torque procedure. (Shown in photo 1.2 / B)

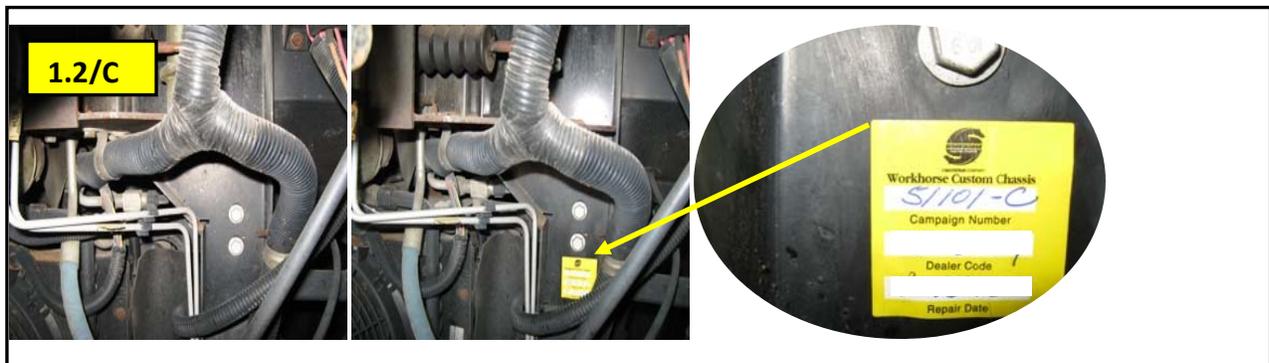
12. Complete the Recall Campaign Completion label and attach to the vehicle bulk head in a visible area near the chassis fuse box / Maxi Booster mounting bracket (Shown in photo 1.2/ C). One completion label (PN W8001493) will be shipped with every two caliper kits ordered.
