HYUNDAI Technical Service Bulletin

Group CAMPAIGN	
		Number 09-01-022-2	
Subject XD ELANTRA, GK TIBURON - FRONT LOWER CONTROL ARM AND FRONT SUBFRAME CORROSION TREATMENT (CAMPAIGN 091)		Date NOVEMBER, 2009	
		Model ELANTRA (XD); TIBURON (GK)	
CIRCULATE TO:	<input type="checkbox"/> GENERAL MANAGER	<input checked="" type="checkbox"/> PARTS MANAGER	<input checked="" type="checkbox"/> TECHNICIAN
<input checked="" type="checkbox"/> SERVICE ADVISOR	<input checked="" type="checkbox"/> SERVICE MANAGER	<input checked="" type="checkbox"/> WARRANTY MGR	<input type="checkbox"/> SALES MANAGER

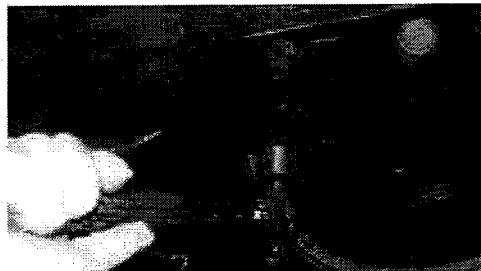
2. Lightly strike the right and left front lower control arms thoroughly with a hammer.

CAUTION: Be careful, **DO NOT** strike the front lower control arms too hard to prevent deformation damage.

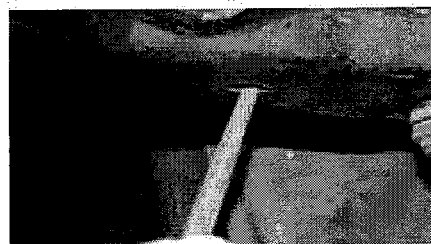
8. With a file, remove burrs around the holes. Totally remove remnants of rust around the holes.

CAUTION: If the burrs are not fully removed, it may prevent the thickness gauge from being inserted over the edge of the drilled holes.

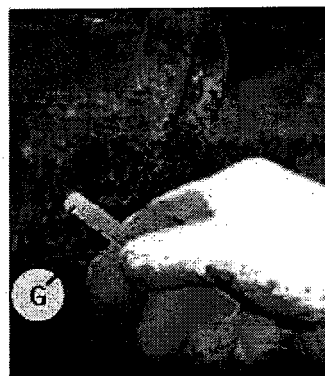
9. Inspect the thickness of the front lower control arm lower panels with the 1.5mm groove of the thickness gauge (G). Check the thickness of the front lower control arms at as many points around the hole as possible.

10. If either the right or left front lower control arm metal fits into the thickness gauge or is inserted into the groove, replace both right and left assemblies. If the front lower control arm metal does not fit into the 1.5mm thickness gauge, go to the procedure **FRONT LOWER CONTROL ARM WAX APPLICATION FOR CORROSION PREVENTION**.
