ABS Rear Valve Harness **Recall Work Instructions**

Recall # 09V-127

Models Affected: All Allegro Buses built on a PowerGlide chassis from May 1, 2007 through April 14, 2009.

ABS REAR VALVE HARNESS REWORK INSTRUCTIONS

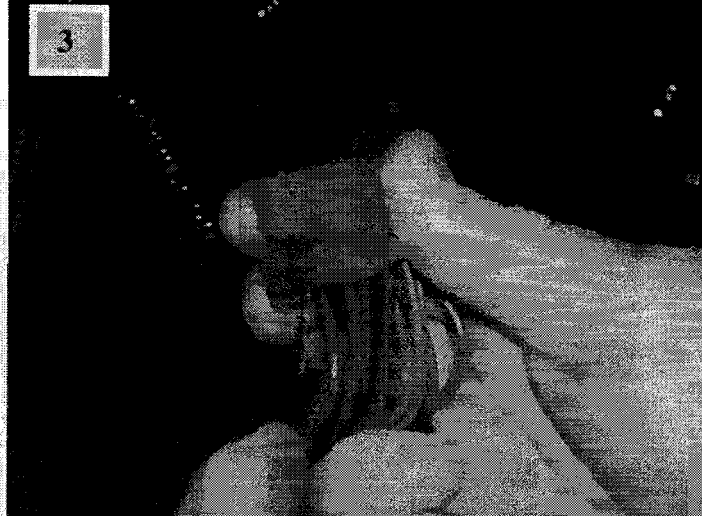
Figures 3,4, & 5.

Begin by removing plug's terminal lock as shown in Figure 3.

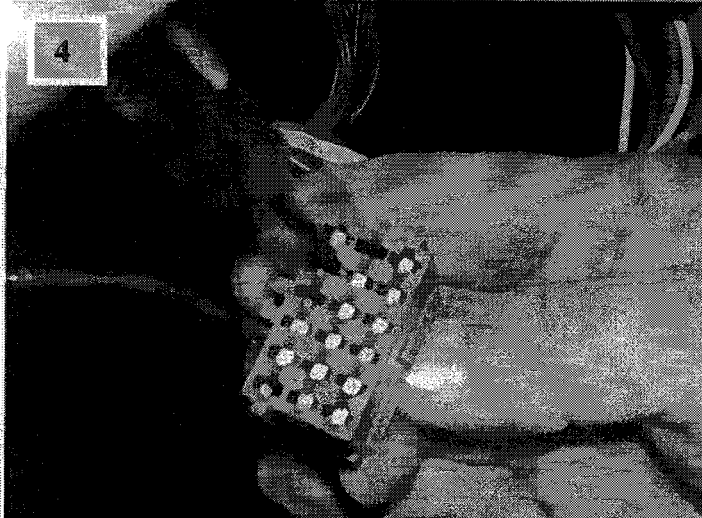
Next, insert terminal extraction tool into both upper and lower cavities simultaneously, on the plug for desired circuit. Figure 4 shows the upper cavity of load 5 on the plug being penetrated by removal tool. (Note circuit/terminal at load 2 has already been removed.)

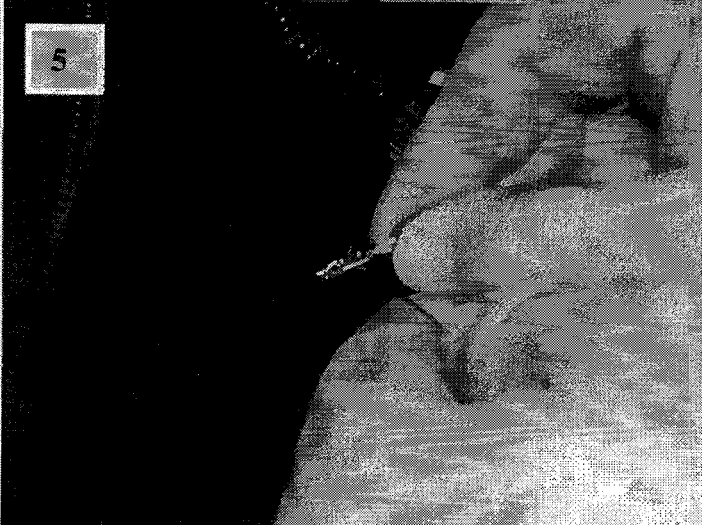
In Figure 5 you can see the terminals locking 'ears' that will need to be compressed by the tool in order to unload the terminal. Also, these ears will need to be reset (as shown in picture) so terminal will properly insert back into plug at its new load position.

The net result needed will be for the circuits loaded into 2 and 5 to be removed and reinserted into loads 8 and 9. At the same time, the circuits loaded in 8 and 9 will be removed and reloaded into plug loads 2 and 5. Net result is to swap the loads for the two pairs of circuits.

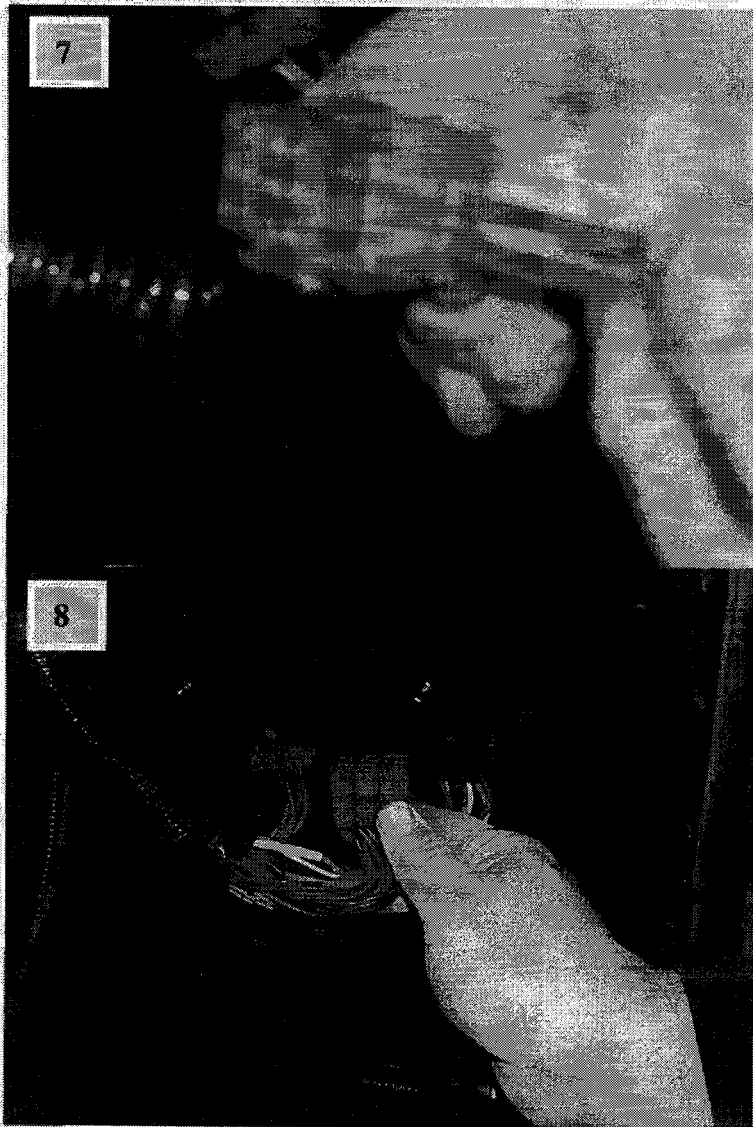
Figure 7.

Once circuits have been reloaded into plug, insert terminal lock back into plug.

Note, lock will not fully insert into plug if terminals are not properly and completely inserted into plug cavities.

Figure 8.

Complete procedure by plugging back into ABS module. Insure plug is properly seated and locked into place.
