Service Bulletin

From: Kalman Takacs, Field Service Engineer
Subject: First Cross Member of Trailer Inspection
Date: 04/14/2009
SBN: SB-09-04-01
Affected: 60BRT and 65 BRT buses built before September 30th, 2007

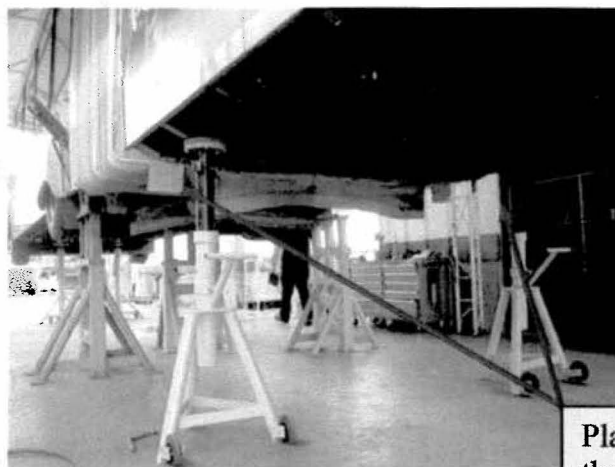
Place jack stands underneath the 2nd cross member of the trailer (rear coach)

- Turn off the battery main switch(es).
- Properly position bus on wheel lifts or over a pit.
 - a. If wheel lifts are used, place four jack stands underneath the colored jacking pads of the front coach and two at the rear coach behind the C-axle.
 - b. Two more jack stands are necessary underneath the second cross member of the trailer (rear coach), (see below).

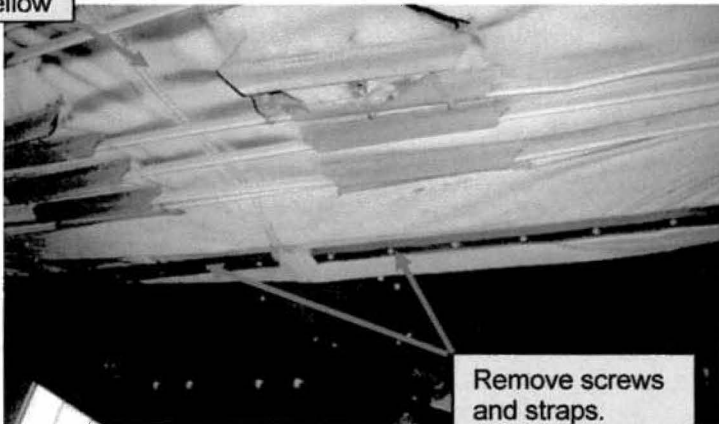
Bellow

- Remove mounting screws and straps those securing the bellow cover to the bottom of the 1st cross member of the trailer (rear coach). Move away the cover from the beam and secure it with a rope.

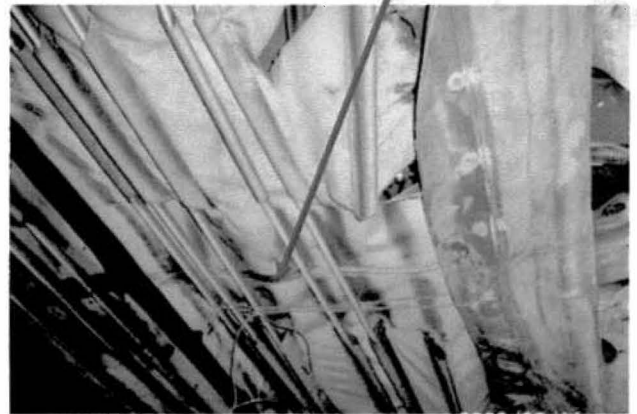
Remove screws
and straps.

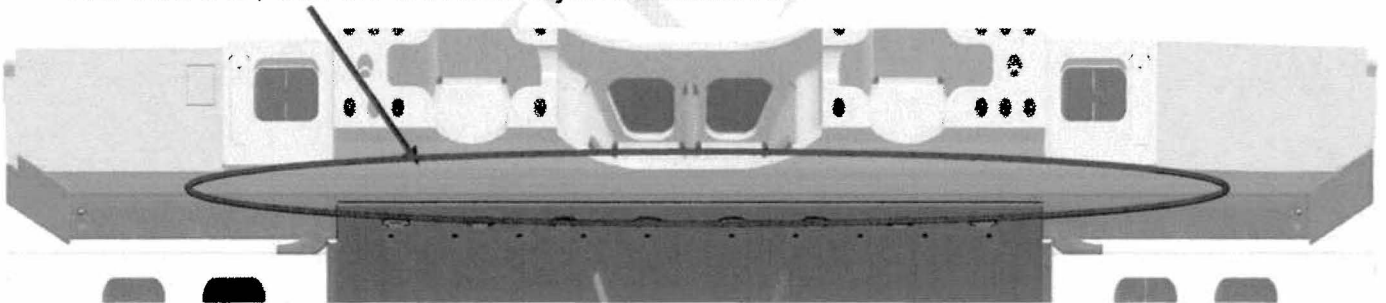
- Visually check welds at the lower forward edge of the articulation joint of the trailer (First Cross Member, circled in the drawing below). This view is from the FRONT looking REARWARD, with the articulation joint uninstalled.

- If crack was found then:***
 - The bus has to be taken out of service.**
 - Mark the location on the attached inspection sheet.
 - Record the length of the crack.
 - Notify immediately Kalman Takacs at 256-453-7583.
 - Send the completed inspection sheet back to 106 National Drive, Anniston AL36207 attn. Kalman Takacs. Or email the inspection sheet to kalman.takacs@nabiusa.com
