File In Section: Product Recalls
Bulletin No.: 09045

# F/CMVSS NONCOMPLIANCE RECALL

Park Brake Inoperative – Fractured Cable Connector

**2009 Chevrolet Traverse**

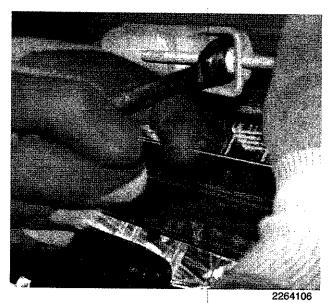
2263780

2. Locate the parking brake cable link (1).

3. Mark the threads of the parking brake adjuster screw where it meets the equalizer.

4. Turn the locknut and adjuster screw counterclockwise about 25 mm (1in).

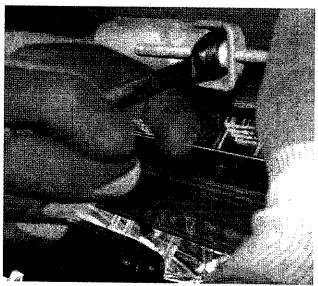
220311

6. Install the new parking brake cable link (1).

- 7. Turn the locknut clockwise until the parking brake adjuster screw is adjusted to the position marked in Step 3.
- 8. Lower the vehicle. Refer to Lifting and Jacking the Vehicle in SI.
