Offset Leg Barrier & 2/3 Seat Back Pads

RECALL

MODELS AFFECTED: School Bus Models Equipped with Offset Leg Barriers and/or 2/3 Seats,
Built January 30, 2003 and Later and Delivered May 06, 2009 and Earlier

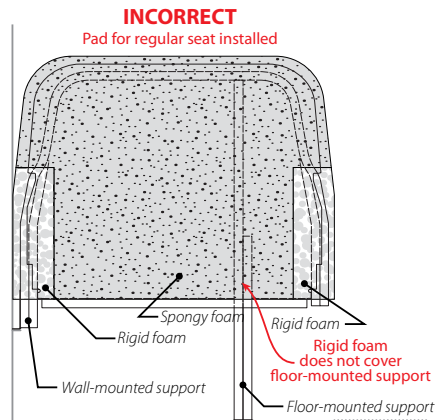
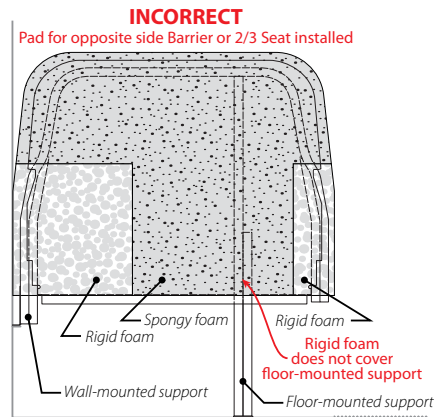
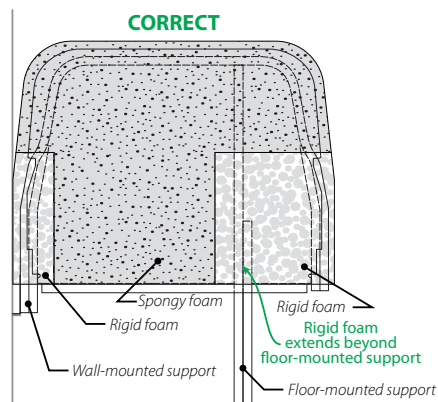
- Correct Pads For Barrier and 2/3 Seat Backs. The offset support legs of Seat Barriers and 2/3 Seat Assemblies extend vertically inside the back frame. These vertical frame members are required to be covered by the rigid foam components of the Pad Assembly.
- Incorrect Pads For Barrier and 2/3 Seat Backs. If a Pad Assembly for a regular full-width seat is installed on a Barrier, or on a 2/3 Seat Back, the vertical extension of the support legs are not sufficiently covered by the rigid foam type.

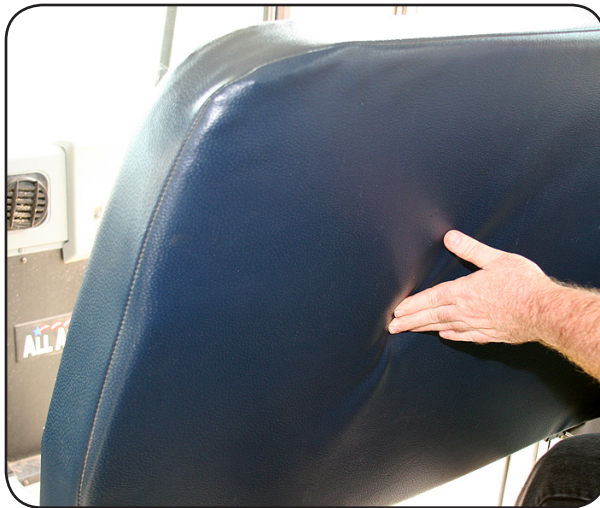
The edge of the rigid foam inside the cover of a Barrier or a 2/3 Seat extends beyond the vertical support leg, which is offset from the aisle-side of the seat.

2.1 On the rear side of the Barrier or Seat Assembly back, starting at aisle-side lower corner, press a hand near the bottom edge and move slowly toward the middle of the back. A change in softness can be easily felt where the rigid foam ends and the spongy foam begins. Mark this location, and compare it to the location of the offset leg portion of the frame.

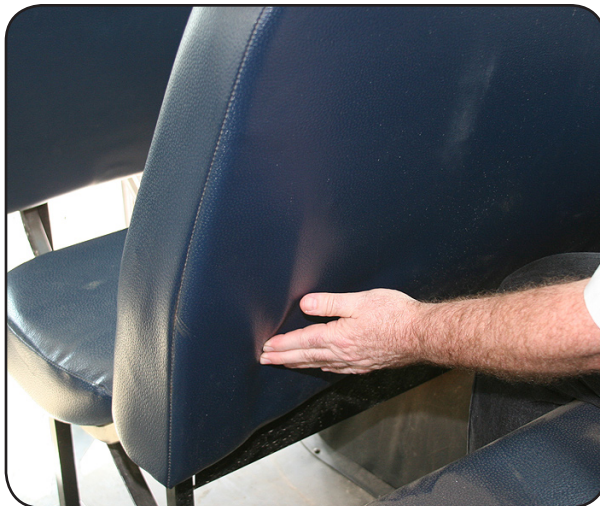
The pad of a regular seat back also has rigid foam pieces, but they do not extend as far from the aisle-side of the seat, because the vertical support leg is not offset.
