Winnebago Industries, Inc. has started a recall campaign.

**SUBJECT: Campaign #113 – Stove Partition**

## INSTRUCTIONS TO PERFORM CAMPAIGN 113

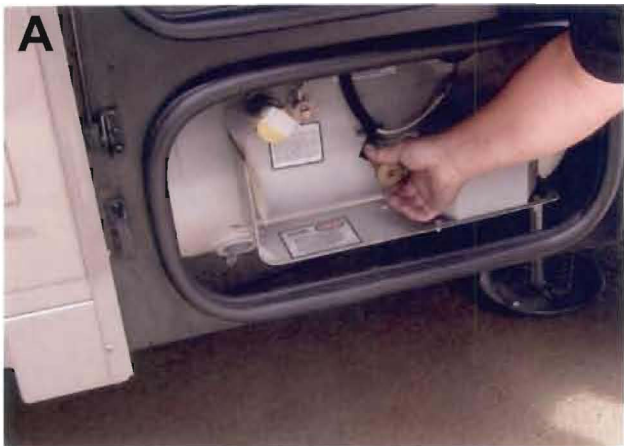
1. Shut off the LP gas on outside of coach. See Photo A.

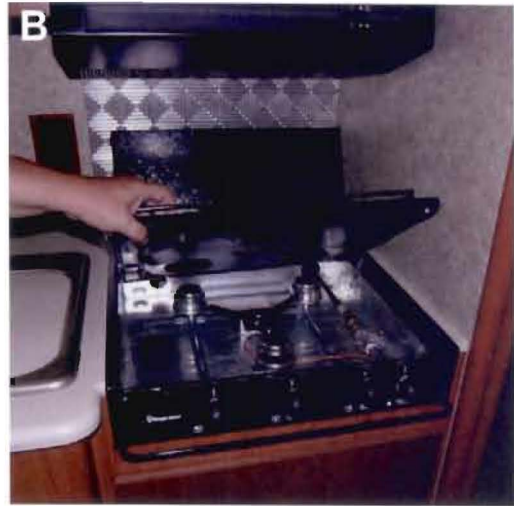
2. Remove range top and set aside. See Photo B.

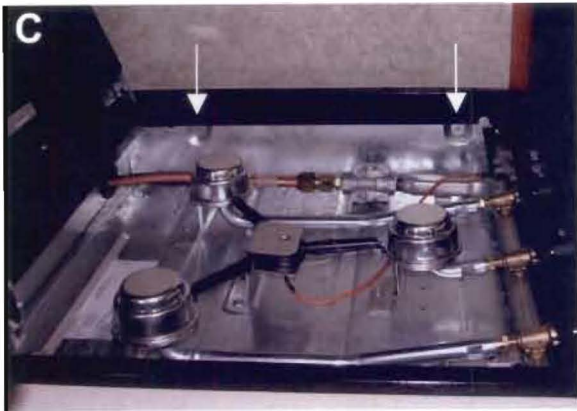
3. Remove four screws to loosen range for removal (two on each side). See Photo C.

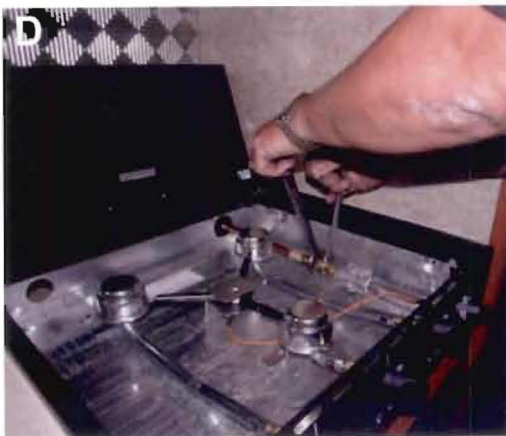
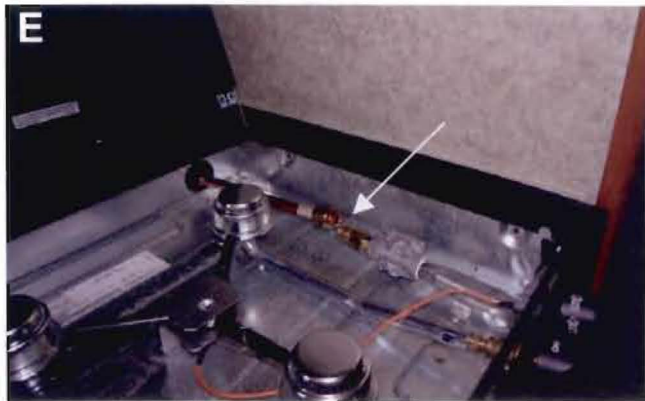
4. Using a 5/8" and 13/16" open-end wrench, loosen and disconnect the LP gas line. See Photos D and E.

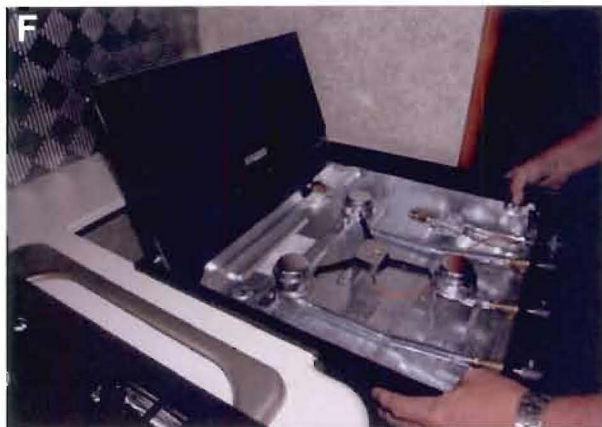
5. Remove range and set aside. See Photo F.

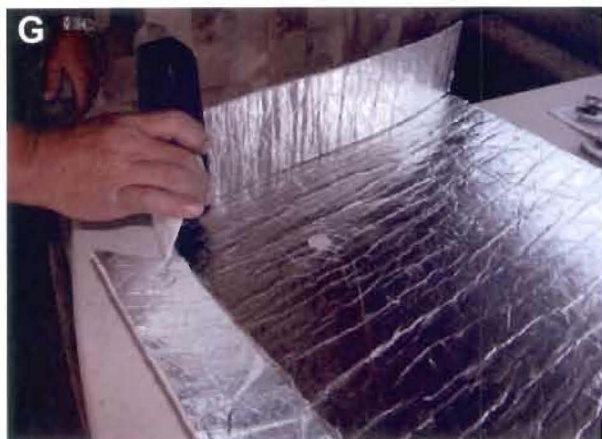
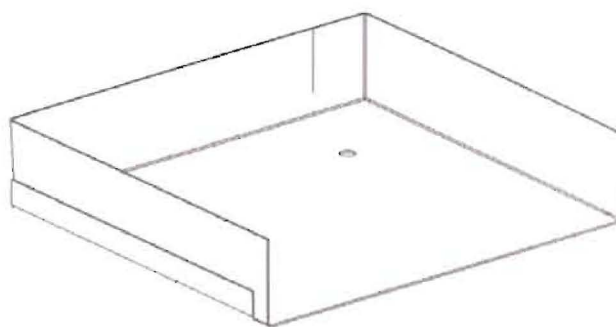
6. Using the perforated lines, fold the stove enclosure into rectangular position and staple to hold shape, making sure the outer lip is stapled to the outside of the stove enclosure. See Photo G and illustration.

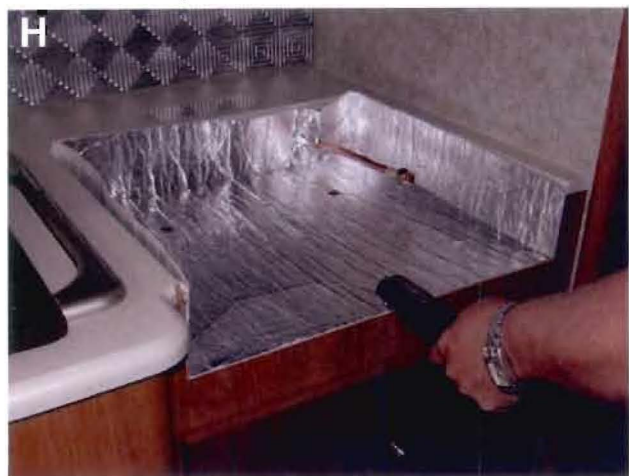
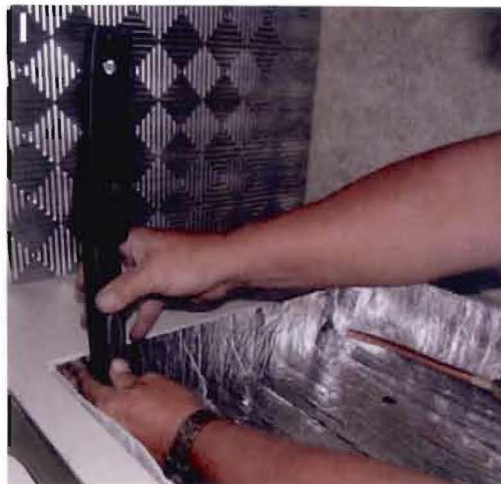
7. Insert stove enclosure (making sure to bring the LP gas line through the stove enclosure slit) and attach to all sides of the countertop/cabinet assembly using a stapler to hold the stove enclosure in place. See Photos H and I.

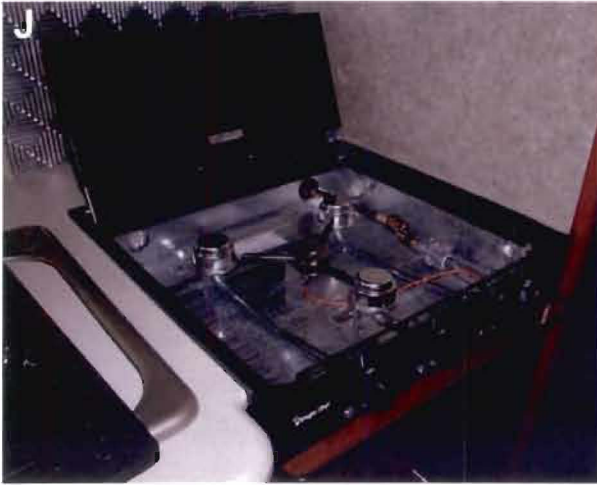
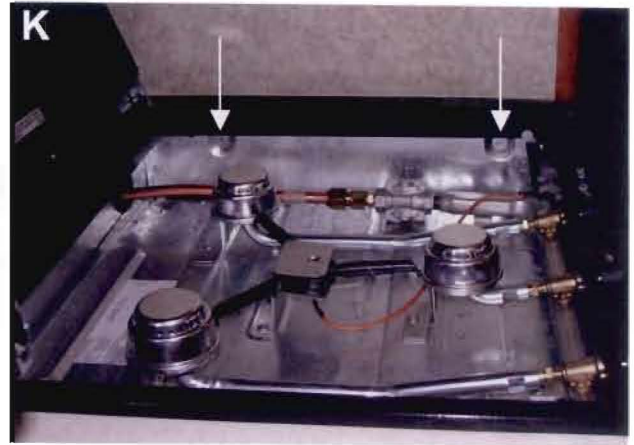
8. Reinstall range and four screws (two on each side) to secure range into place. See Photos J and K.

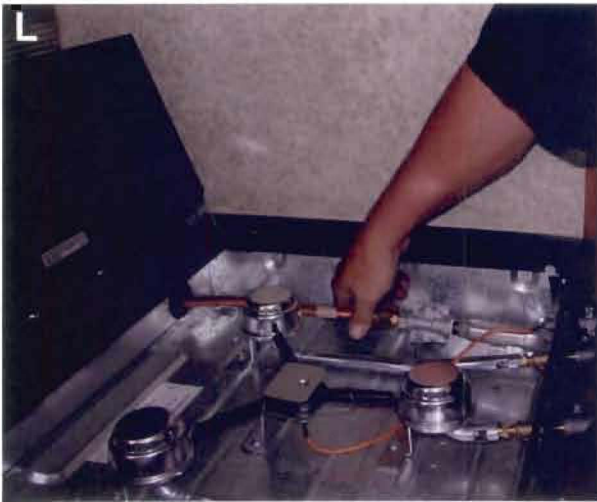
9. Reconnect LP gas line. See Photo L.

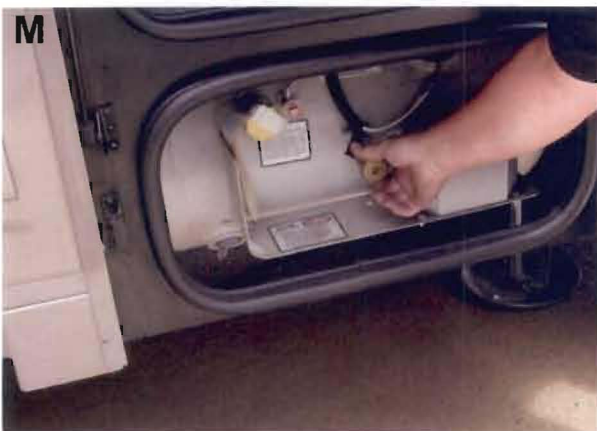
10. Open the LP gas valve on the outside of the coach. See Photo M.

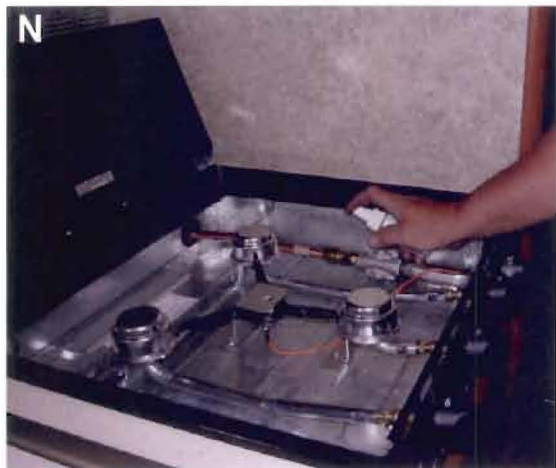
11. Perform an LP leak test by spraying LP leak detector solution on the LP gas line fitting. See Photo N.

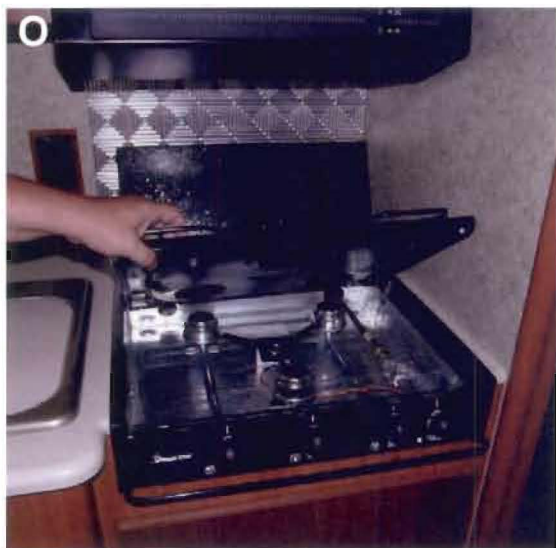
12. Reinstall range top. See Photo O.
