Service Bulletin No. 325B

MODEL G4500 Series Coaches equipped w/ wheelchair	TYPE Field Change Program	SECTION/GROUP 3-Body	DATE Sept. 3, 2009
SUBJECT WHEELCHAIR LIFT (WCL) INTERLOCK DOOR RETROFIT			
CONDITIONS

Ref. NHTSA Recall No.: 09V-345

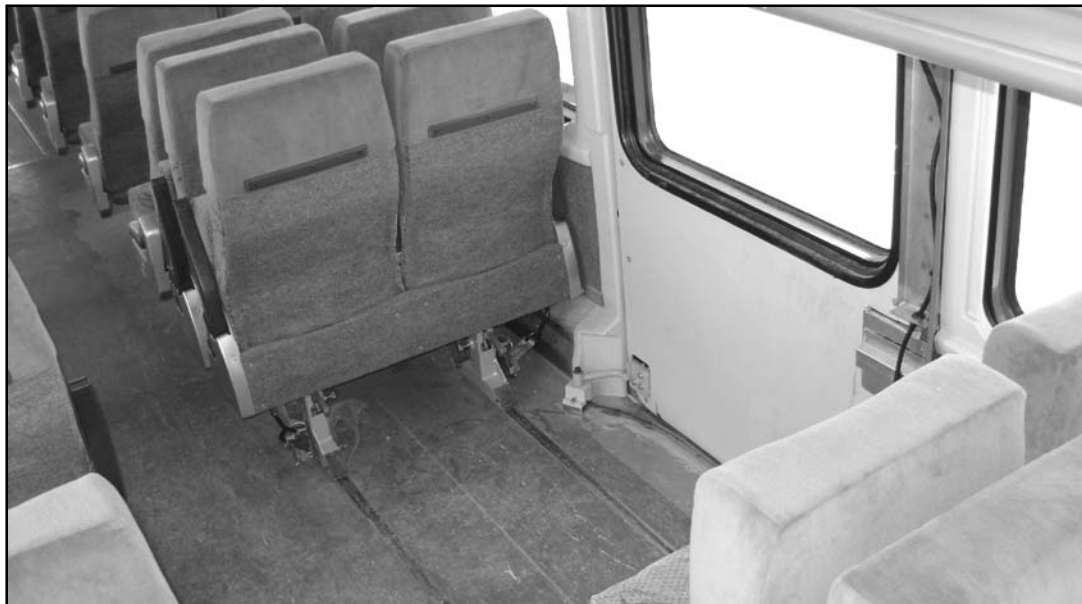
Figure 1.

1. Turn the main battery disconnect switch to the OFF position. Chock both sides of the tires.
2. Fold and position passenger sliding seats to provide access to the wheelchair door (refer to Figure 1).

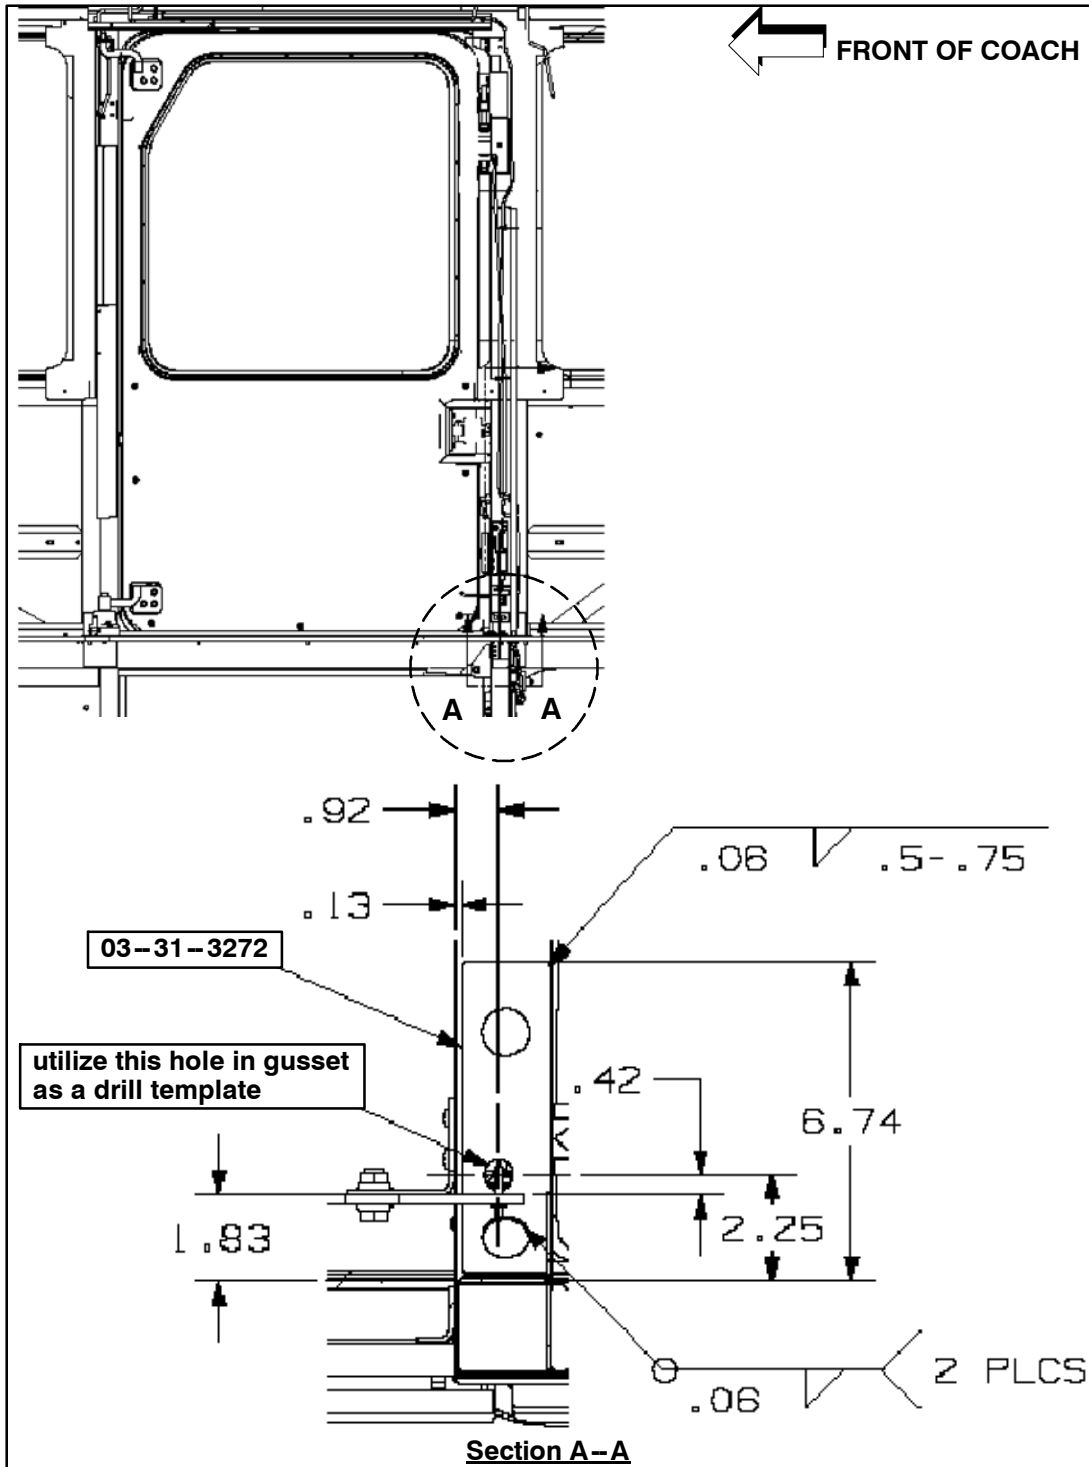
Figure 3. Gusset installation corner (top, rearward corner of the lift access compartment).

4. Locate and open the lift access compartment door, directly below the sliding wheelchair access door.
5. Using an industrial heat gun and steel brush, clean to remove all the dirt and loose paint or rust from the installation area (refer to Figures 3 and 4).
6. Tack weld the gusset (p/n 03-31-3272) into position, according to Figure 3.
7. Weld the gusset, using the weld sizes and locations in Figure 3.

- 8. Using a 0.63 inch drill bit and the hole in the gusset as a template, drill a hole up through the tube frame and floor per the dimensions shown in Figure 5 into the coach cabin (refer to Figures 3 and 4 for hole location on gusset).

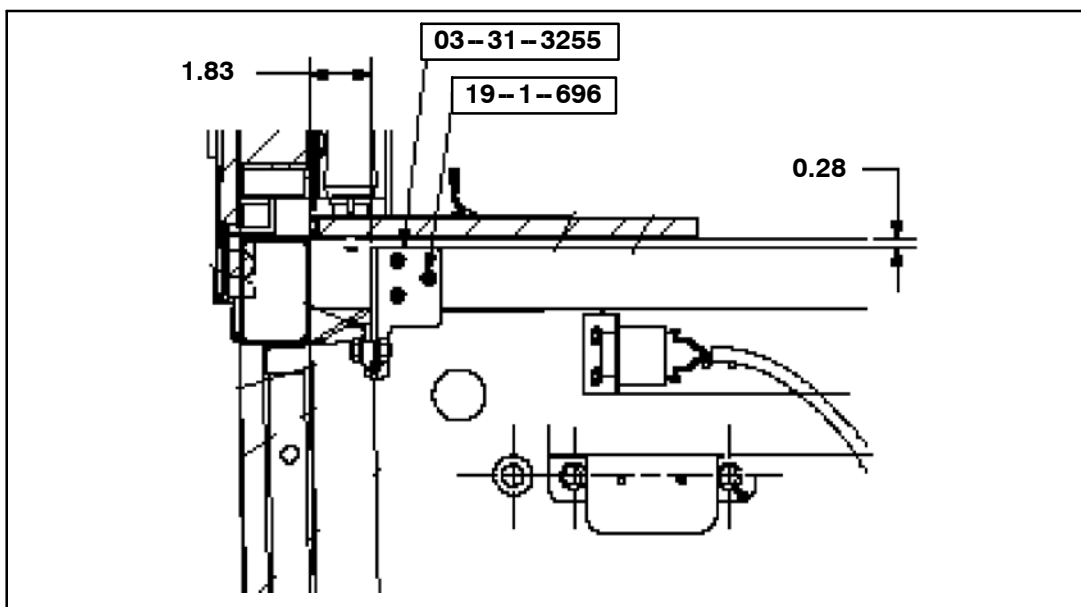
Figure 6. installation dimension.

9. Position bracket, lever, p/n 03-31-3255, as shown in Figures 6 and 7.

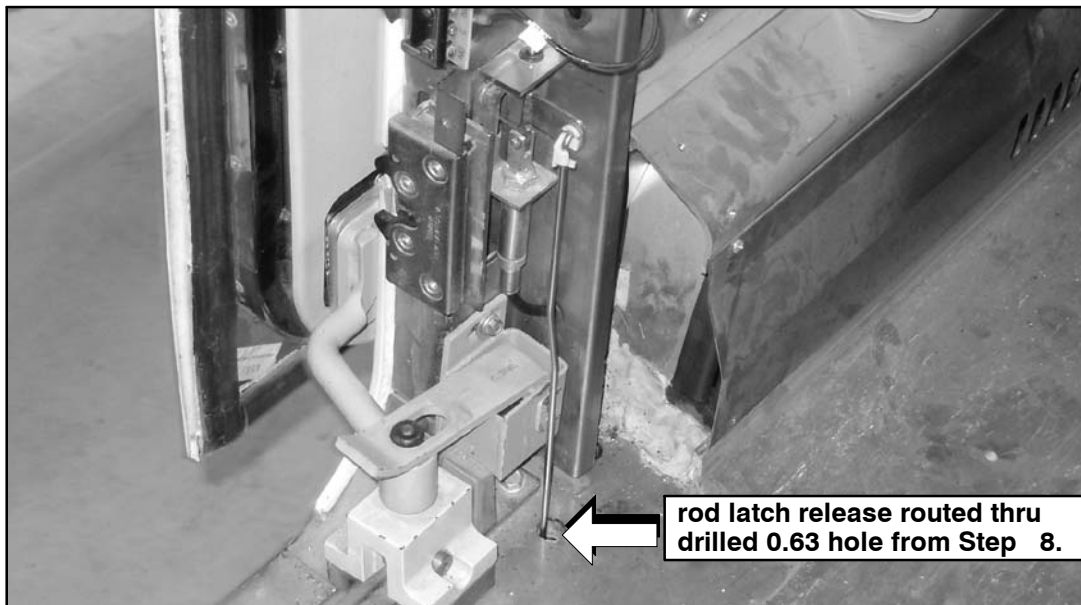
Figure 8.

12. Remove and retain the four (4) mounting screws from the existing lever assy–latch. Discard existing lever assy–latch. Using the four (4) mounting screws, install the new lever assy–latch, p/n 03–31–3257 (refer to Figure 8). Tighten screws to secure.

13. Align and route the rod latch release, p/n 03–31–3258, thru the drilled hole (refer to Figure 8). Using the clip rod, p/n 03–31–1100, install the rod latch release as shown in Figure 9 (refer to Figures 9 and 10).

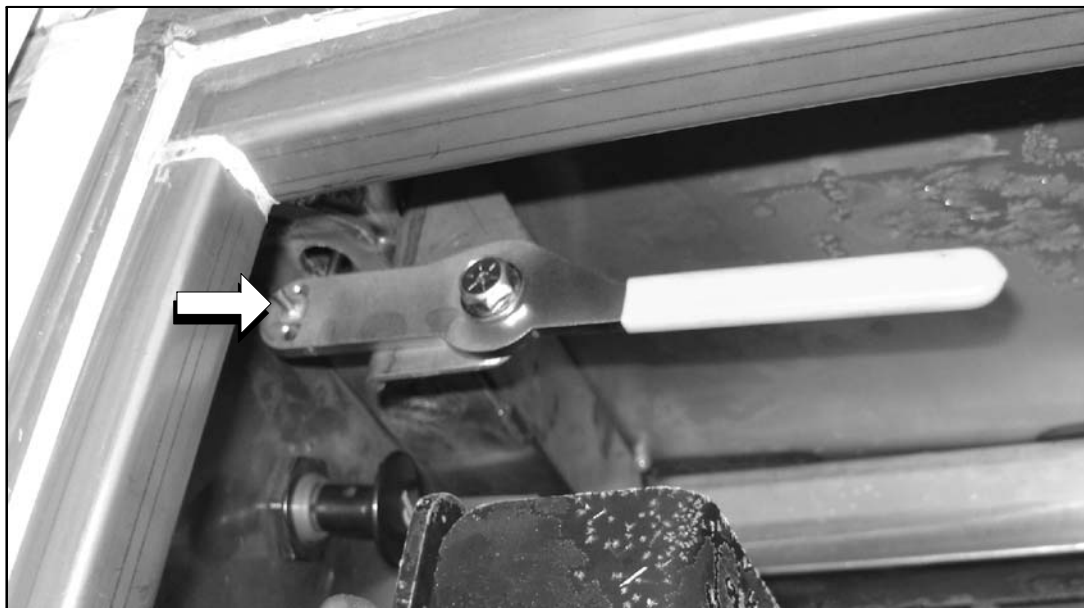
Figure 11.

14. Exit coach cabin and proceed to the lift access compartment. Using pushnut, p/n 19-09-0087, attach rod latch release to the the latch release handle (refer to Figure 11).

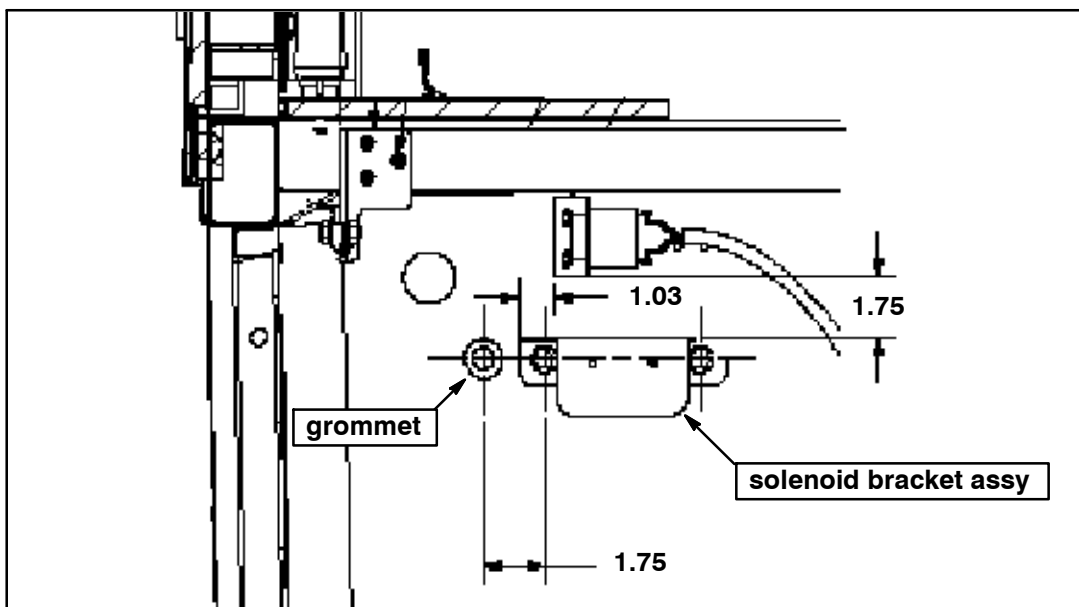
15. Position the solenoid bracket assy, p/n 03-31-3265, on the side panel of the lift access compartment as per dimensions shown in Figure 12 (refer to Figures 12 and 13).
16. Using a 0.34 inch drill bit and the two (2) holes in the solenoid bracket assy as a template, drill two (2) mounting holes. Using capscrew, p/n 19-1-16, fender washer, p/n19-2-187 and locknut, p/n 19-3-183, securely mount the solenoid bracket assy to compartment wall.
17. Using a 0.87 inch drill bit, drill a hole as per dimensions shown in Figure 12. Install grommet, p/n 19-12-20, in drilled hole (refer to Figures 12 and 13).

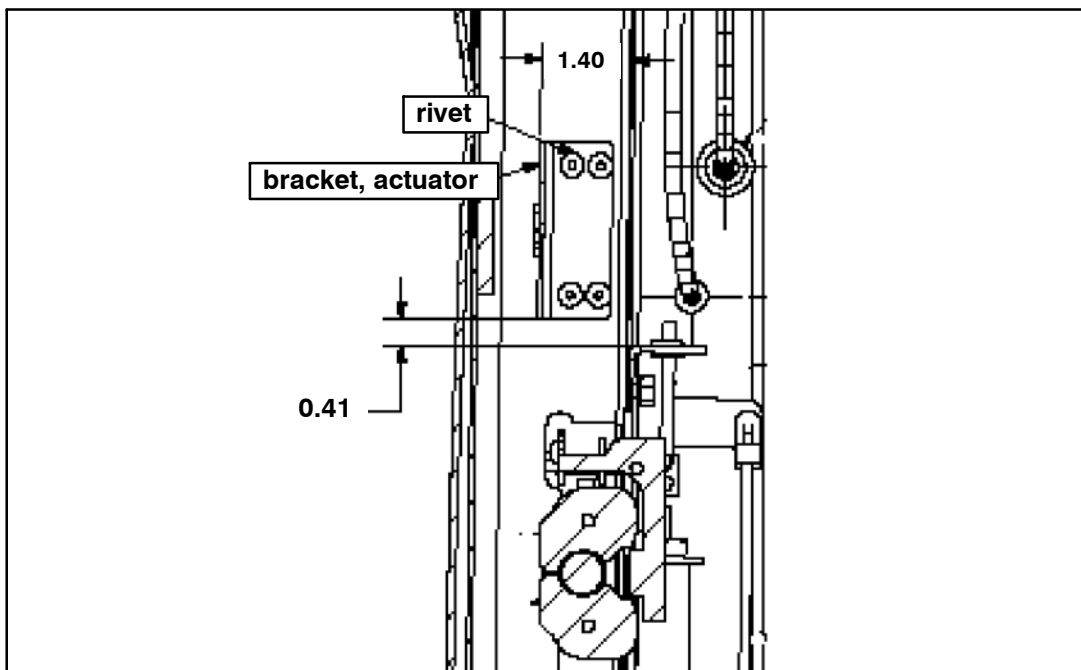
Figure 15.

19. Using the two dimensions (1.40 and 0.41) shown in Figure 15, position the bracket, actuator, p/n 03–31–3281, and secure in place. Using a 0.20 drill bit and the four (4) holes in the bracket, actuator as a drill template, drill four mounting holes into the frame. Using rivets, p/n 19–13–137, mount the bracket, actuator to the frame (refer to Figures 15 and 16).

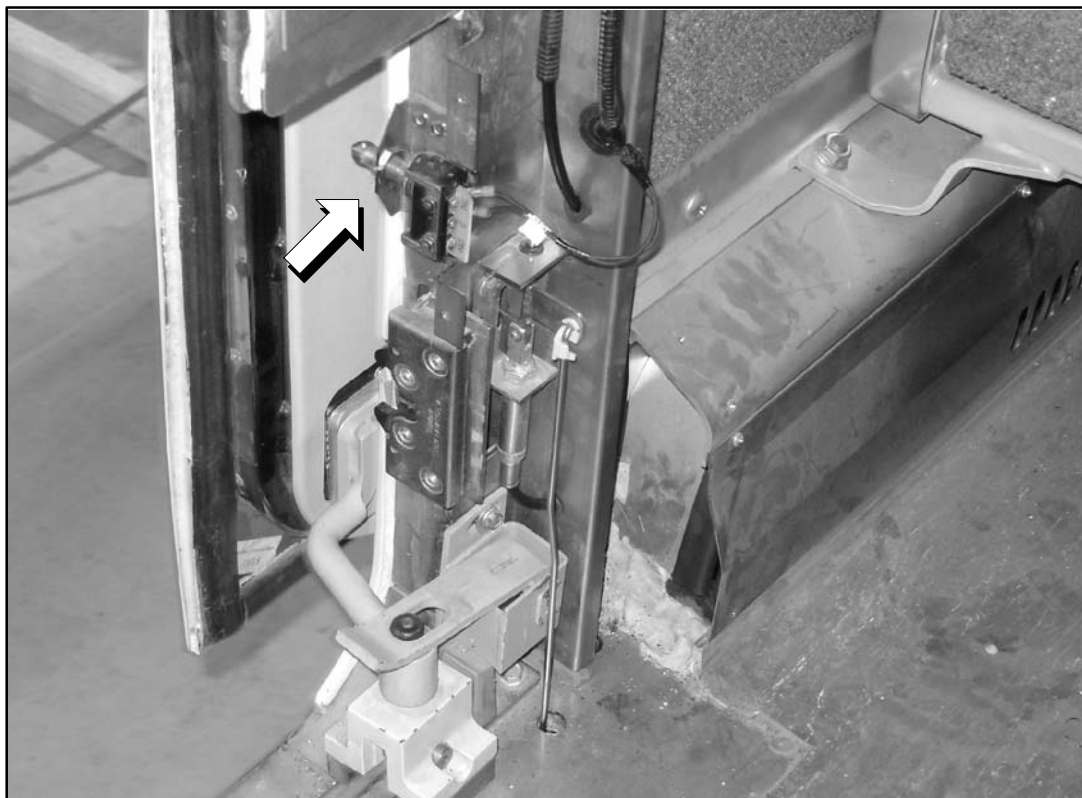
Figure 18.

21. Install the switch and actuator, removed in Step 20. , to the bracket, actuator, p/n 03-31-3281, installed in Step 19. (refer to Figure 18). Connect the harness.

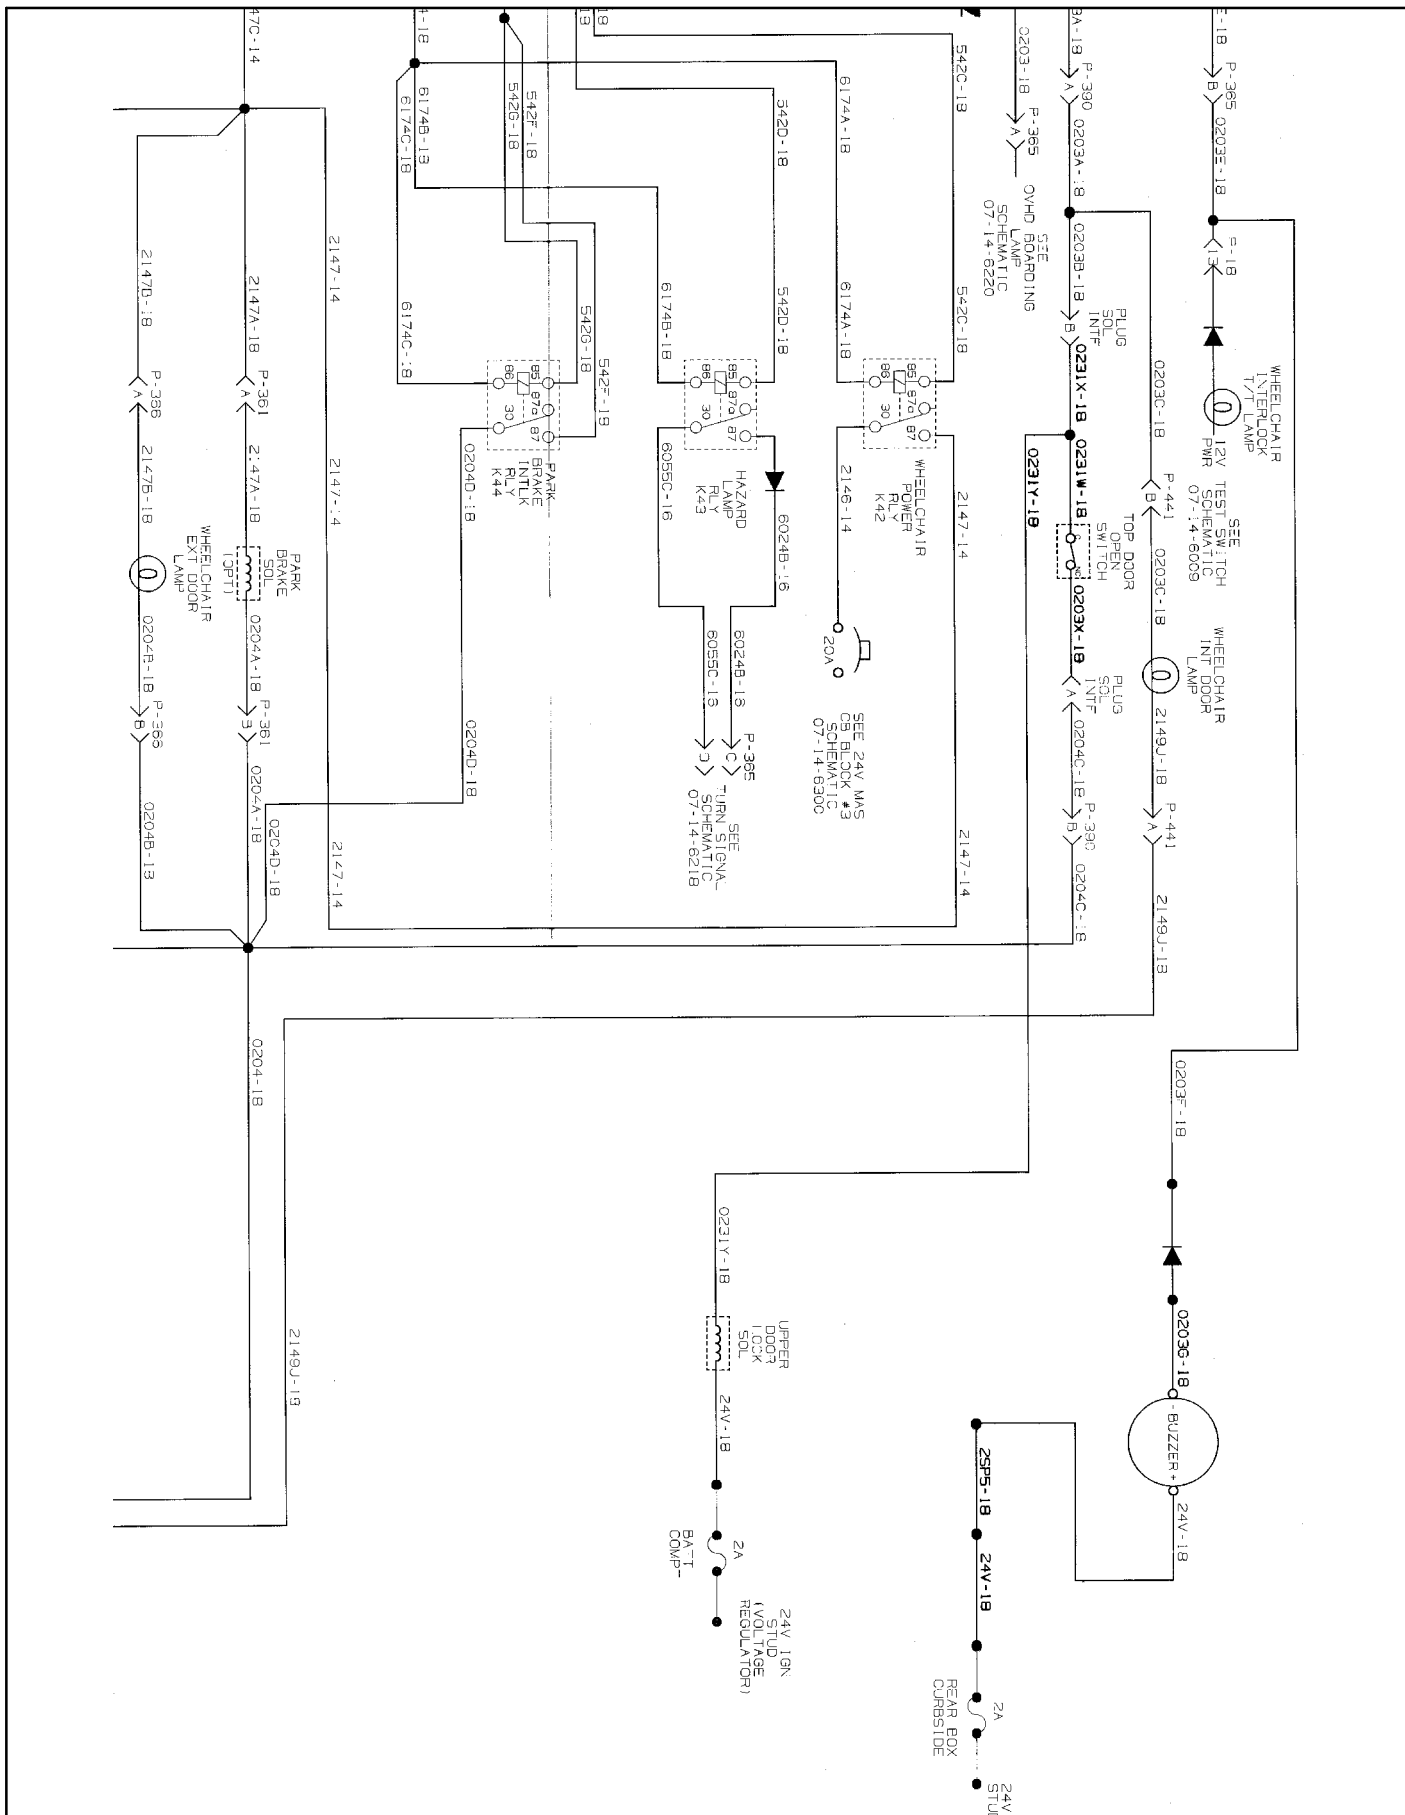
Figure 21. Schematic for non-multiplex coaches.

25. Use tywraps, p/n 19-11-569 throughout routing to secure harness to existing harnesses.
26. Remove ring terminals on existing harness that was disconnected in Step 20. Insert pins p/n 19-11-760, seals, p/n 19-11-2048, and connector, p/n 19-11-845 (refer to schematics in Figure 21 or 22).

27. Route existing harness and connect to harness adapter, p/n 07-12-3066.
28. Connect solenoid adapter harness to the switch and actuator removed in Step 20. , the assy-solenoid p/n 03-31-3265, and the 24V ignition terminal on the voltage regulator (refer to schematics in Figure 21 or 22).

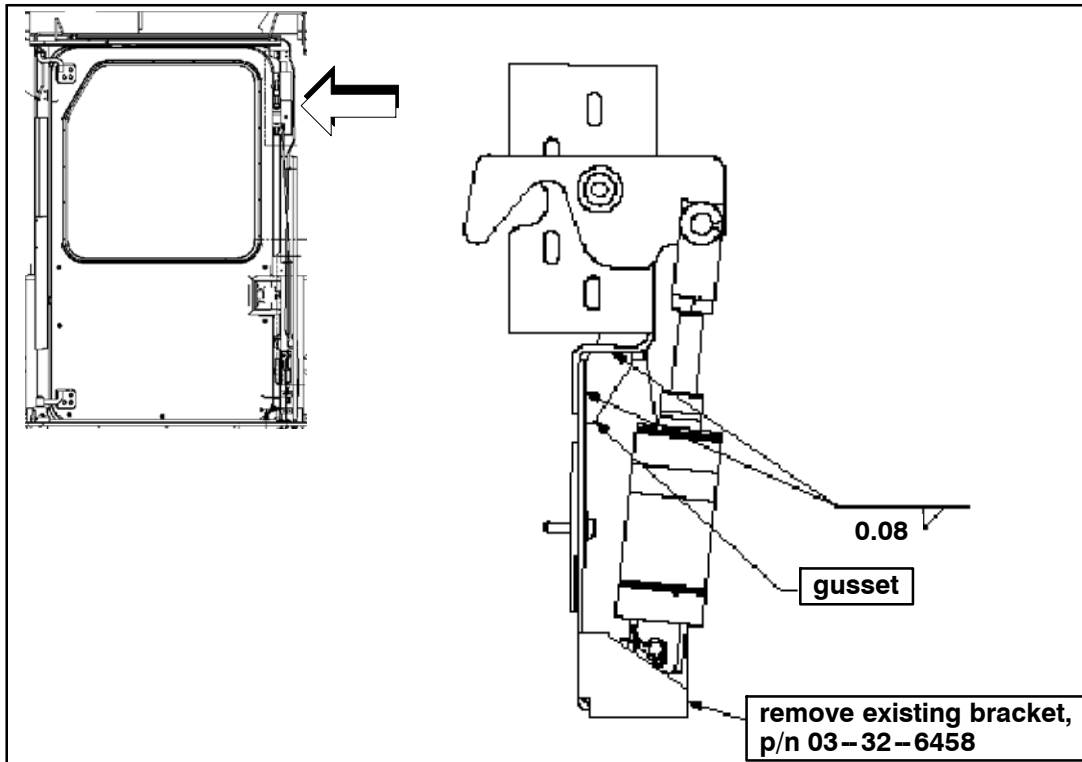
29. Remove existing bracket assy–cylinder upper, p/n 03–32–6458, from door (refer to Figure 23) and place on a workbench. Retain mounting hardware.
30. Position gusset, p/n 03–31–3261, as shown in Figure 23. Weld gusset flush on existing bracket assy–cylinder upper as per specifications shown in Figure 23.

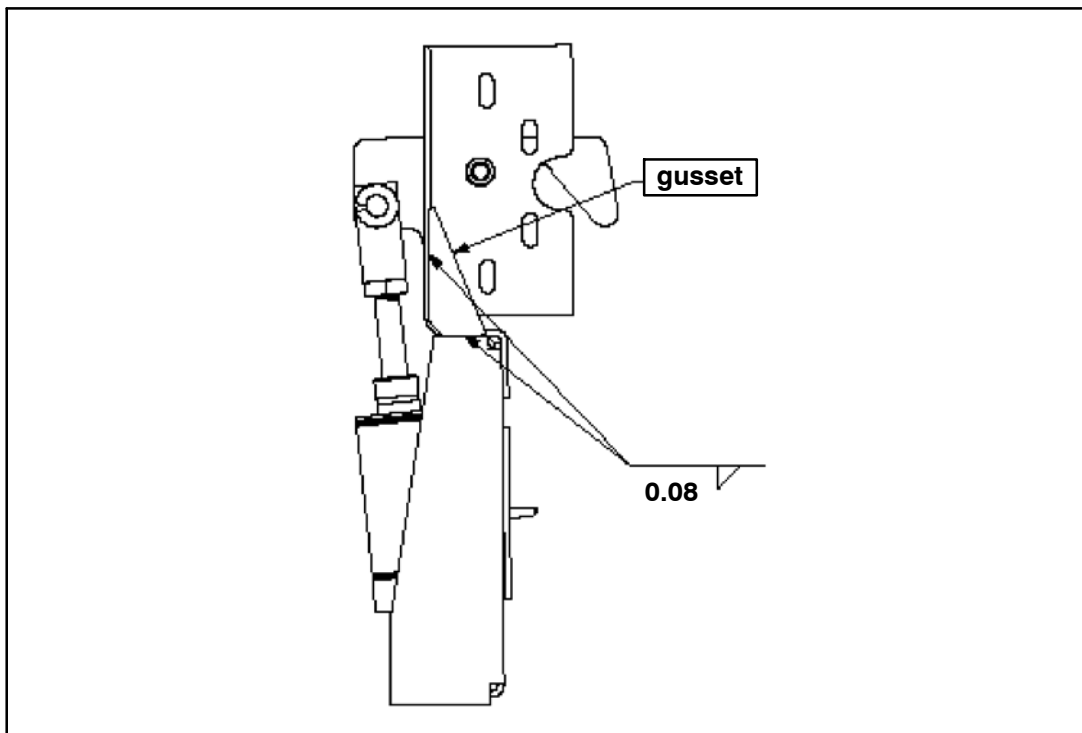
31. Position gusset, p/n 03–31–3260, as shown in Figure 24. Weld gusset flush on existing bracket assy–cylinder upper as per specifications shown in Figure 24.

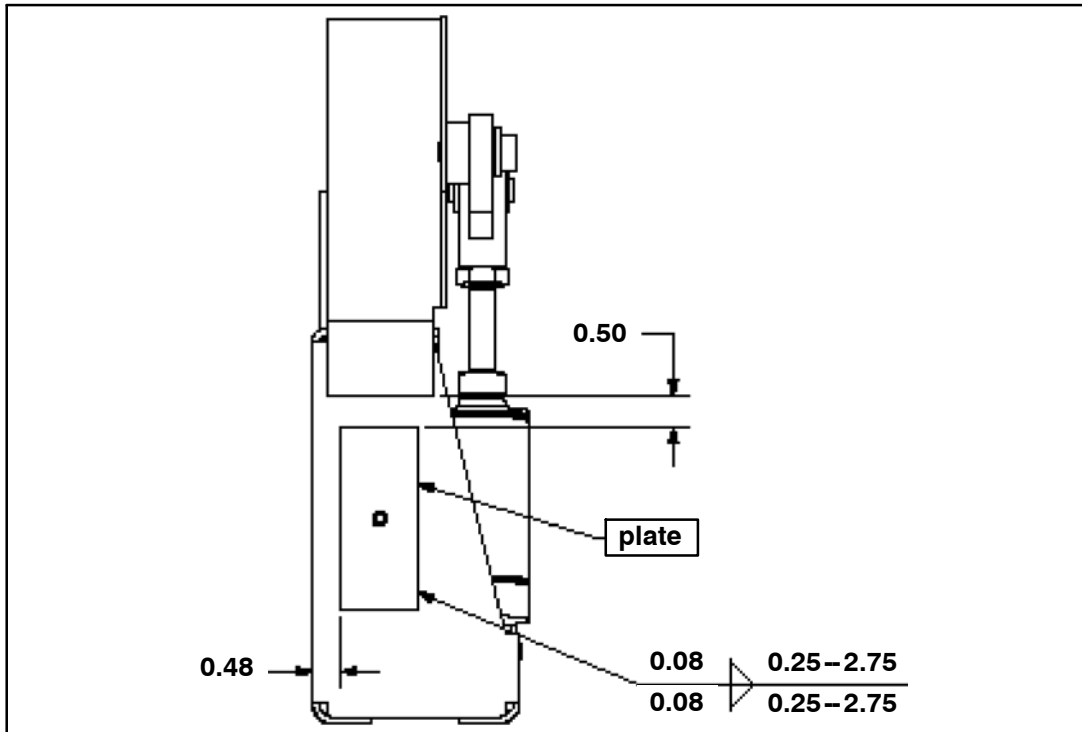
32. Position plate, p/n 03-31-3259, as per dimensions shown in Figure 25. Weld plate on existing bracket assy-cylinder upper as per specifications shown in Figure 25

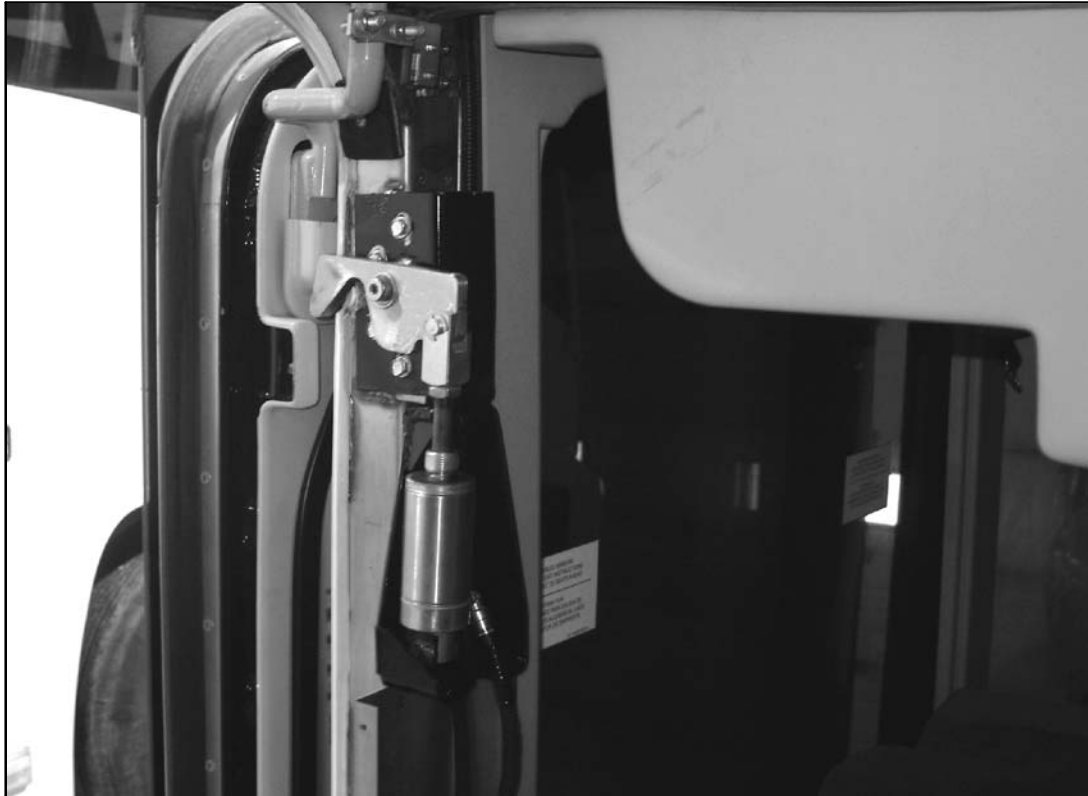
Figure 26.

33. Using a 0.22 dia. drill bit and the hole on plate, p/n 03-31-3259, as a template, drill a hole into existing bracket assy-cylinder.
34. Using MCI black paint, paint the reworked bracket assy.
35. Using existing hardware removed in Step 29. , re-install the reworked bracket assy-cylinder upper.
36. Using a 0.149 dia. drill bit and the hole on the reworked bracket assy-cylinder as a template, drill a hole into the frame. Install screw, p/n 19-01-1957, into drilled hole.

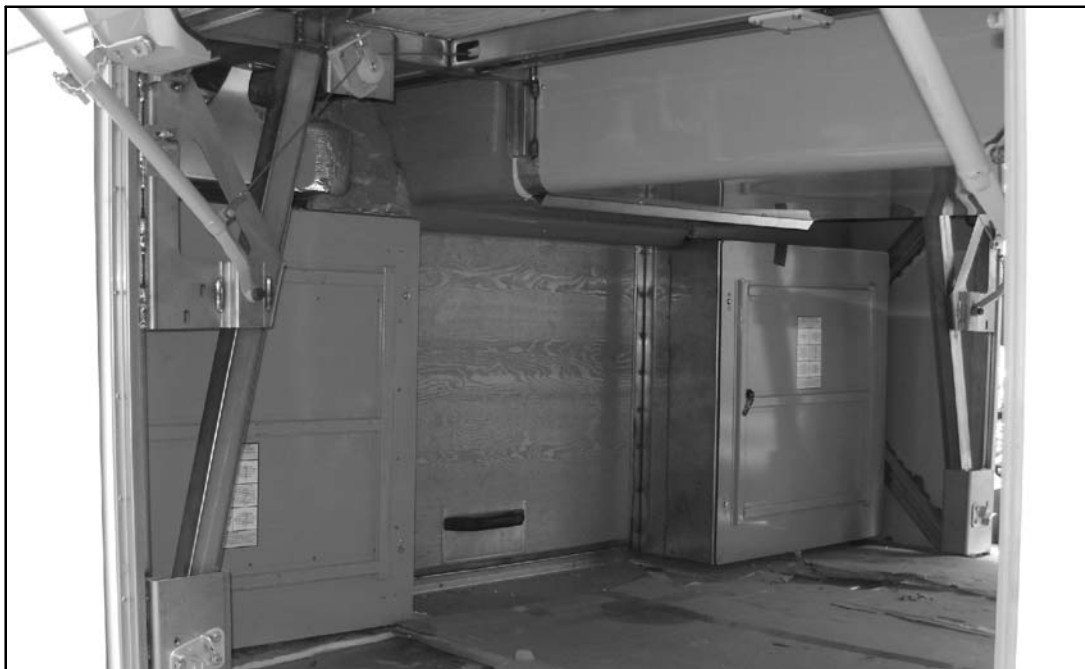
50. Open the curbside and roadside #3 baggage bay compartment doors. Locate the junction box and remove cover (refer to Figure 31).

Figure 31. #3 baggage bay compartment.

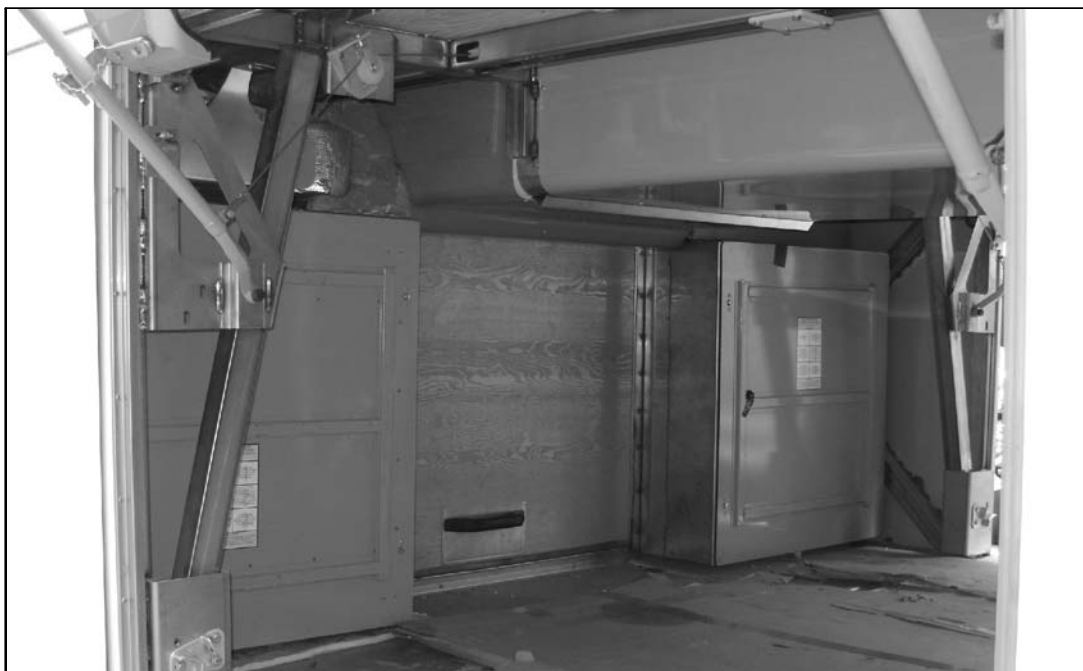
63. Locate wire 0203E on P-18 (3) in the instrument panel connectors (refer to Figure 35). Using heat shrink, p/n 19-11-1465, and solder splice, p/n 19-11-1466, splice wire 0203E to wire 0203F on harness, p/n 07-12-2945, three (3) inches before the connector P-18. Connect harness, p/n 07-12-2945, to beeper. Using tyrap, p/n 19-11-569, secure harness to existing harness bundle.
64. Open the curbside and roadside #3 baggage bay compartment doors. Locate the junction box and remove cover (refer to Figure 37).

Figure 37. #3 baggage bay compartment.
