TECHNICAL INSTRUCTIONS
FOR
SAFETY RECALL 90L
ACCELERATOR PEDAL MODIFICATION
2005 – 2010 MODEL YEAR AVALON
REVISED FEBRUARY 23, 2010

TECHNICAL INSTRUCTION REVISION NOTICE:

- February 23, 2010:
 - Note in Work Procedure section E, step 5, "REFLASH THE ECU" was updated.

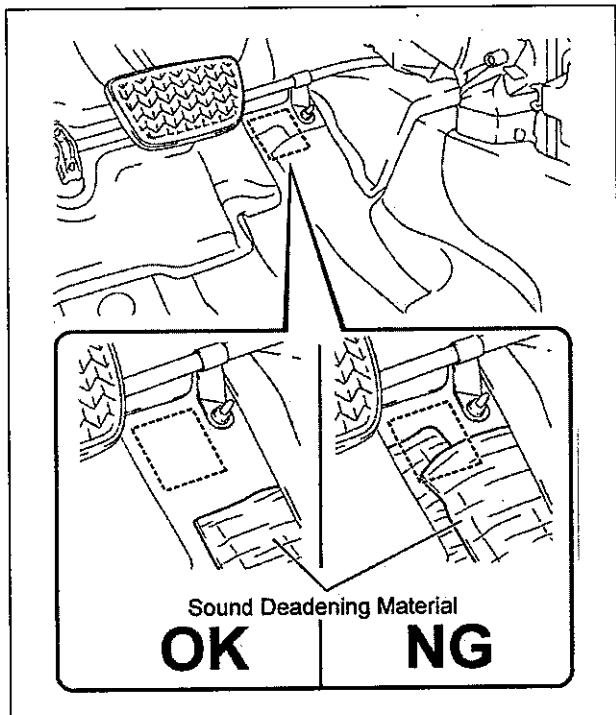
4. RUBBER PAD APPLICATION

- a) Inspect the rubber pad application area for sound deadening material.
 - If OK (no sound deadening material in pad application area), proceed to step "b" below.
 - If NG (sound deadening material found in application area), please refer to APPENDIX "C" for "REMOVE THE SOUND DEADENING MATERIAL".
