TECHNICAL INSTRUCTIONS
FOR
SAFETY RECALL 90L PHASE II
CTS ACCELERATOR PEDAL MODIFICATION
2007 – 2010 MODEL YEAR CAMRY

REVISED MARCH 11, 2010

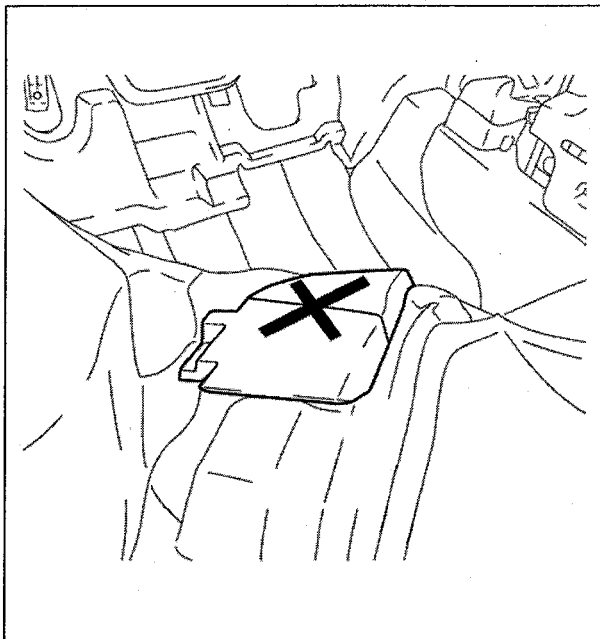
5. REMOVE THE TIBIA PADS

- Place an "X" mark on the tibia pads before removing. This will prevent them from being mixed up with the new pads.
- Using a hair dryer or a low temperature heat gun, warm up the carpet side of the 2 tibia pads until the adhesive is loose. This will make it easier to remove the 2 tibia pads from the carpet. Pay close attention when using the hair dryer or low temperature heat gun to prevent damage to the carpet.
- Remove the tibia pads. **CAUTION: DO NOT** forcefully pull the pads. Doing so may damage the carpet. If necessary, re-heat the carpet to make the adhesive more pliable.
