- 1995-1997 & 2001-2004 Mazda B-Series Cruise Control Deactivation Switch Voluntary Safety Recall 5709J

Subject: Upcoming 1995-1997 & 2001-2003 B-Series Cruise Control Deactivation Switch Voluntary Safety Recall 5709J

This Safety Recall involves an inspection of the Cruise Control Deactivation Switch (CCDS) connector for signs of brake fluid contamination. If there is no brake fluid contamination, the repair will involve the installation of a fused jumper harness. If brake fluid is observed in the CCDS connector, the repair will include replacement of the CCDS and an inspection of the cruise control servo harness connector if applicable. See Flow Chart on page 2.

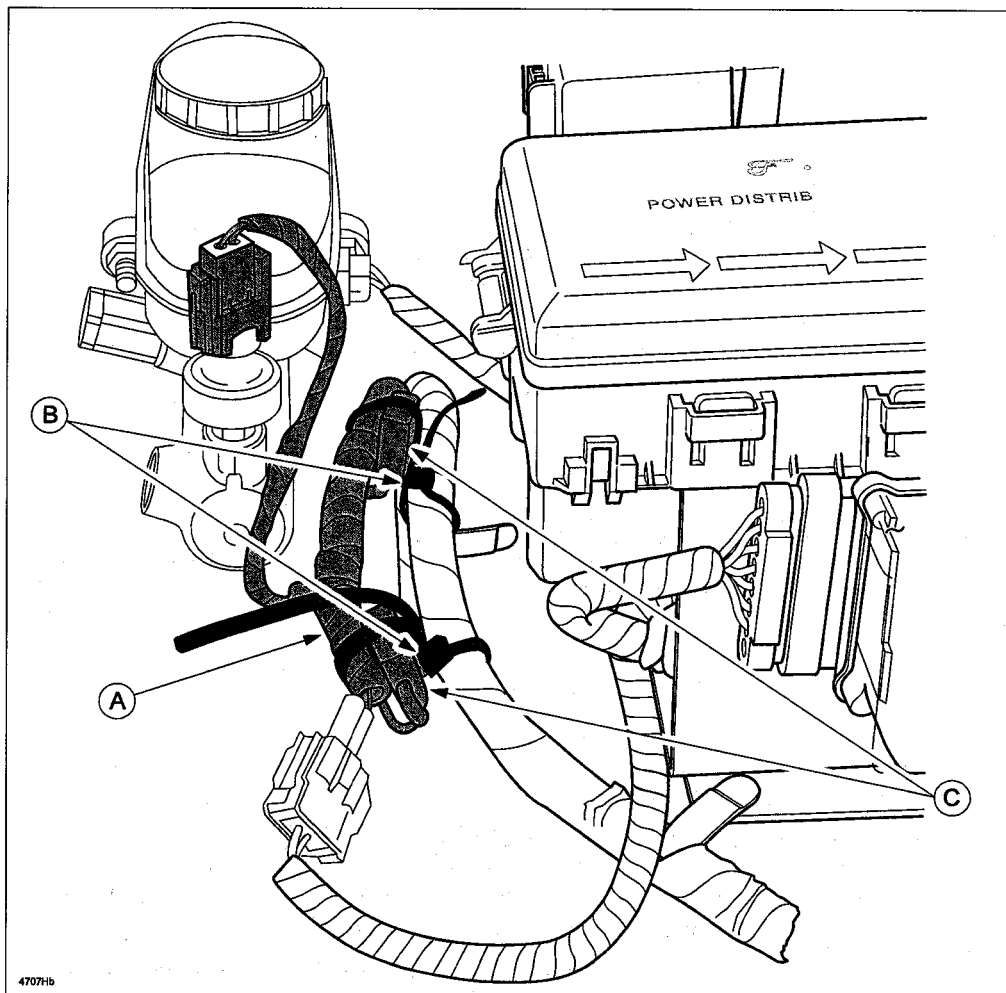
PROCEDURE 1 - For vehicles with non-leaking switches
UNIVERSAL FUSED JUMPER HARNESS INSTALLATION

1. Connect the universal fused jumper harness to the CCDS and the vehicle harness.
2. Position the harness (A) alongside an existing harness, located below or next to the master cylinder so that the fuse holders (C) are higher than the rest of the jumper harness. This will cause any water that enters the engine compartment and gets on the jumper harness to run downhill away from the fuse holder.
3. Secure the jumper to the existing harness with tie straps (B), making sure the fuse holder is positioned vertically with the cap facing upward. Wrap the tie straps underneath, then over the top of the existing harness and verify proper fuse holder orientation.
4. Proceed to "E. CAMPAIGN LABEL INSTALLATION" on page 8.

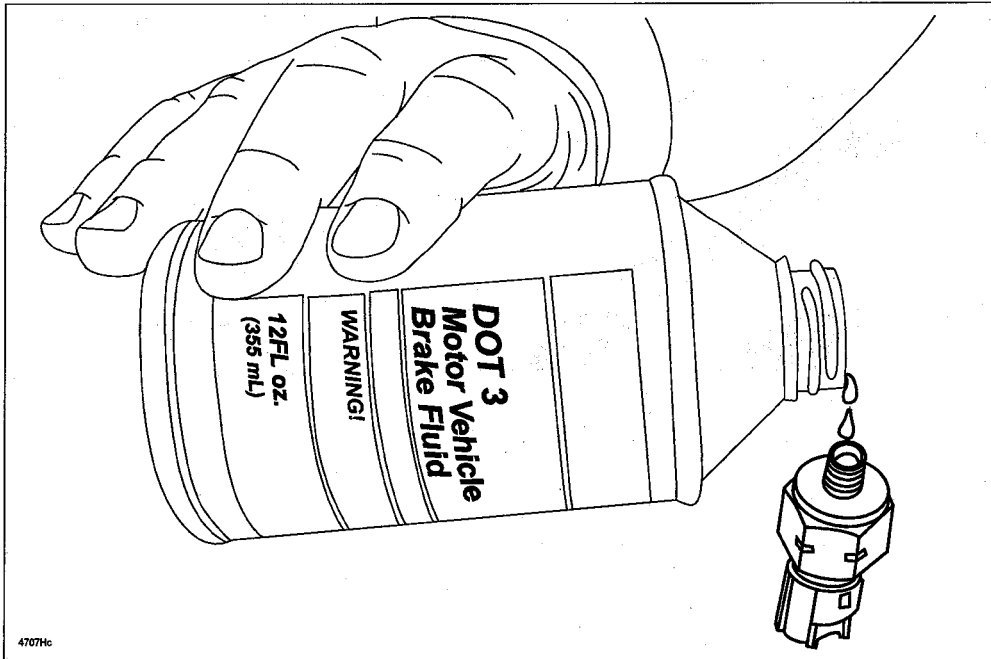
CAUTION: DO NOT apply fluid to the electrical connector or damage to the connector may occur.

2. Add a few drops of DOT 3 motor vehicle brake fluid to the fluid port at the threaded end of the new CCDS.

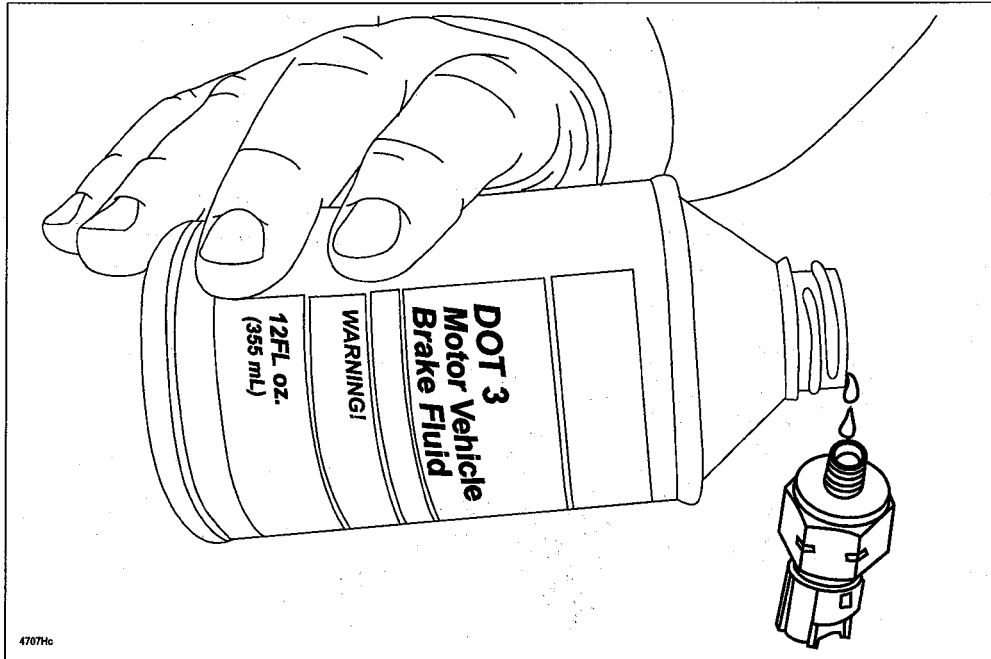
2. Add a few drops of DOT 3 motor vehicle brake fluid to the fluid port at the threaded end of the new CCDS.

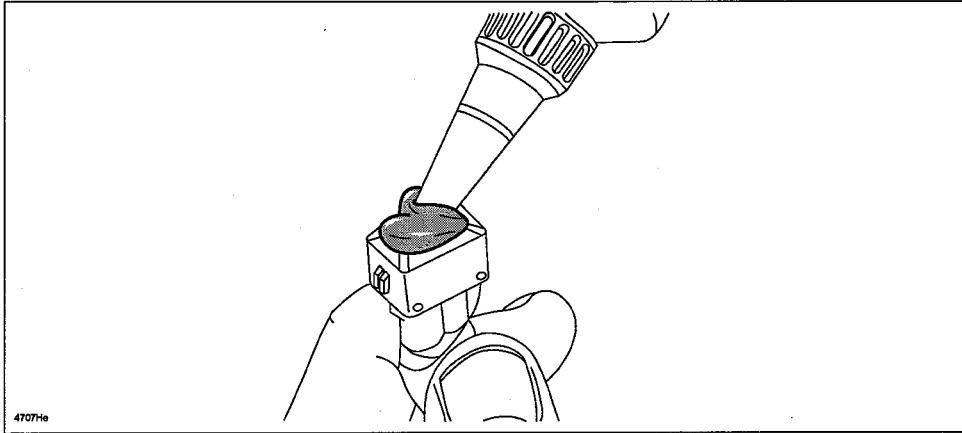
7. Before installing the adapter jumper harness, fill the vehicle harness end of the jumper (male pin connector end) with electrical grease.
