**SAFETY**  
CAMPAIGNMASTER  
WARRANTY

Campaign no.: 2010-0002

December 14, 2009 Subject: **Ignition Switch Connector and Ignition Switch Harness Routing**

November 11, 2009 Subject: **Ignition Switch Harness Routing**No. **2010-1**

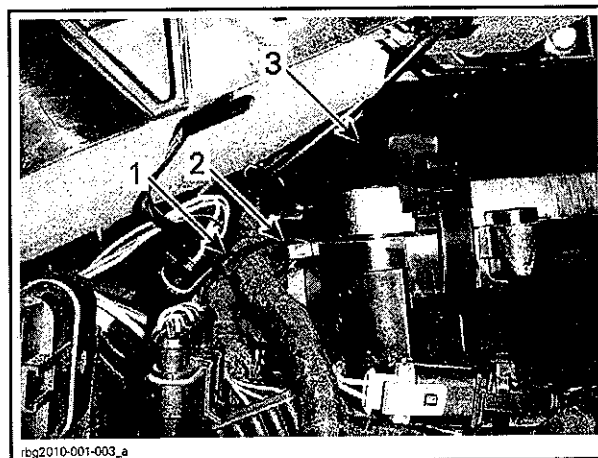
1. Locking tie
2. Attachment point on air box
3. Air box

2. Pull ignition switch harness towards front of vehicle from LH headlight opening.
3. Push harness from LH of vehicle to align with the attachment hole on air box.
4. Verify harness is not tight by pulling from LH headlight opening.
5. Reinstall new locking tie to attach ignition switch harness to air box.

6. Turn steering completely to the LH side and RH side to ensure ignition switch harness is not tight in any position.

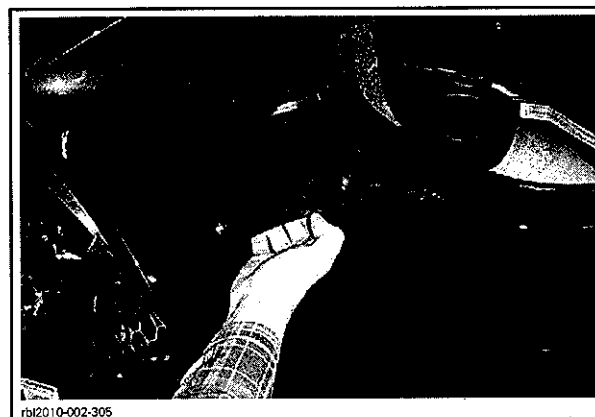
7. Pull out lower part of top side panel to remove it from grommets.

NOTE: Do not remove lower screws from top side panel.

8. Remove top side panels by lifting them upwards.

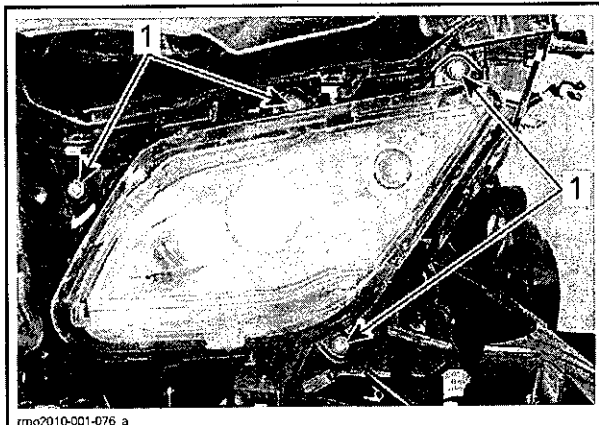
1. Retaining screws

14.2 Remove 4 retaining screws from both headlights.
