# Recall Bulletin

## FMVSS NONCOMPLIANCE RECALL

**SUBJECT:** Tire and Loading Information Label Missing – Install Label

**MODELS:** 2010 Cadillac DTS

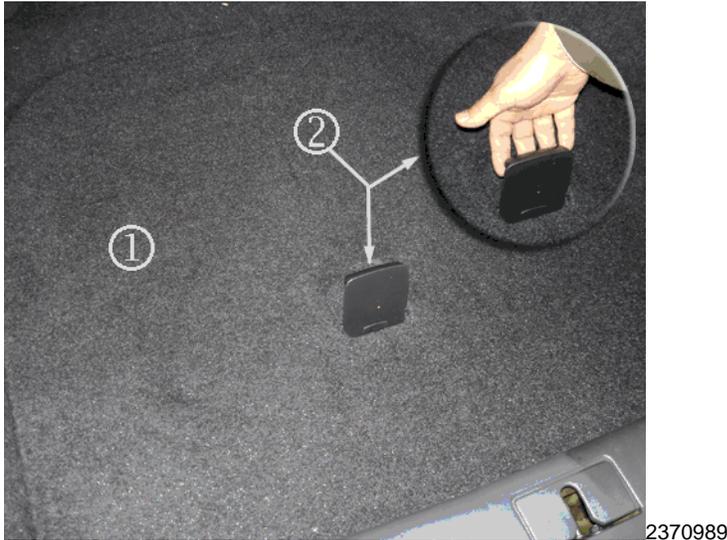
1. Open the trunk.

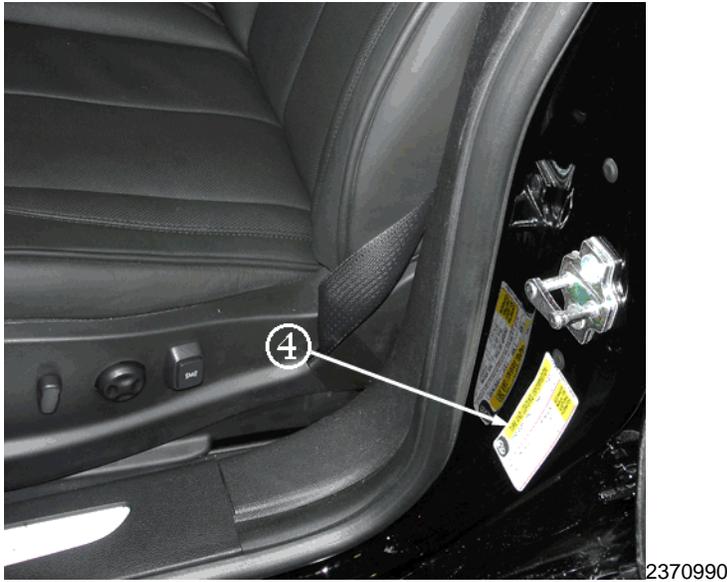
18. Locate the silver Vehicle Certification Label (3) located on the edge of the front driver's side door. Refer to illustration.
19. Remove the Vehicle Certification Label.
20. Clean the label surface area of the door using a cleaning solvent such as Kent Acrysol, P/N 20005 or an equivalent cleaning solvent or adhesive remover.
21. Affix a new Vehicle Certification Label on the door.
22. The Tire and Loading Information Label is missing and not affixed to the driver's side B-pillar.

23. Located the B-pillar and affix the provided Tire and Loading Information Label (4) onto the B-pillar as shown in the illustration.
24. Close front driver's side door.
