**SUBJECT:   RECALL R09PE   VANDAL LOCK STARTER INHIBIT  
NONCOMPLIANCE**

# Vandal Lock Starter Wiring

**MODELS AFFECTED:** 2003-2010 All American Rear Engine models with Vandal Lock Options

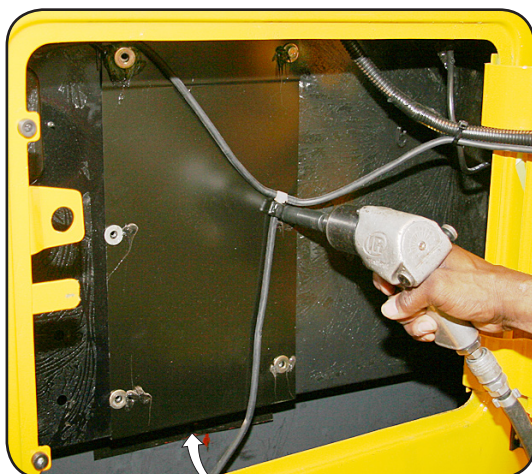
Screw  
Behind Driver's Side Front Access Panel

3.1 Remove six fasteners securing the windshield washer hose and the interior access panel.

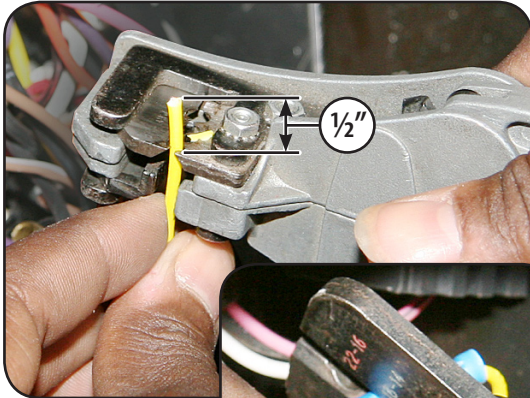
Typical Wire Stripping

3.7 Strip the purple wire 1008 and yellow wire 1009 from the main harness 1/2 inch from the ends. Splice wires together using butt connector provided (BB #00036507).

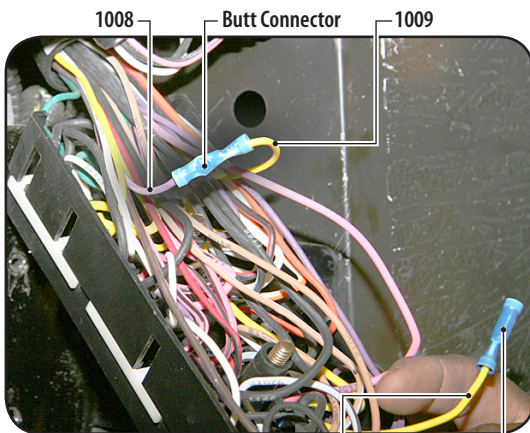
4" Yellow Wire from Vandal Lock Relay  
Splice to new loomed wire provided.

3.8 Strip the 16 gauge loomed wire provided (BB #01871300) and the 4 inch yellow 18 gauge wire coming from the Vandal Lock Relay (referenced in step 3.6) 1/2 inch from the ends. Splice wires together using butt connector provided (BB #00036507).

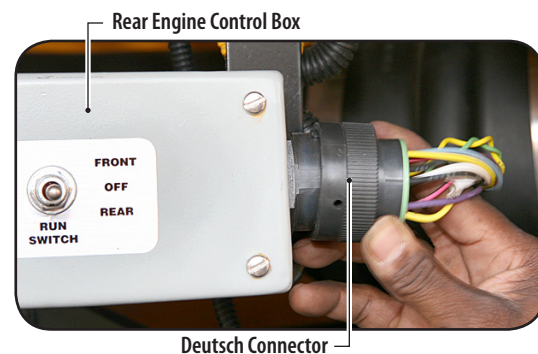
Deutsch Connector

5.1 Remove Deutsch connector from the Rear Engine Control Box. Locate pin positions "X" and "W".
