MODEL: 2008 & 2009 KLR™ 650 (KL650E8F/L, KL650E9F/L)**TITLE: MAIN HARNESS INSPECTION**

RECALL

On eligible units, the main harness can chafe against the frame and cause the engine to stop running creating the potential for a crash resulting in injury or death.

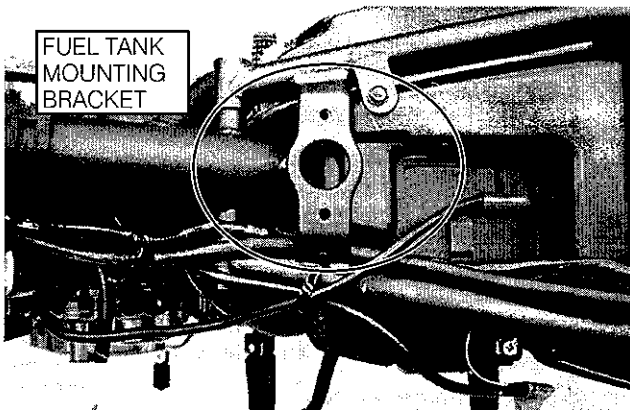
- Remove the side covers, seat, fuel tank and both upper cowlings.
- Check for damage to the main harness leads under the fuel tank mounting bracket.

o *If any copper wire has been exposed, remove and replace the main harness. If harness requires replacement, harness kit must be installed also. If chafing has occurred but has not exposed any copper wire, repair the chafing with harness black electrician's tape.*

- Position the main harness under the reservoir overflow tube so it does not contact the fuel tank mounting bracket. Secure the main harness and overflow tube to the frame tube with the 200mm band included in the harness kit.

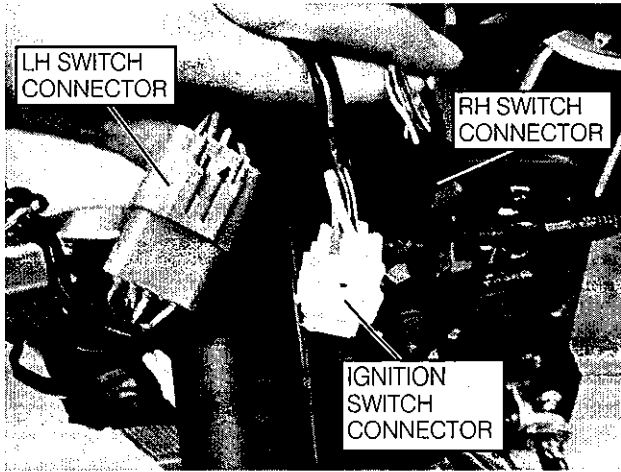
- Pull out the three connectors (LH and RH switch housing connectors and ignition switch connector) from backside of the head pipe and disconnect the connectors.

- o Take care not to cut/damage the leads on the head pipe gussets, etc.

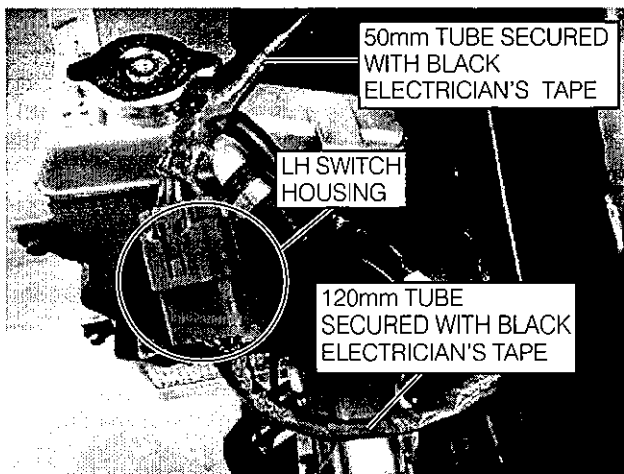
- Check the leads of the LH and RH switch housing and ignition switch for damage.

- Install the 50mm PVC tube on the upper forward LH switch housing lead and secure with black electrician's tape.
- Install a 120mm PVC tube on the lower aft LH switch housing lead and secure with black electrician's tape on both sides of the connector.

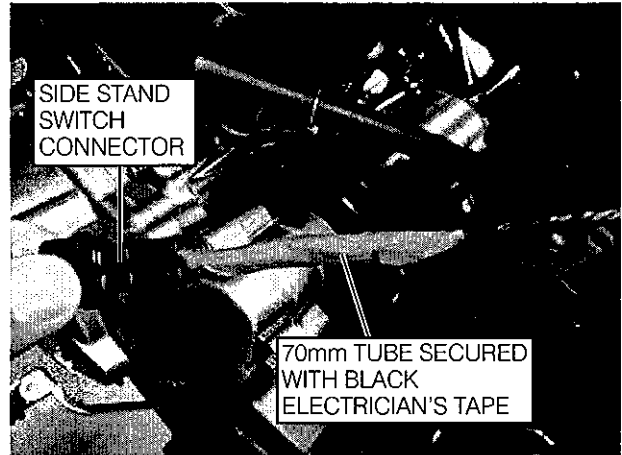
- Disassemble the starter relay cover and disconnect the side stand switch connector.
- Inspect side stand switch leads for damage.

- o If any copper wire has been exposed, remove and replace damaged parts. If chafing has occurred but has not exposed any copper wire, repair the chafing with black electrician's tape.
- Install the 70mm PVC tube on the side stand switch leads (on harness side).
