Re: Recall No. 09V-062 Supplemental Information

MODEL: 2008 & 2009 KLR™650 (KL650E8F/L, KL650E9F/L)

TITLE: MAIN HARNESS INSPECTION

## RECALL

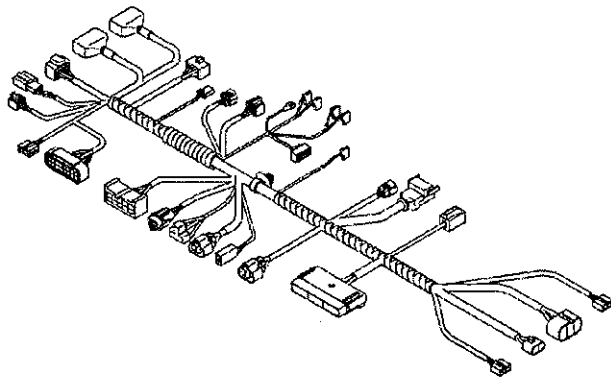
On eligible units, the main harness can chafe against the frame and cause the engine to stop running creating the potential for a crash resulting in injury or death.

Kawasaki has initiated a Recall campaign to repair all eligible units. The repair consists of reinforcing and rerouting the main harness and removing a clamp and a plate.

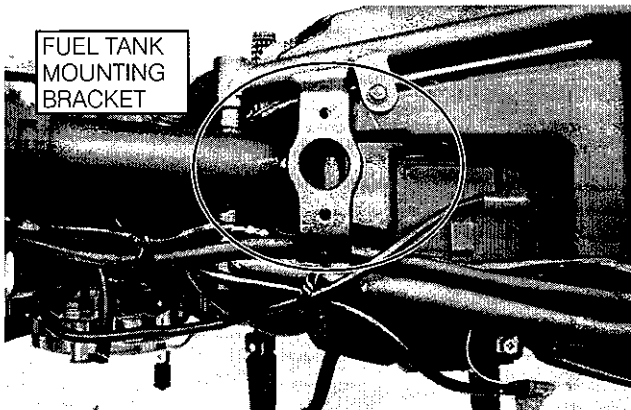
- Remove the side covers, seat, fuel tank and both upper cowlings.
- Check for damage to the main harness leads under the fuel tank mounting bracket.

*o If any copper wire has been exposed, remove and replace the main harness. If harness requires replacement, harness kit must be installed also. If chafing has occurred but has not exposed any copper wire, repair the chafing with harness black electrician's tape.*

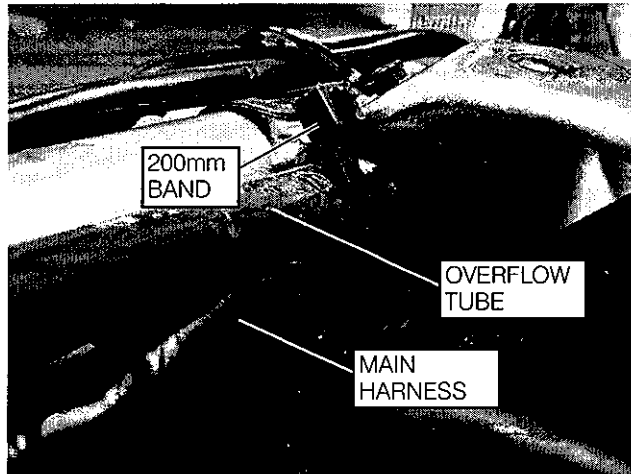
- Position the main harness under the reservoir overflow tube so it does not contact the fuel tank mounting bracket. Secure the main harness and overflow tube to the frame tube with the 200mm band included in the harness kit.

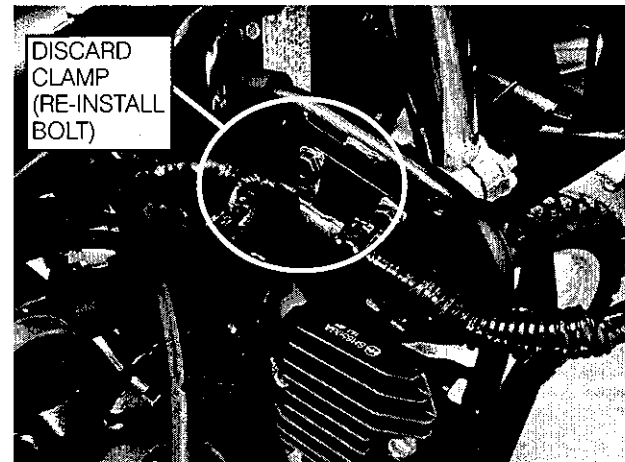
- Remove and discard the inside clamp on the horn bracket. Reinstall the bolt.

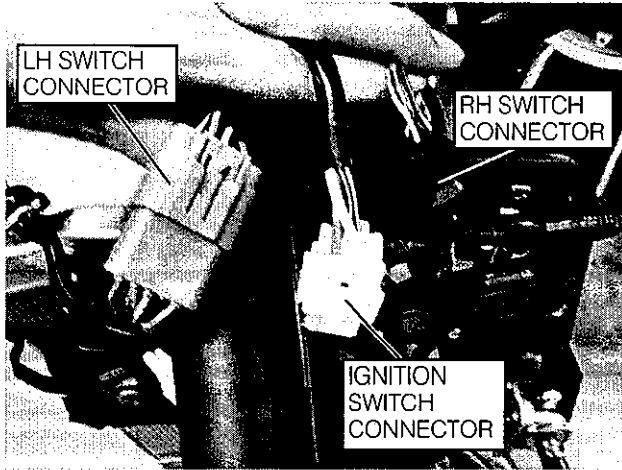
- Pull out the three connectors (LH and RH switch housing connectors and ignition switch connector) from backside of the head pipe and disconnect the connectors.

- o *Take care not to cut/damage the leads on the head pipe gussets, etc.*

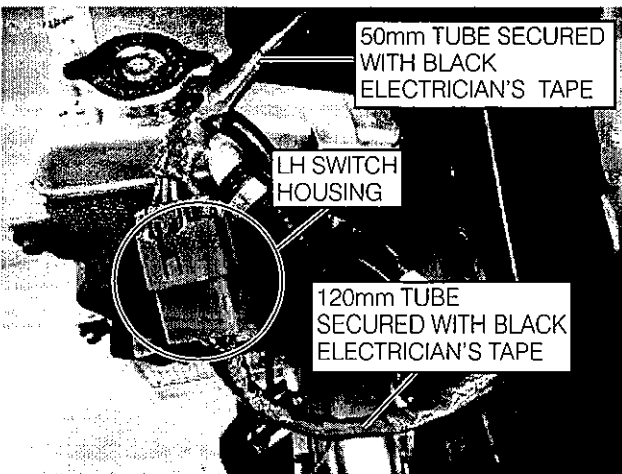
- Check the leads of the LH and RH switch housing and ignition switch for damage.

- o *If any copper wire has been exposed, remove and replace the damaged parts. If chafing has occurred but has not exposed any copper wire, repair the chafing with black electrician's tape.*

- Install the 50mm PVC tube on the upper forward LH switch housing lead and secure with black electrician's tape.
- Install a 120mm PVC tube on the lower aft LH switch housing lead and secure with black electrician's tape on both sides of the connector.

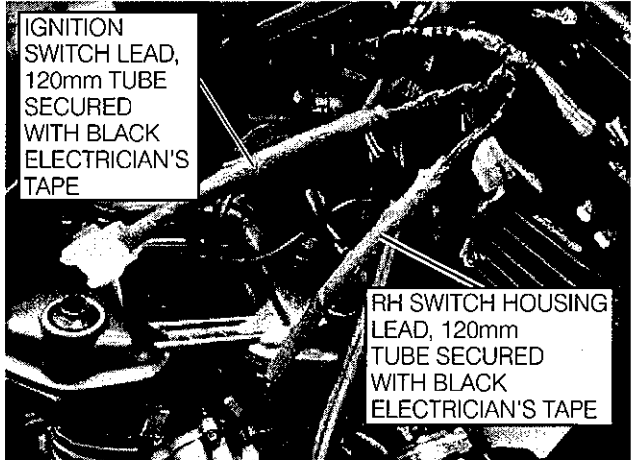
- Install a 120mm PVC tube on the RH switch housing lead and ignition switch lead of main harness and secure with black electrician's tape on the harness side of the connectors only.

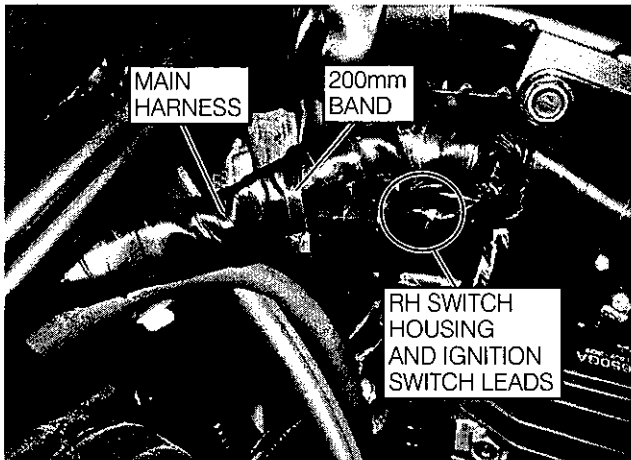
- Apply dielectric grease to the connector pins and connect the connectors and position the ignition switch connector and RH housing switch connector vertically into the backside of head pipe.

- Fasten the RH switch housing lead and ignition switch lead to the main harness with a 200mm band included in the harness kit.

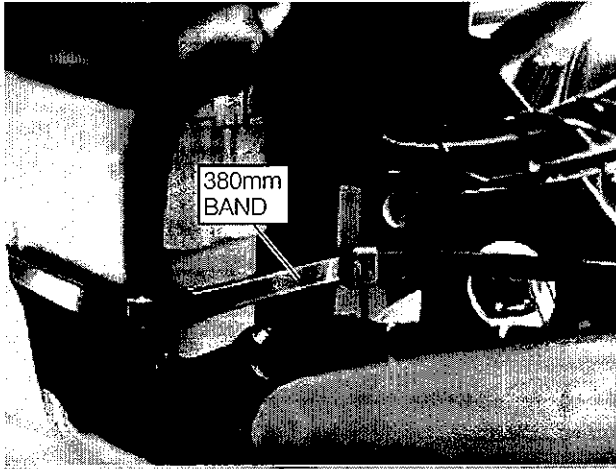
- Secure the connectors inside the opening on the backside of the head pipe with the 380mm band included in the harness kit.

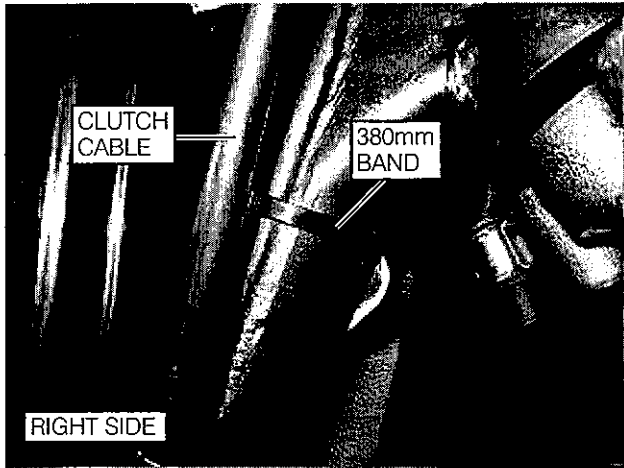
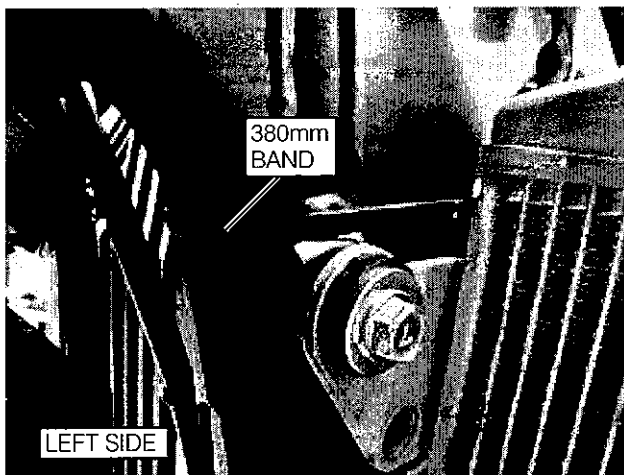
- o Route the band under the clutch cable and above the radiator mount.

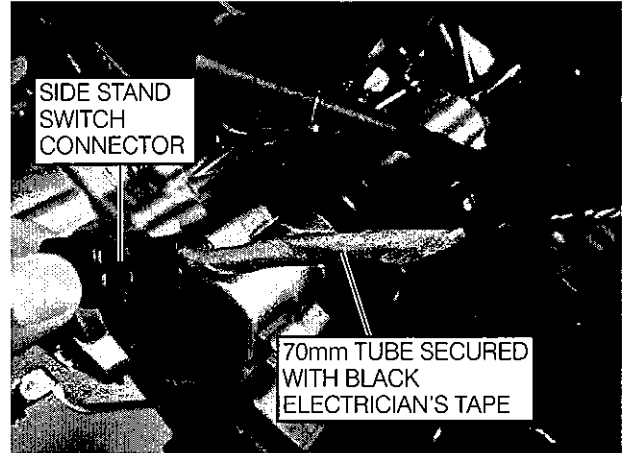
- Disassemble the starter relay cover and disconnect the side stand switch connector.
- Inspect side stand switch leads for damage.

- o If any copper wire has been exposed, remove and replace damaged parts. If chafing has occurred but has not exposed any copper wire, repair the chafing with black electrician's tape.
- Install the 70mm PVC tube on the side stand switch leads (on harness side).
